[Three] Examples of Ferroresonance in Distribution Systems

Roger C. Dugan Sr. Consultant Electrotek Concepts, Inc.

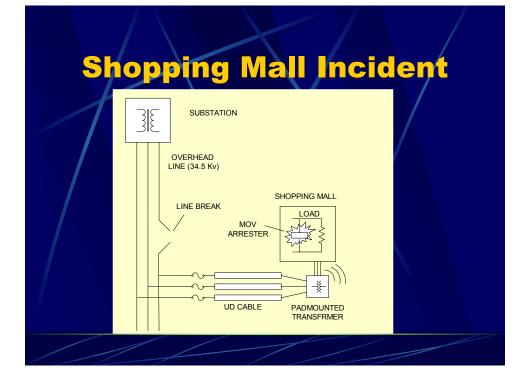
Shopping Mall Incident

34.5 kV distribution system

- "Power Surge" & Noisy Transformer
- Paint on top bubbled, charred
- Transformer tested OK
- Root Cause: Automobile accident
- Failures:TVSS in mall registers, etc
- 3-phase load likely tripped

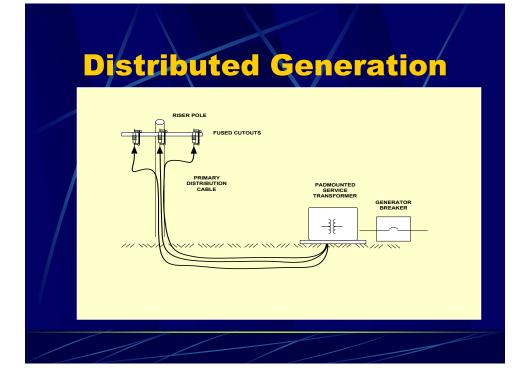
Distributed Generation Interconnection requirements conflict DG must have separate transformer DG must separate at first sign of trouble If trouble is a blown riser pole fuse, unloaded transformer yields ideal

Same issue in modern commercial buildings

ferroresonance condition

Solutions

Three-phase switchgear at riser pole
Too expensive for small generators
Recommendation: No fuses between substation and 3-phase DG
3-phase reclosers or sectionalizers
Replace cutouts with solid blade Potentially detrimental to PQ

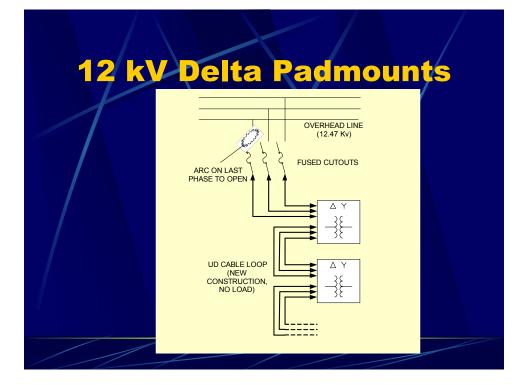
12 kV Padmounts...

- Ferroresonance less likely at 12 kV than at 25 or 35 kV
- Grd Wye-wye transformers the norm at 25 and 35 kV
- Many utilities continue to use deltaconnection in 12 kV systems without many known problems

Corrective Measures

- 3-phase switchgear
- Open or close all three cutouts as
 - simultaneously as possible
- Ensure the transformer is loaded while being switched.
- Eliminate fuses
- Prevent inadvertent fuse operation
 - Animal guards, etc.
