Norman Kerle · Benjamin van Wyk de Vries ·  
Clive Oppenheimer

## New insight into the factors leading to the 1998 flank collapse and lahar disaster at Casita volcano, Nicaragua

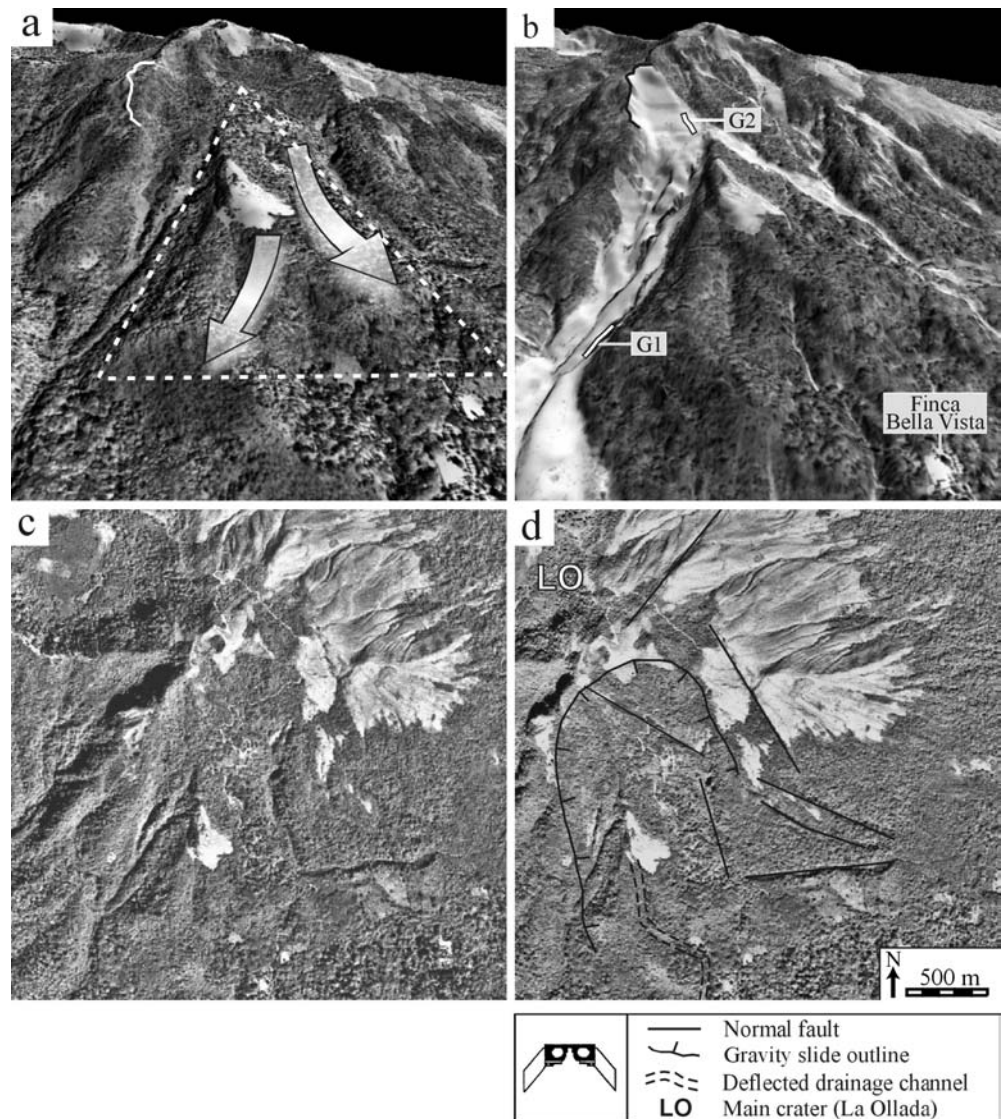
**Fig. 2** **a** Pre- and **b** post-disaster DEMs of Casita, surface-draped with corresponding aerial photographs acquired in 1996 and 2000. Note how edifice-wide deformation has resulted in a triangular gravity slide along Casita's southern flank, forming adjacent ravines through which avalanche material descended following the flank collapse (*solid lines* indicate failure scarp). The locations of gullies G1 and G2 surveyed before and after the 2000 rainy season are indicated. **c, d** 1996 stereogram of Casita's south-east sector, with major faults and deflected drainage channels indicated. All stereograms in this paper are best viewed with a standard pocket stereoscope

Figure 2 shows pre- (a) and post-event (b) digital elevation models (DEMs) of Casita's south-eastern flank, surface-draped with aerial photos taken in 1996 and 2000, respectively. The DEMs outline the crescentic gravity slide that is marked by steep headwalls, which enclose a roughly triangular area delimited in the east and west by prominent ravines, and by basal thrusts in the south. The main debris avalanche followed the western one of the

ravines, while approximately 15% of the material overflowed into the eastern ravine (Scott et al. 2003). An analysis of the structural features, including the steep, horseshoe-shaped rim, and deflected fault lines and drainage channels (Fig. 2c, d) has suggested ongoing edifice deformation (Kerle and van Wyk de Vries 2001), which is thought to have begun at least 500 years ago, and is considered to be the result of a hydrothermally altered core (van Wyk de Vries et al. 2000). Such deformation, however, also implies the possibility of changes in erosion patterns, and an active headward propagation of gullies located within the western ravine originating at the collapse site (Montgomery and Dietrich 1988, 1989; Hovius et al. 1998). A set of aerial photos spanning 42 years (Table 1) was obtained to investigate such temporal changes in gully size and extent. Three stereo, pre-event datasets, acquired in 1954, 1987 and 1996, were used in the analysis. While an orthorectification of the 1996 photos was possible, poor image quality and lack of camera information for the 1954 and 1987 photos precluded using them for topographic correction. However, image quality and scale were sufficient for all datasets to be used in a qualitative stereoscopic analysis in ERDAS Imagine's StereoAnalyst (essentially a digital stereoscope). Figure 3 depicts stereograms of the Casita failure area and the western ravine, which is dominated by two principal gullies. Each stereo-pair is complemented by a drawing that outlines areas of hydrothermal alteration, the principal and secondary gullies and depressions, and the extent of the flank failure. Note that the stereograms are vertically exaggerated as a function of photo-overlap and flying height, which must be considered during photo interpretation. When viewed with a pocket stereoscope, it is apparent that the overall shape of the gullies in 1996 was not different from 1954 and 1987. An apparent decline in hydrothermal activity over the time period covered by the photos, associated with an increase in vegetation cover, is likely to have contributed to the stability. Only the shallow depression upslope from the principal gullies had grown in extent. Of greater concern for flank instability appears to be a depression labelled D1 in the 1954 structural map. However, the apparent undercutting of the slope is virtually unchanged in the 1996 photos.

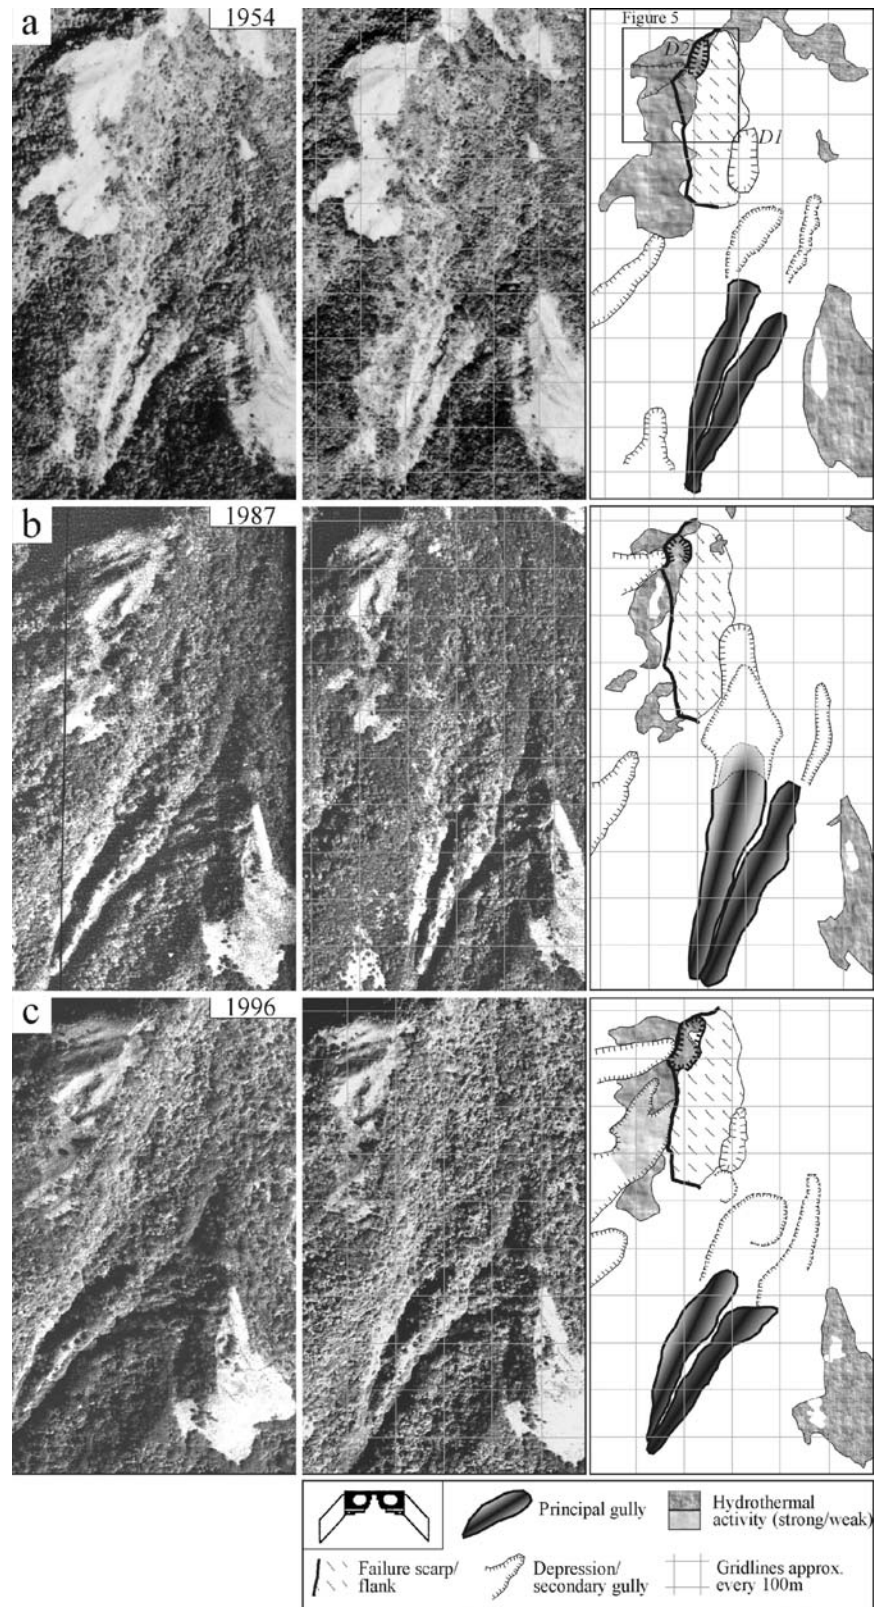
While the morphology of the western ravine shows high temporal stability, significant changes occurred near the top of the failure scarp (indicated by the solid black line in Fig. 3). The north-eastern section of the hydrothermal field contains an oval-shaped depression (D2 in Fig. 3a). In 1954 it was only faintly apparent, and had a length of approximately 60 m. By 1996 it had deepened and extended to about 110 m in length, as illustrated in the close-up stereograms shown in Fig. 5b, c. By the time of failure, the section had extended along more than a quarter of the length of the eventual failure scarp, and was entirely incorporated in the collapse material (Fig. 3c). Although the magnitude of the change in depth can not be quantified due to the aforementioned inferior quality of the 1954 photos and lack of camera information, the increase in size in all three dimensions is clear. The depression further corresponds precisely to an area of highly fractured and brecciated lava and tephra, strongly hydrothermally altered, and with clear signs of subsidence (Fig. 5a). The area is distinctly separated from a well-layered, largely undeformed and unaltered section to the south. This deformation would have fuelled further fracturing, and facilitated infiltration of meteoric water, the effects of which are discussed in more detail in a later section.

**Fig. 3a–c** Stereogram time series of the 1998 flank failure site and the western ravine through which the initial avalanche travelled, and corresponding structural drawings. Photographs shown were acquired in **a** 1954, **b** 1987 and **c** 1996. The photos document a lack of significant morphological change in the principal gullies, an increase in depth and extent of a small depression (*D2*) within the failure area, and a decrease in hydrothermal activity, evidenced by increased vegetation cover

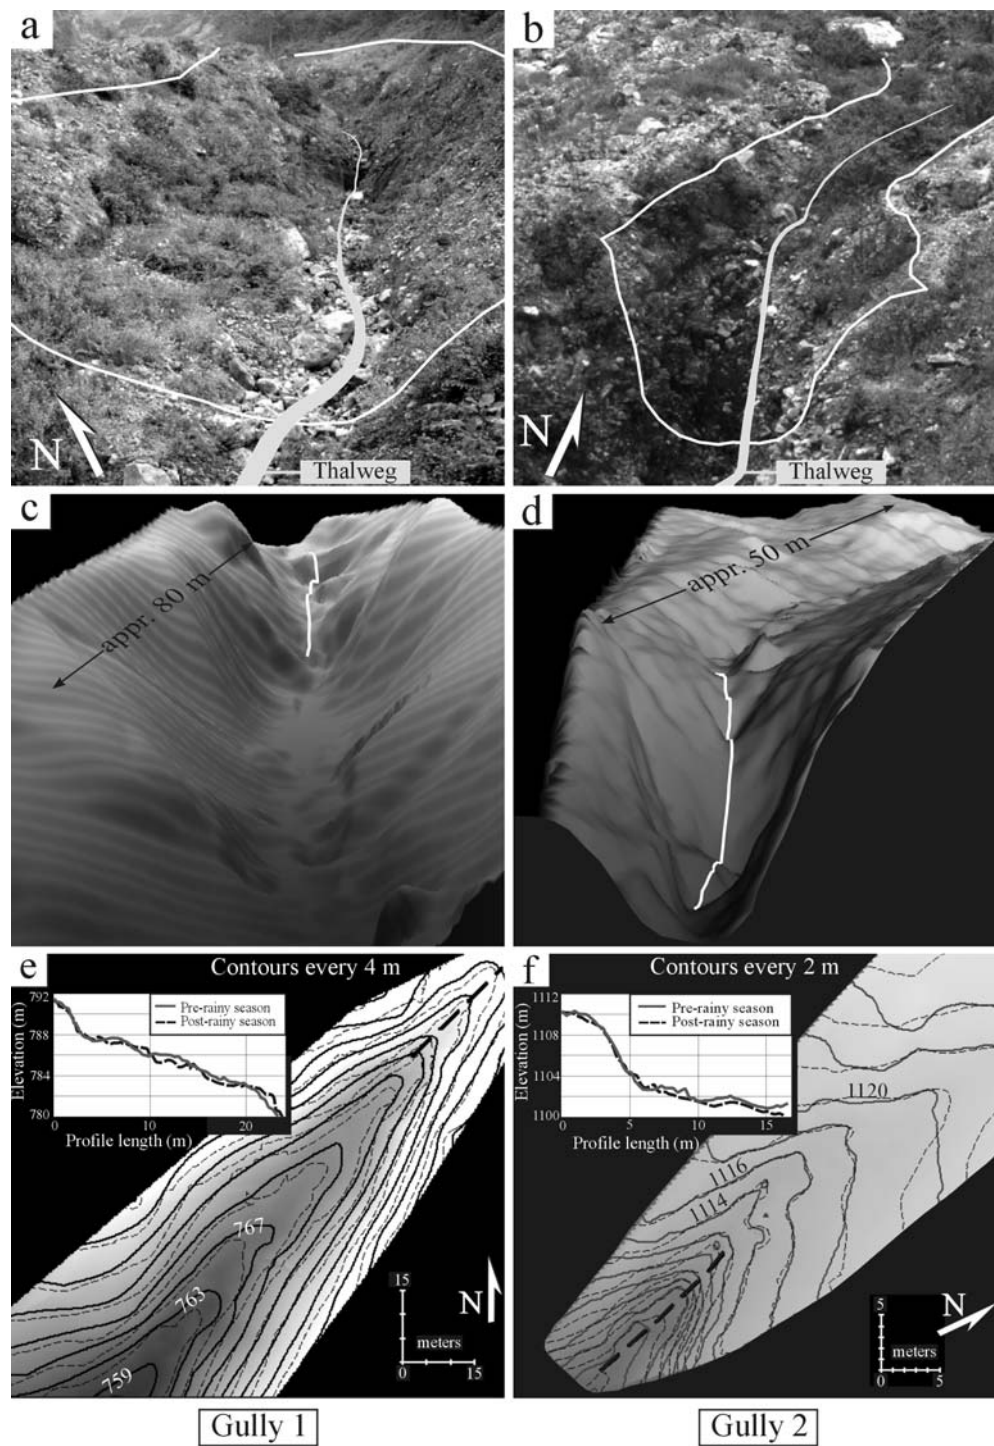
The stabilising effect of vegetation was lost when the avalanche denuded the ravine (see Mejia-Navarro et al. 1994). To test for short-term changes in morphology, two gullies, G1 and G2 (Fig. 4a and b, respectively, locations marked in Fig. 2b), were surveyed. The surveys were carried out in March and November 2000, effectively bracketing the annual rainy season. Approximately 1,600 mm of precipitation were recorded in Chinandega during that time, including more than 400 mm between 30 September and 3 October during Hurricane Keith (INETER, archived data). For each gully, between 170 and 350 measurements were collected with a Geodimeter Total Station during each survey, resulting in detailed DEMs with 0.3-m grid spacing. Figure 4c, d illustrates the topography of both channels before the rainy season. The

lack of significant long-term change in gully morphology observed during the time-series photo interpretation was mirrored by the survey. Despite strong rainfall and lack of vegetation, no appreciable changes occurred along the gully heads. Figure 4e, f shows superimposed contours for both gullies, interpolated from the respective pre- and post-rainy season data. Profiles for the actual gully head (thick hatched line, and solid white line in c, d) are virtually unchanged. The survey suggests that gradual erosion from surface runoff plays a limited short-term role in gully propagation. This can be explained by the slope material, which consists of block- and boulder-rich deposits from previous avalanches, which provide resistance to fluvial erosion (Fig. 4a, b; see also Fig. 5 in Kerle and van Wyk de Vries 2001). Previous studies, both in temperate (Montgomery and Dietrich 1988; Dietrich et al. 1993) and tropical (Hovius et al. 1998) environments, have identified mass failures along gully heads as the primary engine for drainage network expansion. The lack of steady, erosion-induced morphological change in the surveyed gullies, even under favourable conditions, points to a similar mechanism at Casita.

**Fig. 4a–f** Analysis of morphological changes in two gullies within the western ravine over the course of the 2000 rainy season. **a, b** Photographs of the gullies, with the approximate extent of the area surveyed (*thin white line*) and the thalwegs indicated. **c, d** DEMs of the surveyed gullies, interpolated from the pre-rainy season data collected with a Geodimeter Total Station. **e** Contour lines calculated from the pre- and post-rainy season datasets of gully 1 and **f** gully 2 (refer to Fig. 2b for gully locations). *Insets* show elevation profiles of the two gully heads, which demonstrate that no upslope gully propagation occurred during the 2000 rainy season. The profiles are marked by *solid white lines* in **c** and **d**, and *thick hatched lines* in **e** and **f**. See text for discussion

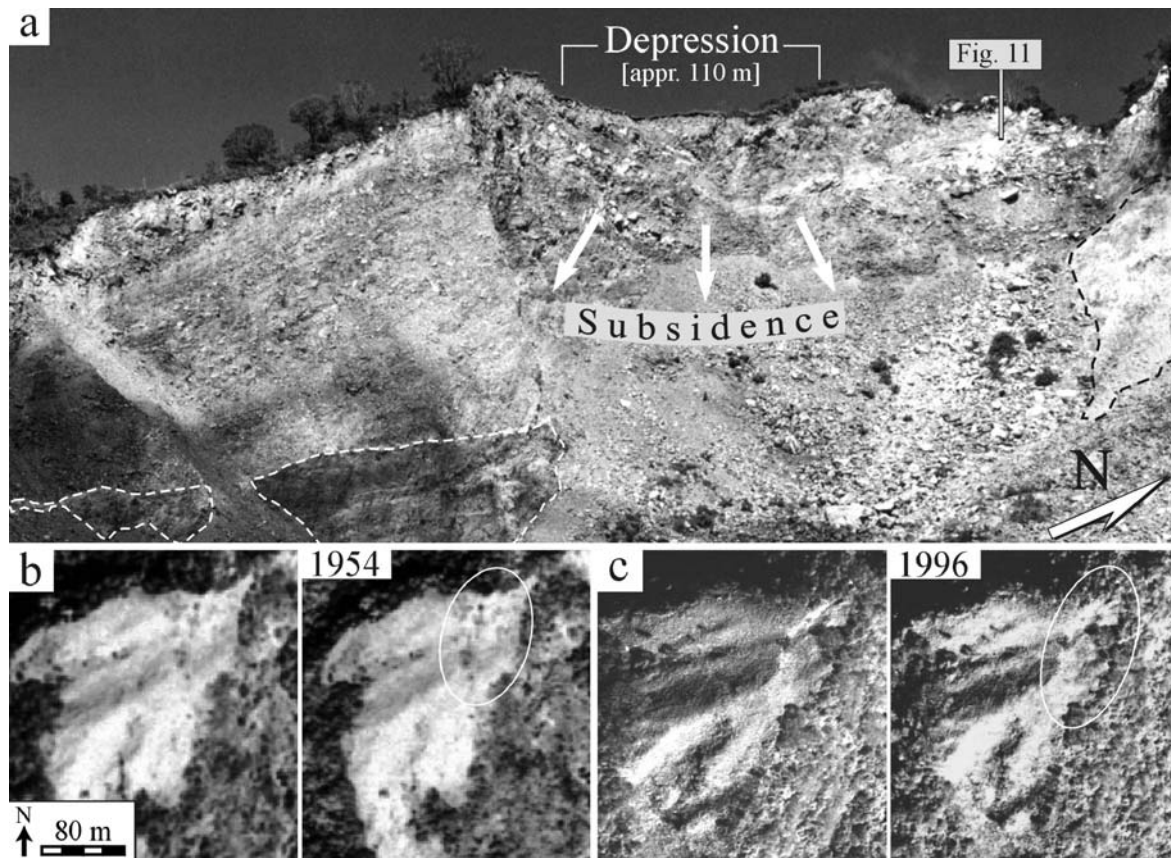
**Fig. 5** a Photograph of the 1998 failure scarp, showing a central area of subsidence, marked by heavily hydrothermally altered and brecciated material. This area corresponds to the depression

identified in Figs. 3a–c. b, c Large-scale stereograms of the depression, showing how the area has become larger and deeper between 1954 and 1996

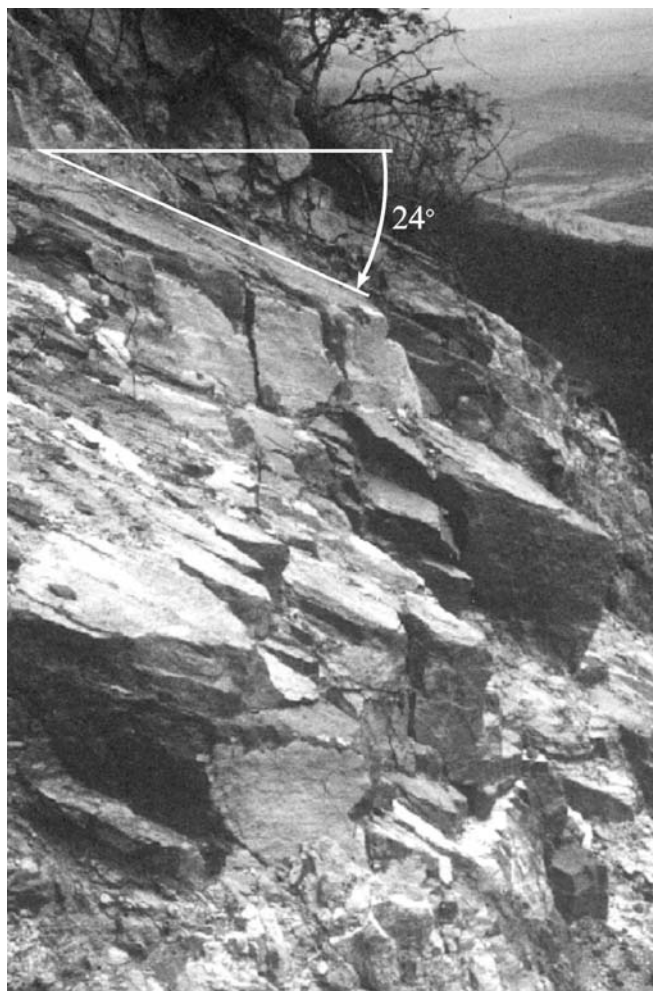
**Fig. 11** Lava and tephra lithologies dipping south by as much as  $24^\circ$ . Viewing direction is towards the east. Photo location is indicated in Fig. 5a

a fast pressure rise (Harper 1975). Surface flow drainage is not slope-parallel, but produces a curved flow field that directs seepage forces outwards from the slope (Iverson and Reid 1992). Such flow, which also leads to shear stress, is facilitated where low-conductivity layers are encountered (Reid and Iverson 1992), a condition provided by the clay-rich bedrock layer. At Casita this was increased by flank material dipping towards the south by as much as  $24^\circ$  (Fig. 11).

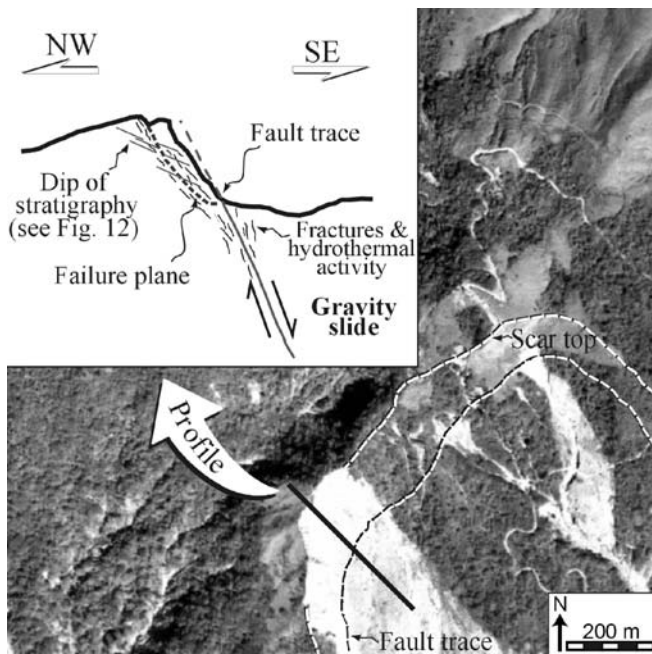
**Fig. 12** Post-failure orthophoto, superimposed with the approximate location of the gravity slide boundary fault and the top of the scar. *Inset* shows a structural cross section of the failure cliff

earthquakes have occurred in its vicinity in the past. Damage reports for seismic events in 1938 and 1955 indicate a strong intensity amplification by the volcanic structures, as well as the ability of such events to open new surficial cracks and fissures. Given that several comparable earthquakes occurred between Alleta and Mitch, notably in 1983 and 1987 (magnitudes of 6.0 and 6.2, respectively), we can assume that those events had a cumulative destabilising effect on Casita's summit area. The consequences for the 1998 failure site could have been particularly severe, as the failure plane runs above the gravity slide-bounding fault (Fig. 12).
