6. Priority Pollutants and Critical Areas

6.2. Critical Areas

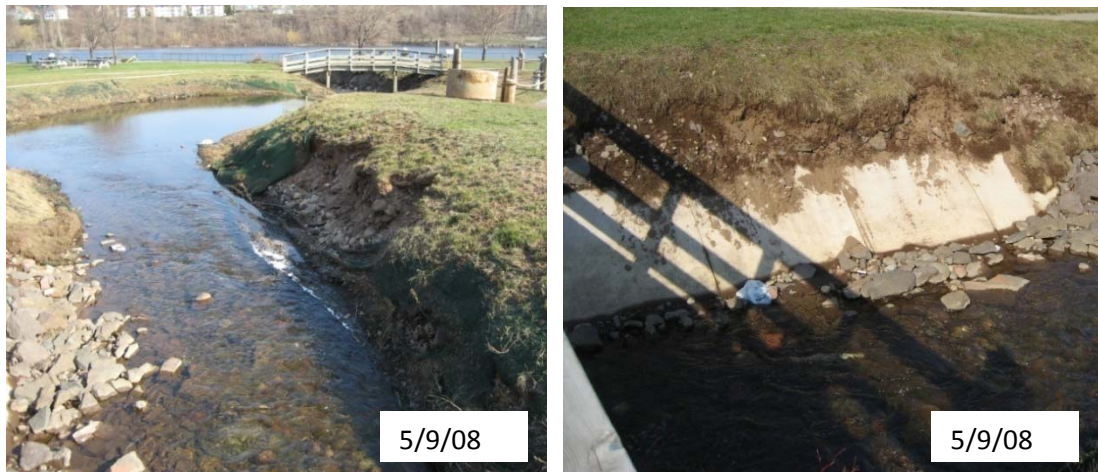
Figure 6.2 Eroded banks in the Kestner Waterfront Park

2007 caused several bank areas to completely fail (Figure 6.2) resulting in steep, undercut and unprotected slopes. Various methods have been used to attempt to stabilize the banks over the years including rip-rap, herbaceous plantings and erosion matting with lawn grass. Each method has eventually given way to severe bank erosion.

The priorities for this area are (a) the repair and stabilization of the creek banks, (b) planting of vegetation along the creeks banks to provide a more natural setting, and (c) replacing the sidewalk-culvert outlet with a bridge. The improvement of the creek in the Waterfront Park is recognized as a high priority by the Huron Creek WAC, since the park is practically the only location where the public interacts with the creek, and so it is especially important to present the creek as a natural amenity here. The thought is that, if the public enjoys the creek as a natural amenity in the park, they are more likely to support the protection and restoration of the remainder of the creek and its watershed.

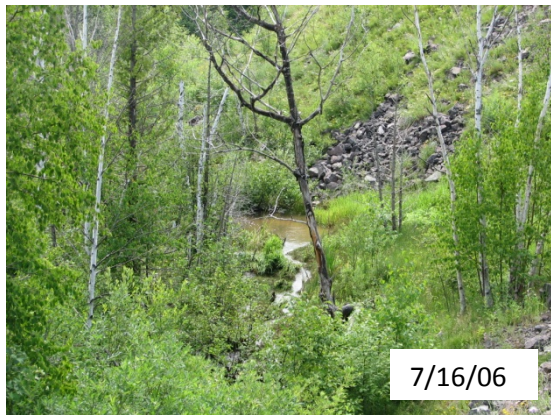
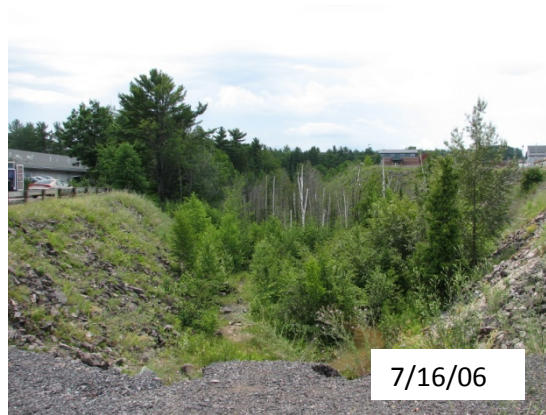
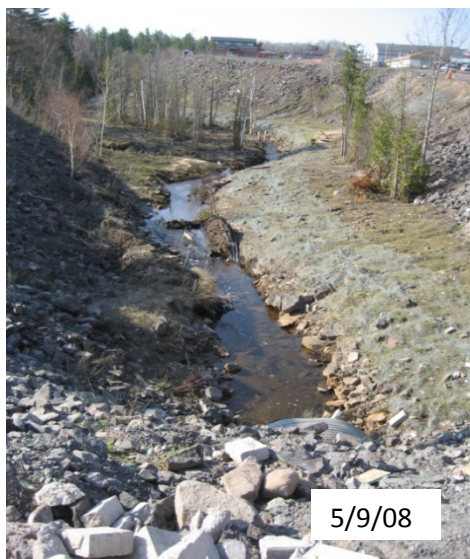
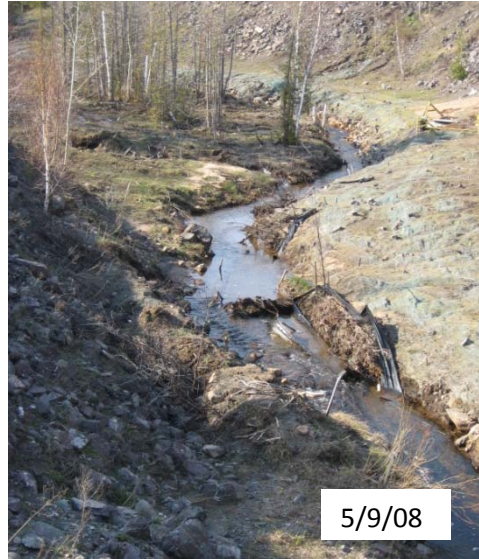
Figure 6.4 Huron Creek and leachate collection system installation area

Although the installation of the leachate collection system is potentially solving the problem of leachate impacting the creek's water quality, the construction during installation of the system resulted in disturbance of soils and vegetation along that portion of Huron Creek. The City of Houghton took measures to control erosion and stabilize the site, but some are in need of repair, or additional stabilization should be completed. For example, the steep side slope of the old landfill that was disturbed during construction is showing rill and gully erosion despite installation of erosion matting and attempts at planting grass seed. Grass is only sparsely filling in on erosion mat at the base of the slope due to a thin or non-existent soil layer. Other locations remain with bare soil and would best be stabilized through planting native riparian vegetation. Figure 6.4 shows the creek and construction area as viewed from the current Arby's parking lot. In addition, as seen in Figure 6.4, the dense shrub and tree vegetation that existed before installation of the leachate collection system has not been replaced.

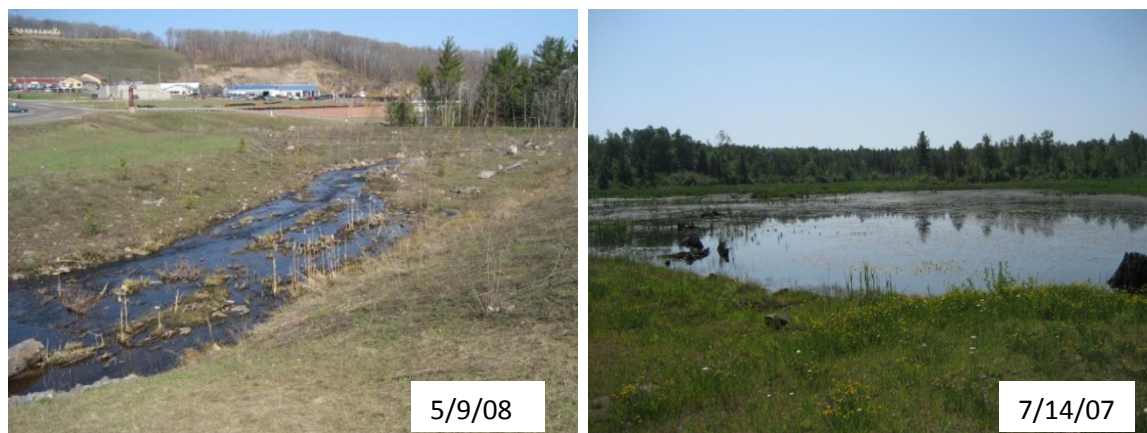
Figure 6.5 Huron Creek Re-route and former Huron Lake mitigation areas

The former Huron Lake area has been rehabilitated and enhanced as part of the mitigation. In the creek re-route area, the vegetation survey and general observations have indicated that much of the vegetation planted there has not survived or has been out-competed by invasive species such as spotted knapweed (*Centaurea stoebe*) and white and yellow sweetclover (*Melilotus alba*, *Melilotus officinalis*).

Currently the creek re-route area is open and does not have a variety of tree and shrub species that might provide shade and thereby reduce the warming of the creek water. Invasive species such as spotted knapweed can prevent establishment of any other vegetation through altering the biological or chemical characteristics of the soil, as well as by out-competing them through reproductive or other adaptive means. Therefore, a main concern for this area is to eliminate invasive species and establish a more diverse, preferably native riparian habitat.

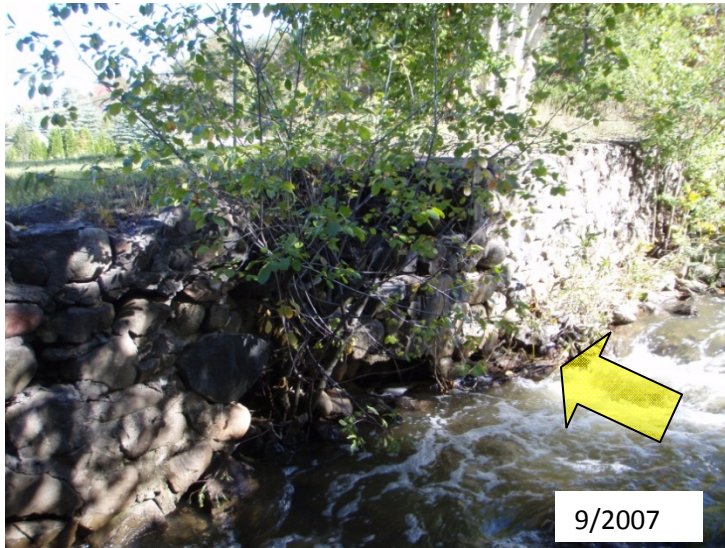
Figure 6.6 Critical Erosion Location "A."

Location "A": At this location, Huron Creek flows through a man-made rectangular rock channel that was constructed during historical mining operations. It is located immediately south of the Kestner Waterfront Park, north of Canal Road. As shown in Figure 6.6, portions of the channel have collapsed causing soil to erode on the bank above, and the creek to undercut the rock wall.

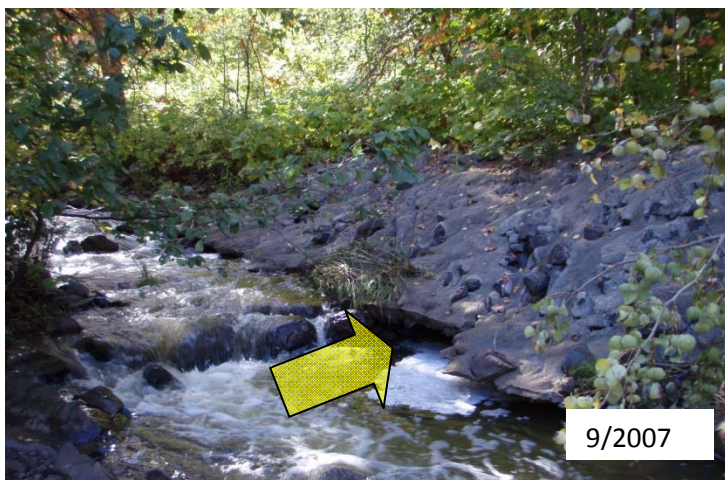
Figure 6.7 Critical Erosion Location "B."

Location "B": This area of erosion is located immediately south of where Huron Creek passes under Canal Road. In this location, concrete was used to stabilize the creek bank. However, as shown in Figure 6.7, the creek has managed to undercut the concrete and is now flowing underneath it.

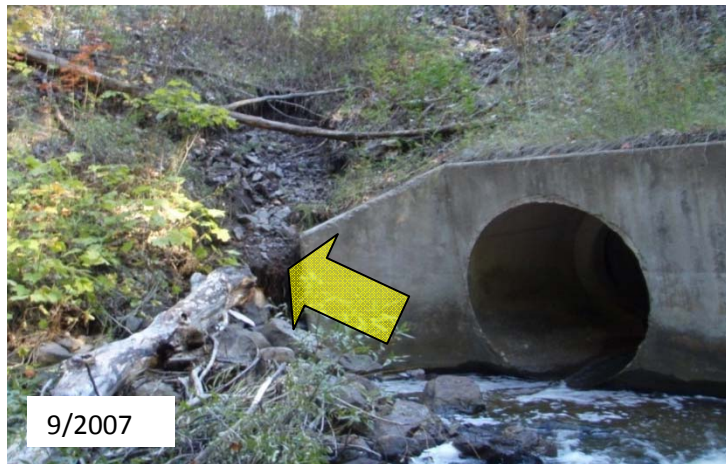
Figure 6.8 Critical Erosion Location “C”

Critical Erosion Location “C”: This site (see Figure 6.8) is located immediately downstream (north) of where Huron Creek passes under Highway M-26. At this location, a gully has formed adjacent to the culvert sidewall and extends up-slope to M-26.

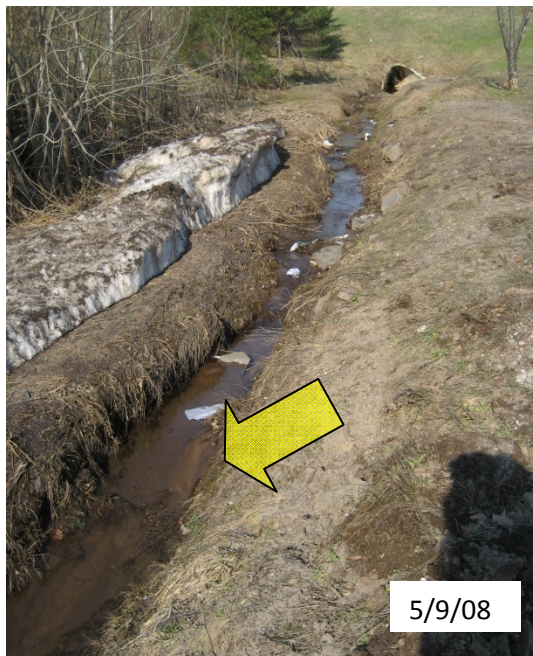
Figure 6.9 Critical Erosion Location “D”

Critical Erosion Location “D”: This site (see Figure 6.9) is a ditch that drains to Huron Creek from a culvert that passes under M-26. The culvert conveys stormwater runoff from the Shopko and Econo Foods areas, and possibly from the Perkins/Kirkish Furniture/Holiday Inn Express development area. The ditch runs between Sharon Avenue and the parking lot of the Rice Memorial Mental Health clinic. It is showing signs of erosion on the parking lot side and undercutting of the banks of the ditch.

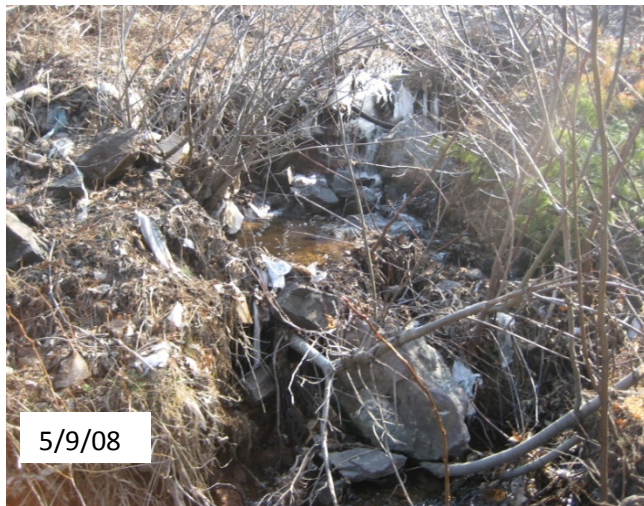
Figure 6.10 Critical Erosion Location “E”

Critical Erosion Location “E”: This site (see Figure 6.10) is located on the west side of the parking area between the Taco Bell and Dairy Queen restaurants. A culvert discharges stormwater at the edge of the pavement which runs down a slope and combines with Huron Creek. The discharge, as well as the steepness of the slope has carved an approximately 2 to 3-foot deep channel. The banks of the channel are undercut and slope failure is apparent. Sediment from erosion of the bank deposits at the base of the slope near where the stormwater enters Huron Creek.

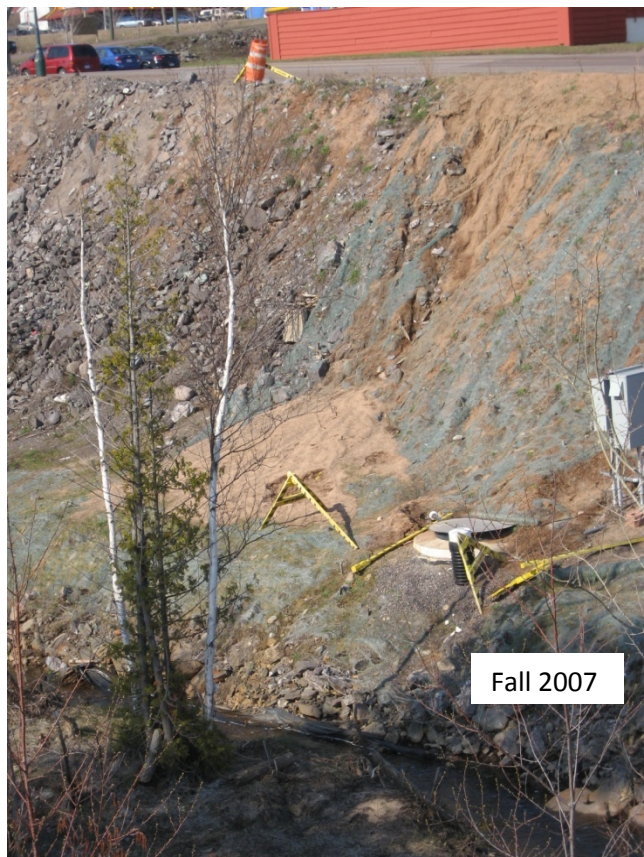
Figure 6.11 Critical Erosion Location “F”

Critical Erosion Location “F”: As mentioned in the description of Critical Area #3, there are several locations of erosion along the steep slopes of this area, predominantly on the west side of Huron Creek. The photo in Figure 6.11 shows a location near Keweenaw Gem & Gift where slope stabilization methods have failed. The photo in Figure 6.12 shows a similar location on the same slope near the Ming Restaurant.

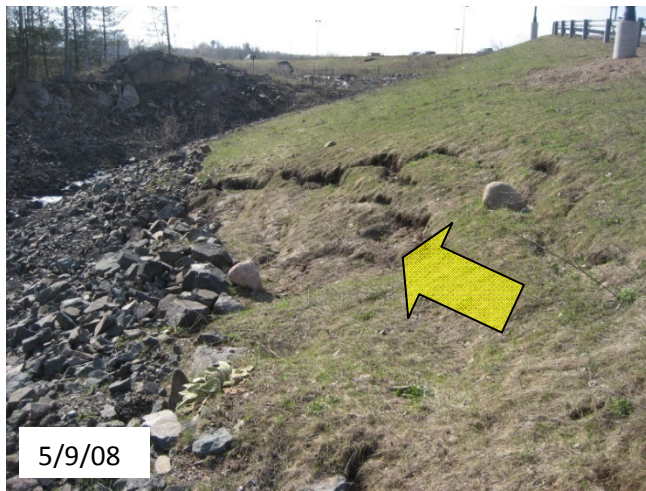
Figure 6.13 Critical Erosion Location "G"

Critical Erosion Location "G": This site is located on the east side of Ridge Road in the creek corridor below Applebee's Restaurant. Here (see Figure 6.13), the soil is showing signs of slope failure. It is evident that the grass planted on this slope is not providing enough stability to hold the soil in place. Although this location is separated from Huron Creek by a zone of rip-rap, it has the potential to create a large area of slope failure and erosion, and may eventually cause sediment to reach the creek.

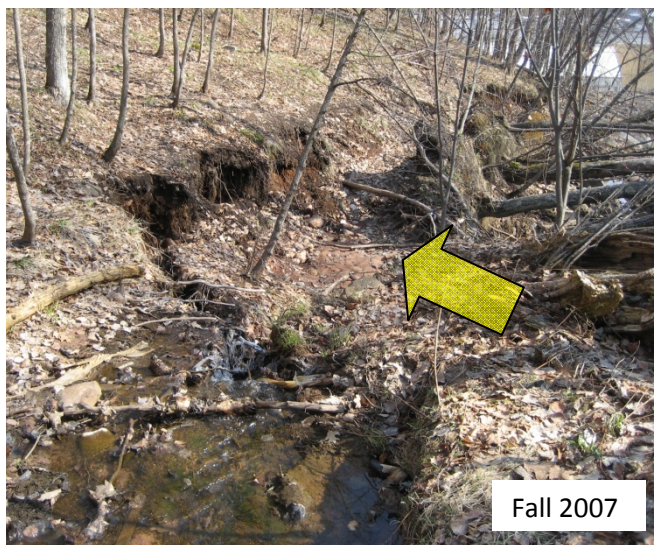
Figure 6.14 Critical Erosion Location "H"

Critical Erosion Location "H": This site is an erosional feature called a headcut, and is one of the most prominent erosion locations in Critical Area 4. A headcut occurs when flow in an earthen channel or gully encounters a weak point (or "knickpoint") and soil is severely eroded downstream resulting in a sudden elevation decrease of the channel bottom (Hanson, 2008). This elevation decrease creates a small waterfall which, through scour occurring at its base, continues movement of the headcut in an upstream direction. As can be seen in Figure 6.14, the entire portion of Shopping Cart Creek that passes through a hill downstream of the headcut is a large eroded

gully. After the gully, the flow follows a smaller channel that passes behind Wal-Mart and then enters the Wal-Mart stormwater ponds prior to discharging to Huron Creek. The headcut poses at least two problems. First, visual observation of the Wal-Mart stormwater ponds indicates that the inlet and outlet culverts are at the same elevation as the bottom of the ponds. If this is the case, sediment entering the ponds is free to pass through them and into Huron Creek. If this is not the case, sediment washing into the storm ponds from Shopping Cart Creek presents a maintenance issue. Sediments collecting in the bottom of the ponds would have to be removed in order to preserve the volume of stormwater the detention ponds were designed for.

Second, The continual movement of the headcut in an upstream direction would eventually lead to the large gully extending all the way to the Copper Country Mall parking lot and culverts. This would result in a large amount of land loss and soil erosion, and may pose a threat to ground stability in the parking lot area.

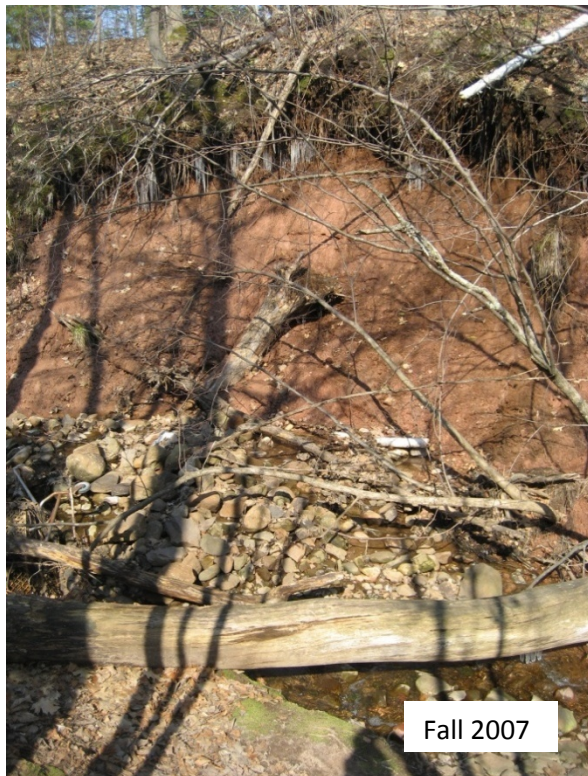
Figure 6.15 Critical Erosion Location “I”

Critical Erosion Location “I”: This site is another prominent area of erosion in Critical Area 4. It is located only a few hundred feet downstream of the Copper Country Mall culverts and the Festival Foods area ditch. As shown in Figure 6.15, the bank of the creek has been eroded away leaving a bare soil and rock face that is approximately 6 to 8 feet high. If this area is not stabilized, it may continue to erode in an outward direction as it is located on the outside of a curve in the creek. As mentioned earlier, this erosion is most likely attributable to the increased peak flow rates and volumes that are generated by runoff from impervious surfaces such as the parking lots of the Copper Country Mall and the development area around Festival Foods.
