FERRORESONANCE

- Case Study #1.: 3Ø transformer in ferroresonance with secondary side cable.
 Case Study #2.: Delta primary wound transformer in ferroresonance with primary underground cable.
 Case Study #3.: Cable in ferroresonance with transformer that has a delta secondary winding
 Case Study #4.: Overhead capacitor in resonance with improperly grounded overhead transformer bank (3-1Ø transformers) with a delta secondary connection
 Case Study #5.: Primary side circuit in ferroresonance with primary flux leakage of grounded y-grounded y 5 legged core & coil transformers
 Case Study #6.: 3Ø overhead transformer bank of 3-1Ø amorphous core transformers in ferroresonance with itself
 Case Study #7.: 1Ø secondary ferroresonance with customer step up transformer - cable - step down transformer
 Case Study #8.: Cable Ferroresonance feeding a Scott T connected 3Ø pad mount transformer.

APPROVALS	FERRORESONANCE	Article	Revision
Sponsor Engineer:		TS-60	
Engineering Best Practices Chairman:	  Ameren Electrical Distribution Design	Sheet	
Date: 05/11/04		1 of 23

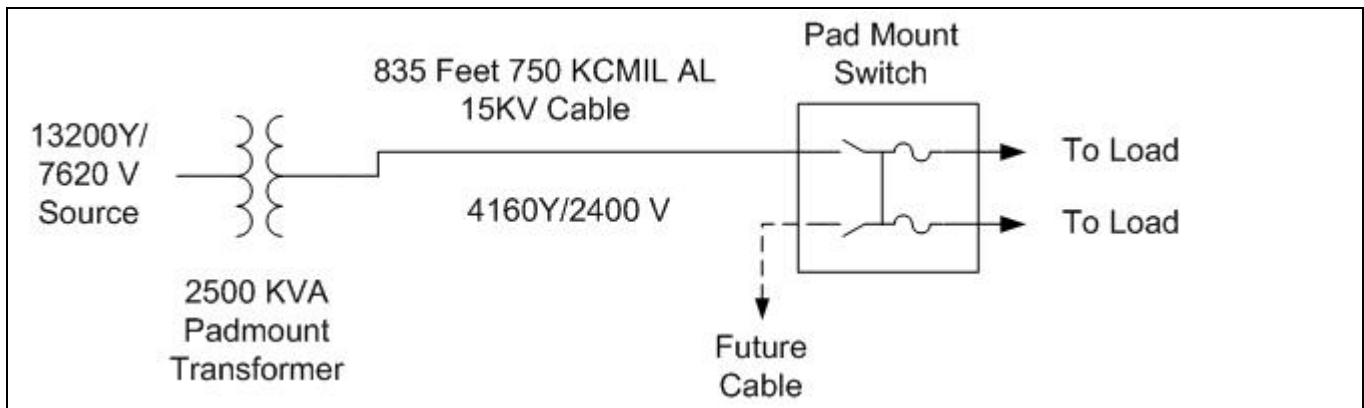
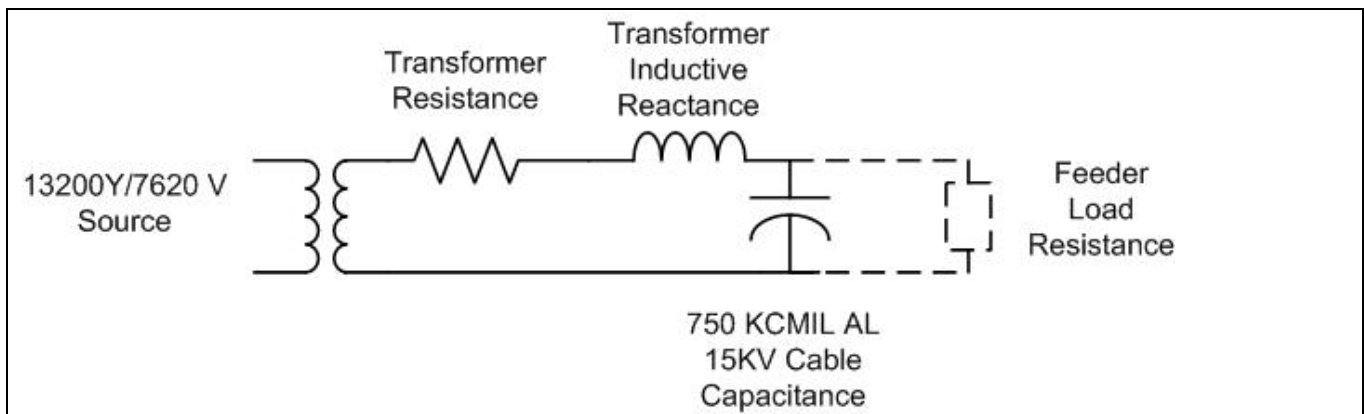
Figure 1. Physical Representation of Case Study #1

A 13200Y/7620 V circuit is feeding a 2500 KVA 3Ø grounded Y-grounded Y 5 legged core & coil padmount transformer that is the source for a 3Ø portion of a distribution circuit operating at 4160Y/2400 V through a 60 foot length of 750 KCMIL AL 15KV EPR underground cable to an overhead line. This transformer had previously been installed to replace an obsolete 13.2KV to 4KV substation which had a little remaining load that could not readily be converted to 13.2KV operation.

A road improvement project has forced the rebuild of the first block of the overhead line to underground construction. The consequence is that this transformer will now feed an 835 foot length of 750 KCMIL AL 15KV EPR underground cable instead of the 60 feet of this cable it formerly fed. At the end of this section of 865 feet is a pad mounted switch that connects to the load. The crew plans to energize the transformer into the 750 AL and then pick up the load with the pad mount switch. When energized, the crew hears the transformer make a lot of noise and fail.

The reactance of the transformer is in series with the shunt capacitance of the cable, creating a resonant circuit which overvoltages and fails the transformer.

Close the padmount switch prior to energizing the replacement transformer, thus connecting the load to the circuit to be energized.

The impedance of the load is lower than the impedance of the cable's shunt capacitance, thereby effectively shorting out the capacitive reactance that goes into resonance with the transformer's inductive reactance.

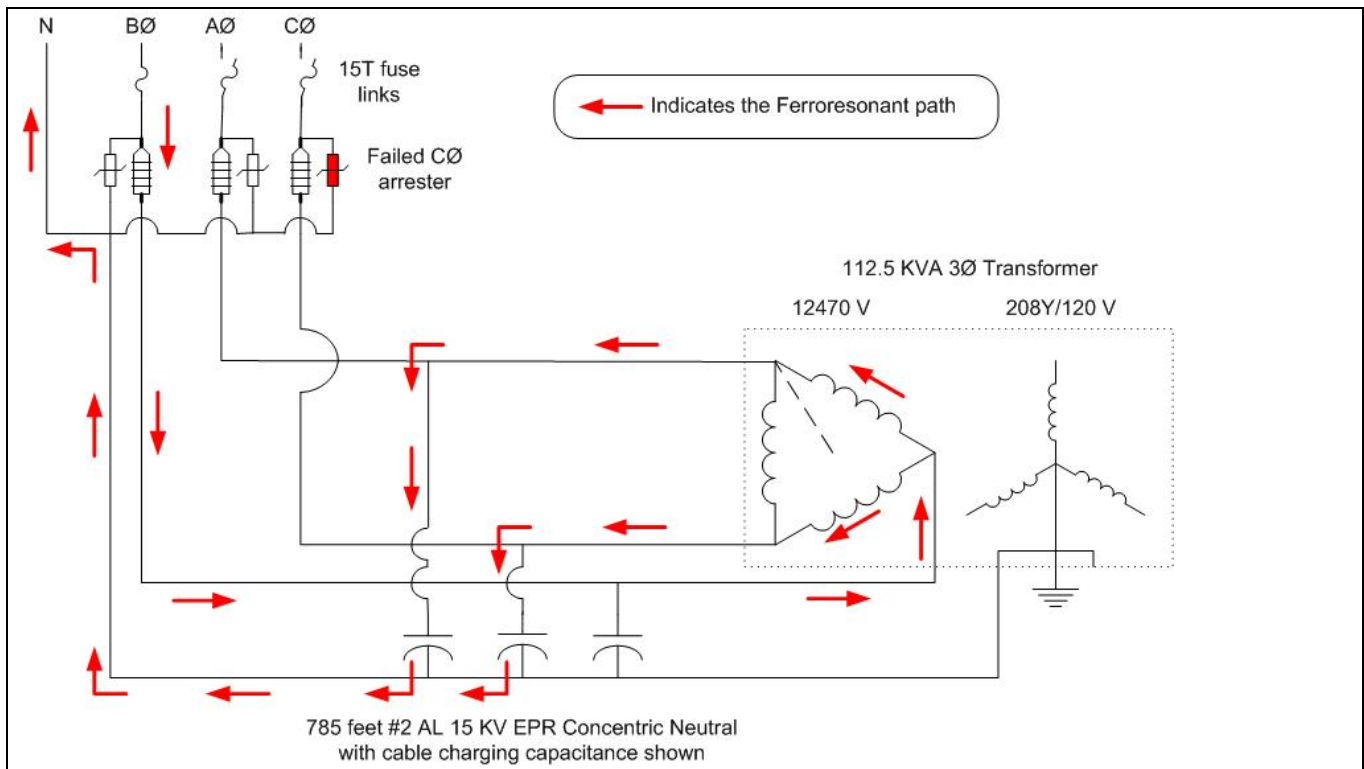
Figure 3. Physical Representation of Case Study #2 with Ferroresonant path shown.

The crew first closed the BØ fused cutout at the riser. The crew then closed the CØ fused cutout. The BØ and CØ cutouts are on opposite sides of the pole. The crew was preparing to close the AØ fused cutout when the CØ surge arrester, installed adjacent to the CØ termination, failed violently and the CØ 15T fuse link opened. The crew estimated the time between closing the BØ cutout and the CØ cutout to be about 10 seconds.

In this scenario, the transformer is energized from BØ and goes into ferroresonance with the un-energized cable capacitance on CØ via the direct electrical connection of the high side winding. The CØ arrester is overvoltaged by the ferroresonance and begins to heat up. When the CØ fuse is closed, energizing the CØ arrester from the line, the impedance of the ferroresonant circuit is bypassed, letting the degraded arrester draw current from the line unrestricted by the ferroresonant circuit impedance. This adds more energy to the already failing arrester, which fails in about 10 seconds, blowing the CØ fuse.

After verifying that the transformer and cable were not damaged the line crew obtained 3 space heaters and clip lead connected the space heaters to the secondary of the pad mount transformer. The transformer then was successfully energized by closing in the fused cutouts in the same BØ, CØ AØ order.

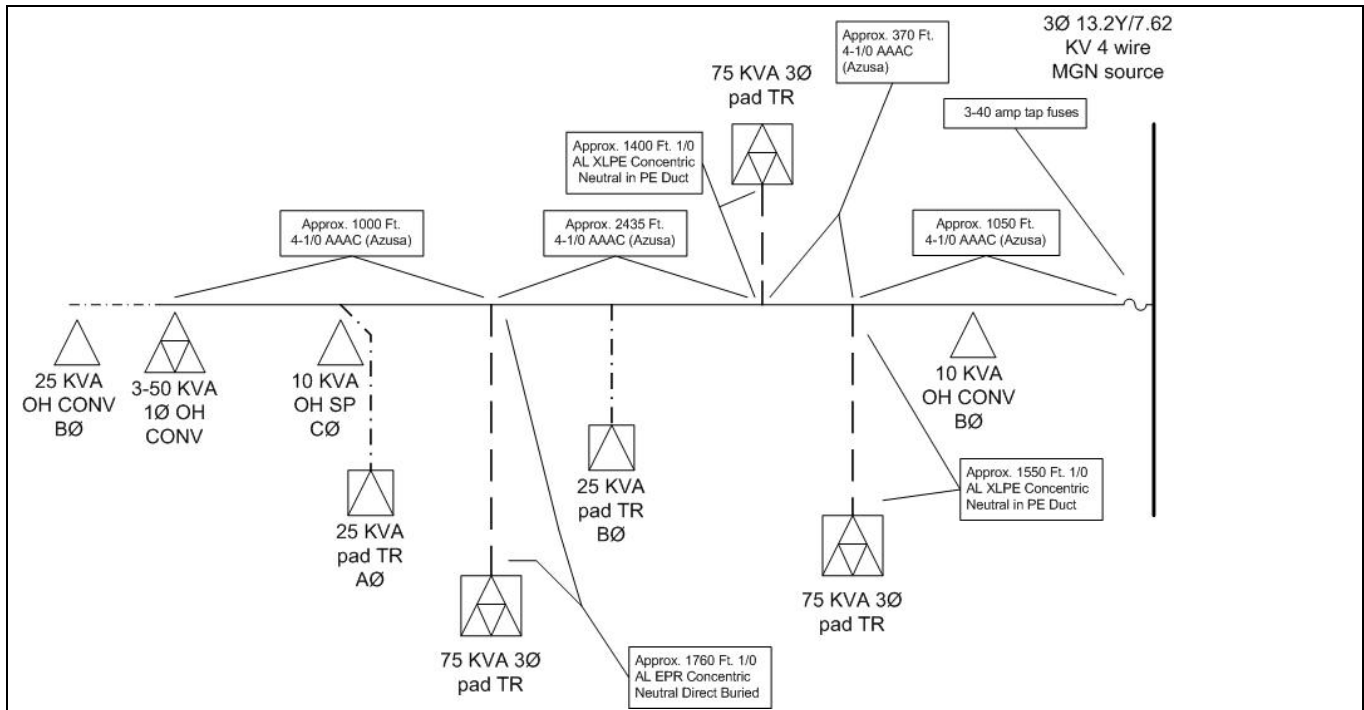
Figure № 5 Case Study #5 Physical Layout with Dimensions

In a rural area, on an overhead 13.2Y/7.62 KV 3Ø fused tap, there are 9 transformer installations serving 9 customers. Five transformers are single phase units feeding residential farms at 120/240 1Ø 3 wire. Another transformer is a 3Ø overhead bank constructed of 3 single phase 50 KVA conventional transformers. The last three transformers are pad mount 75 KVA 13.2Y/7.62 KV design units. All 4 3Ø transformer banks feed irrigation. Each of the 75 KVA pad mount transformers is connected to the overhead 3Ø line with its own dedicated underground tap line. Occasionally there are momentary faults on the overhead line, which blows one of the fuses where this line taps off the 3Ø line feeding it. When a momentary fault occurs, a tap fuse blows, and single phase customers experience 130+ volts on the “faulted” phase.

Some extensive testing was performed. After disconnecting all customers' loads when irrigation was not needed, with 1, 2, or all 3, 75 KVA pad transformers and their respective cable feeds energized in different combinations, one of the tap fuses was opened. In all cases, the voltage on the opened fuse phase, on the 120V winding of the 1Ø transformers, was in excess of 130V.

Stray flux leakage between the primary windings of the 3Ø pad mount transformers was energizing the “faulted” phase which in turn was going into ferroresonance with the cable charging capacitance of the cables feeding each transformer.

Replace the 3Ø 5 legged core and coil transformers with the less ferroresonant susceptible triplex core and coil design.

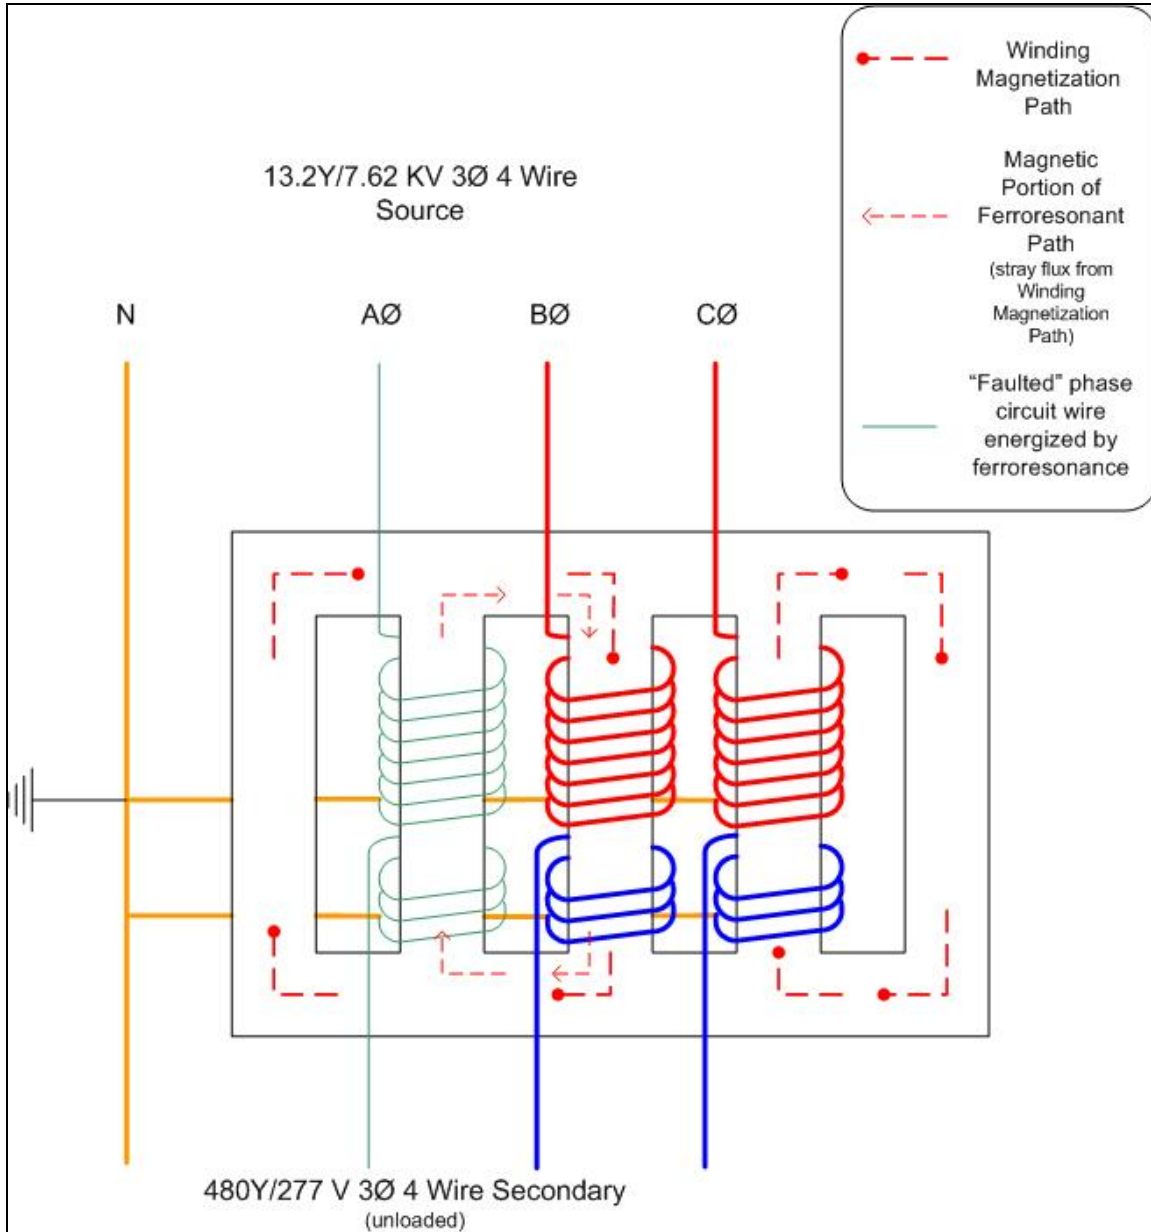
Figure № 7 Flux path details of a 5 legged Core & Coil Transformer with 1 "Faulted" Phase

Figure № 7 shows a wye-wye 5 legged core & coil transformer and the magnetic flux leakage paths, with one phase not energized from the source. This figure shows how magnetic flux, also known as

leakage flux, that flows through the “faulted” phase’s part of the core from the energized phases. It is this leakage flux that attempts to energize the faulted phase’s coil. This is a weak circuit which does not support much load. So if there were many customers connected, or if there was a lot of single phase load on the secondary of this transformer, the voltage would collapse from the load resistance shorting out the inductance of the “faulted” phase of the transformer. In this particular case, there is no secondary load and there is extremely light other customer load, so in the absence of load to short out the “faulted” phase, the faulted phase goes into ferroresonance via the magnetic connection of the leakage flux with the primary cable capacitance as shown in Figure № 8.

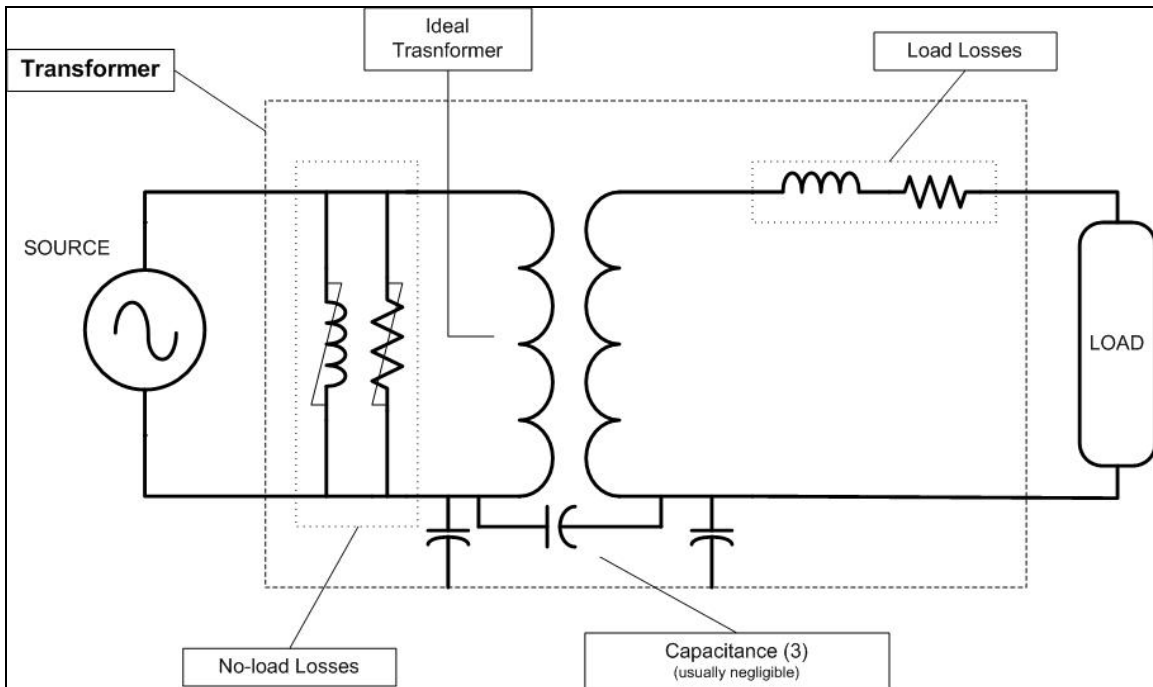
Figure № 10 Typical Transformer Model with Capacitance Shown

Figure № 10 illustrates the typically used transformer model. This figure, however, adds the capacitance. The capacitance is usually negligible but has been added because the no-load loss watts are so low with amorphous core transformers, that the capacitance is no longer negligible.

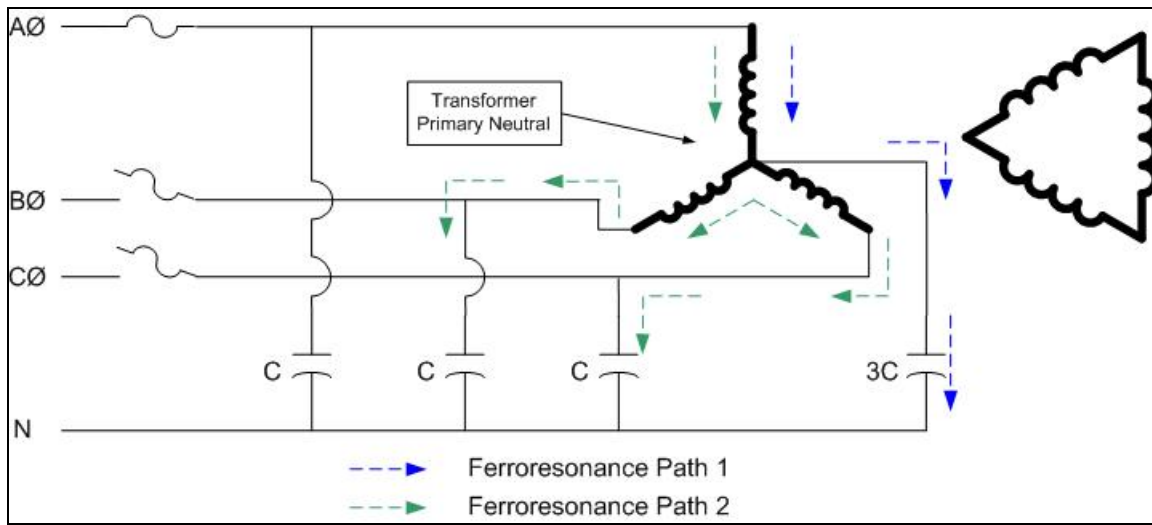
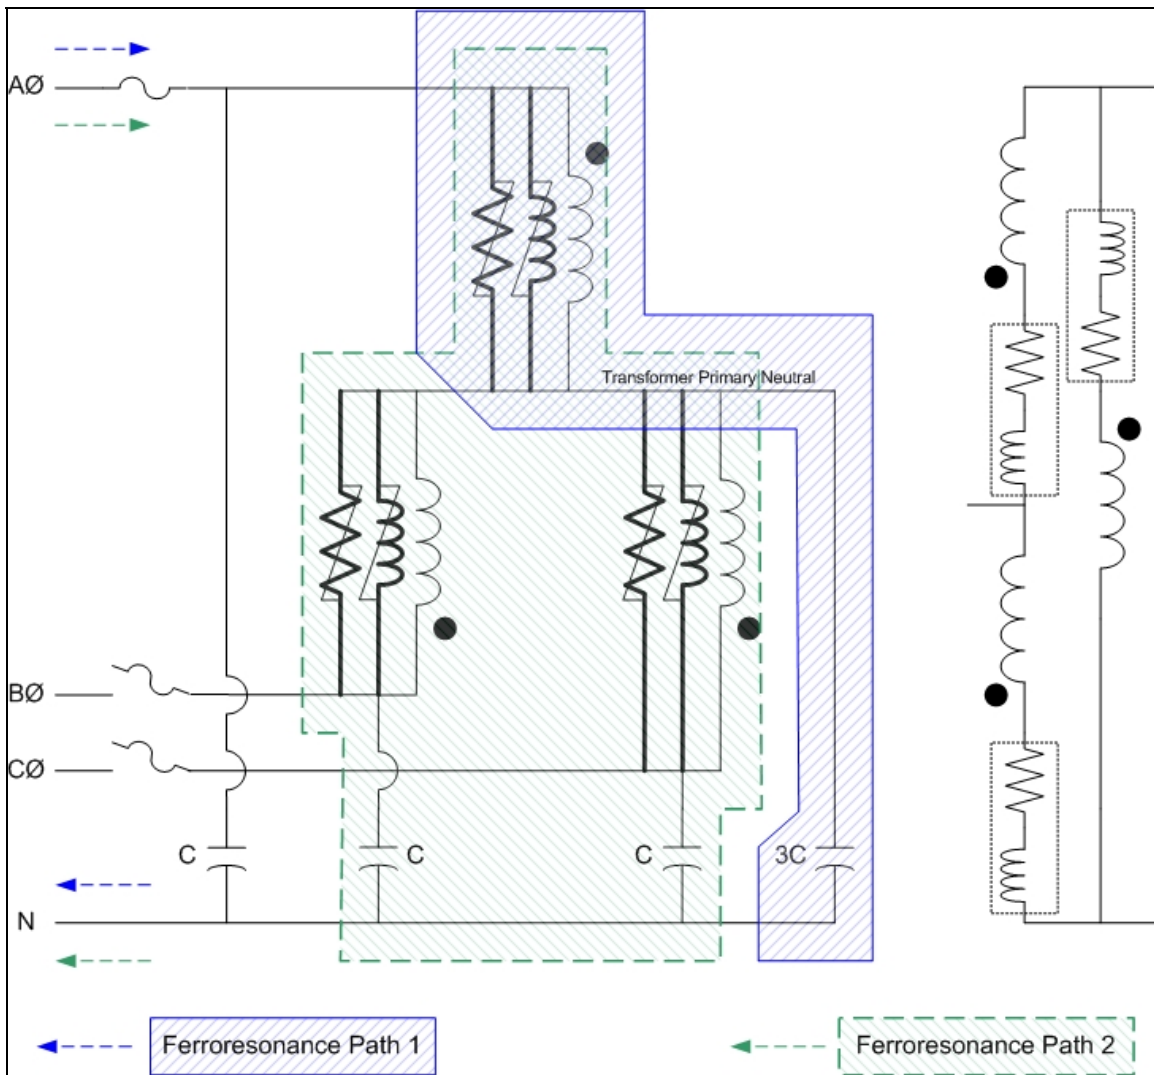
Figure № 12 Possible Ferroresonant Paths of an Ungrounded Wye – Delta Transformer Bank with Losses

According to Hopkinson – Ferroresonance During Single-Phase Switching, the capacitances in a 3Ø transformer bank, made of 3 single phase transformers, can be re-arranged as shown in Figure № 11 to simplify the analysis. The no-load losses are omitted from Figure № 11 to simplify the drawing.

Rearranging Figure № 11 and adding the transformer losses, Figure № 12 is developed. Figure № 12 shows how the no-load losses can dampen the ferroresonance possibility. The lower no-load losses are, the higher resistance component of the no load losses will be. With higher no load resistance, the no load losses become more inductive. The no load inductances become in series with the capacitances present in the transformer bank. These series circuits then just have to be energized single phase, as shown in Figures № 11 and № 12, for ferroresonance to occur. Conversely, the higher the no load losses are, the lower the no load resistance is, the more resistive the no load impedance becomes and the series circuit becomes more resistance in series with capacitance, eliminating the ferroresonance between inductance and capacitance.

Replace the amorphous core transformers with standard transformers. In the future, don't use amorphous core transformers in 3Ø transformer banks.

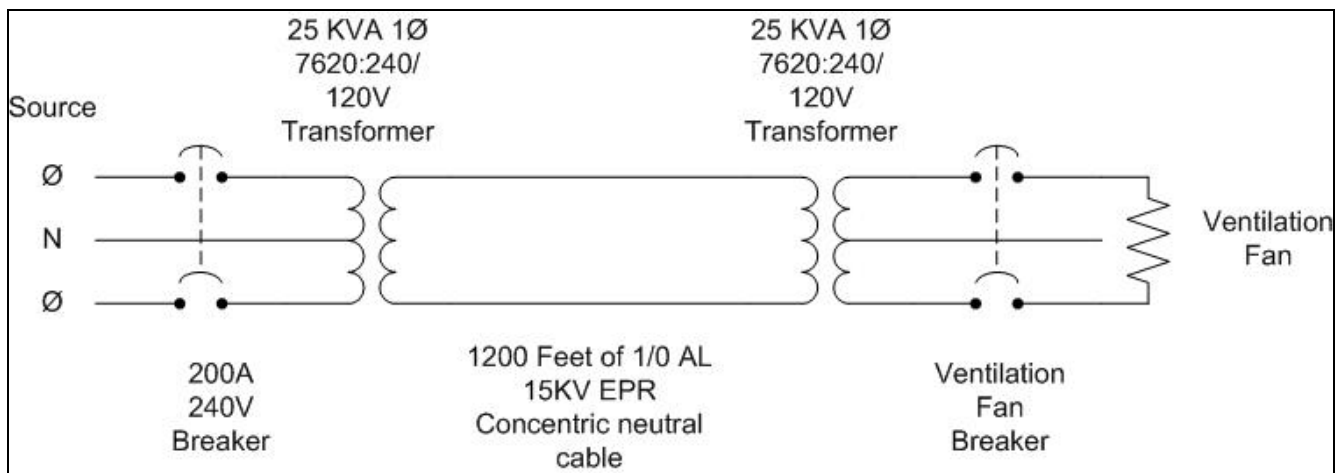
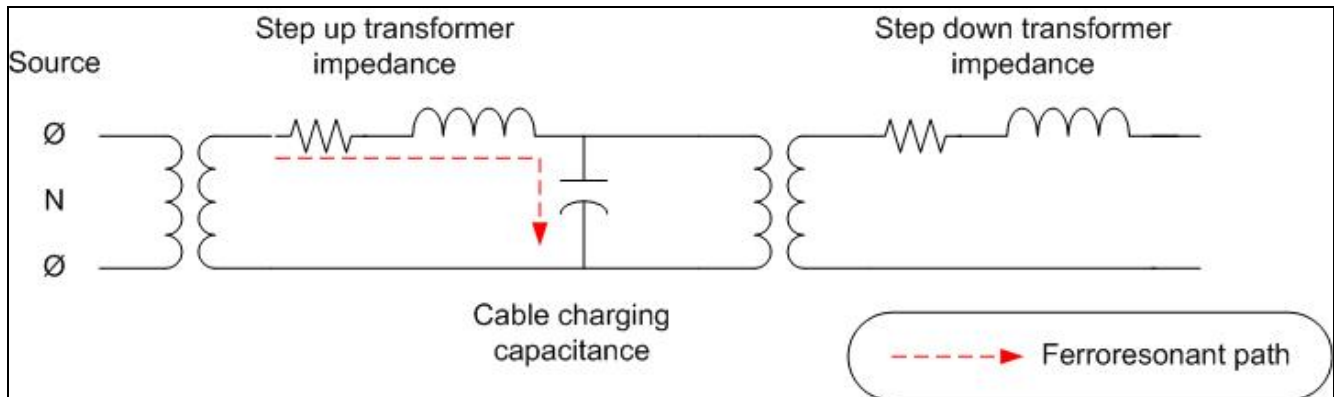
Figure № 14 Illustration of Ferroresonant Circuit in Case Study № 7

An agricultural customer is expanding his hog farm. The additional facility has to be located 1200 feet from his service. He hires an electrician to do the work. The electrician and farmer come to the decision that the best solution is to install a step up transformer and a step down transformer and high voltage cable to connect the latter to the former. They decide to purchase two 25 KVA single phase pad mount transformers, of the type commonly used by the local utility, from the local utility (thinking that if there is a future transformer problem, that the local utility will have spares handy). They also purchase 1200 feet of 1/0 AL 15KV EPR cable and elbows from a local electrical supply house. The electrician feeds the step up transformer from a 200 amp 240V breaker in the farmer’s main panel. The day comes to energize the feed to the new hog building. The electrician throws the breaker, and it immediately trips. After checking everything he can check, the electrician thinks the local utility sold him a bad transformer. So he and the farmer call the local utility and have the local utility check the transformers. The local utility finds that the transformers are good, and also verifies that the cable and elbows are good. The utility crew, however, can’t figure out what’s wrong either. The farmer, in frustration, calls the utility rep. The rep, thinks it might be ferroresonance, but he’s never heard of ferroresonance on anything but a 3Ø system, so he calls engineering.

The step up transformer is in series resonance with the cable capacitance. This is the same circuit as in Figure № 2, but on a single phase circuit, instead of a 3Ø circuit. This is shown in Figure № 14.

Engineering thinks that it is ferroresonance and asks if the farmer has anything wired up in the hog building. The electrician has wired up the ventilation fan. Following Engineering's instructions, the electrician turns on the breaker to the ventilation fan before closing the 200 amp breaker to the step up transformer. When the 200 amp breaker is closed, the breaker holds closed and the fan starts working.

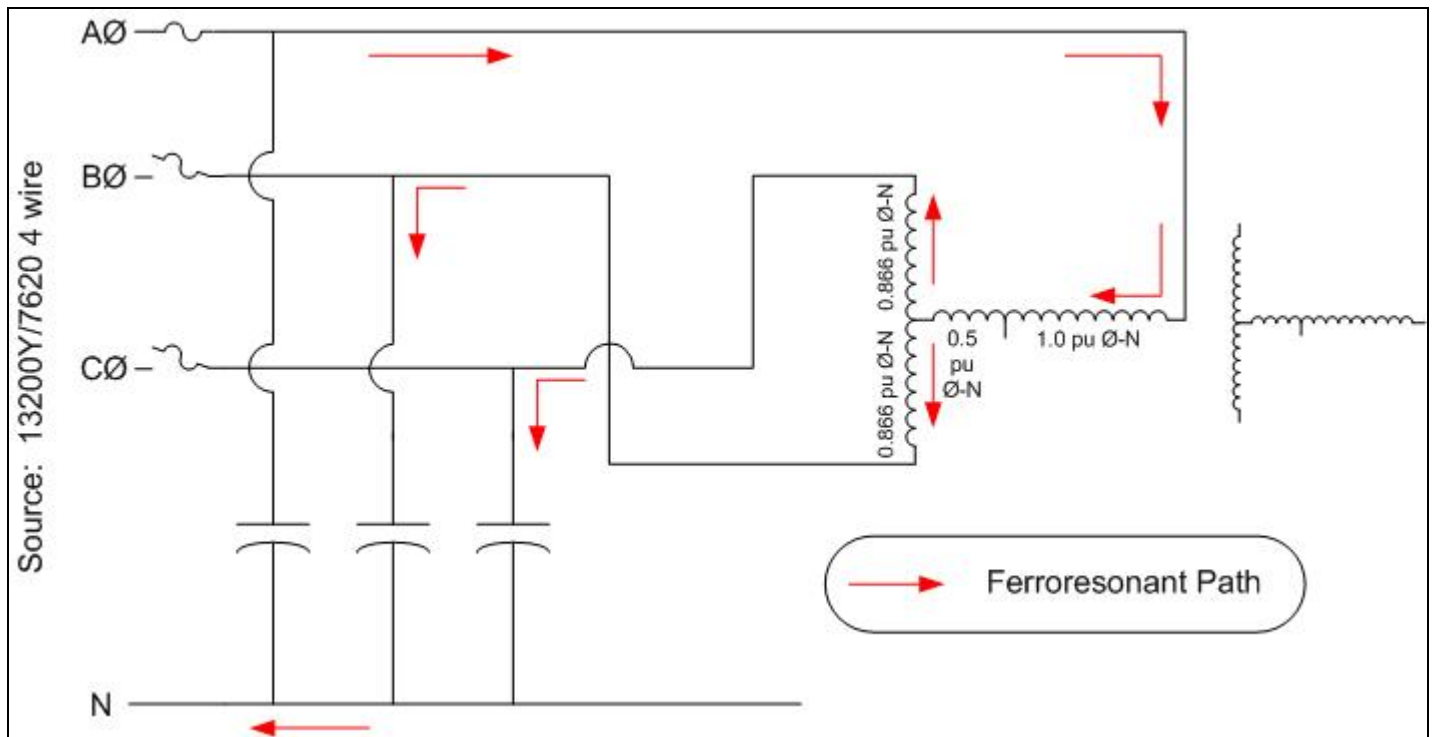
Figure № 16 Ferroresonance path through Scott Tee Wound 3Ø Transformer

A customer owned transformer 1000 KVA pad mount is fed by an underground cable that is about 550 feet long. The underground cable is feed off an underground system from a subsurface vault having 4 way load break stand off bars. The primary cables were first connected to the transformer in preparation for energizing the transformer from the vault. When energizing the transformer from the vault, the cable riser fuses blow.

Energizing any phase of the transformer, energizes the other winding that shares the common core with that winding which was energized. The winding that was energized via the common core is energized into the cable capacitance. The cable capacitance is in series with the energized winding, so may experience ferroresonance.

Figure № 16 shows the start of the unsuccessful energizing sequence that went into ferroresonance for this particular installation. In this case energizing AØ first caused ferroresonance to occur.

A switching routine was developed which was able to energize the transformer by first energizing the transformer's BØ, then CØ, and last the transformer's AØ.
