Huron Creek Watershed Management Plan

Completed July 31, 2009

Michigan Technological University

Center for Water and Society

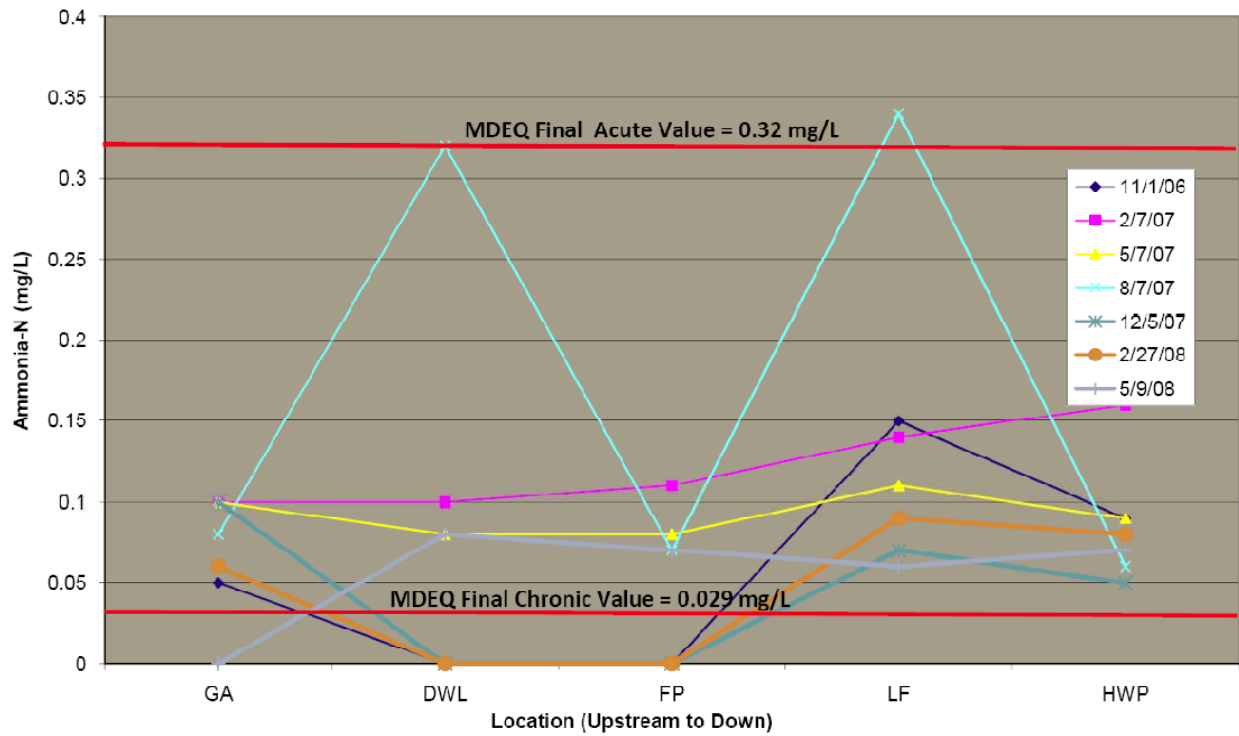
Figure 5.3 Ammonia (as mg N/L) concentrations as a function of sample location and date.

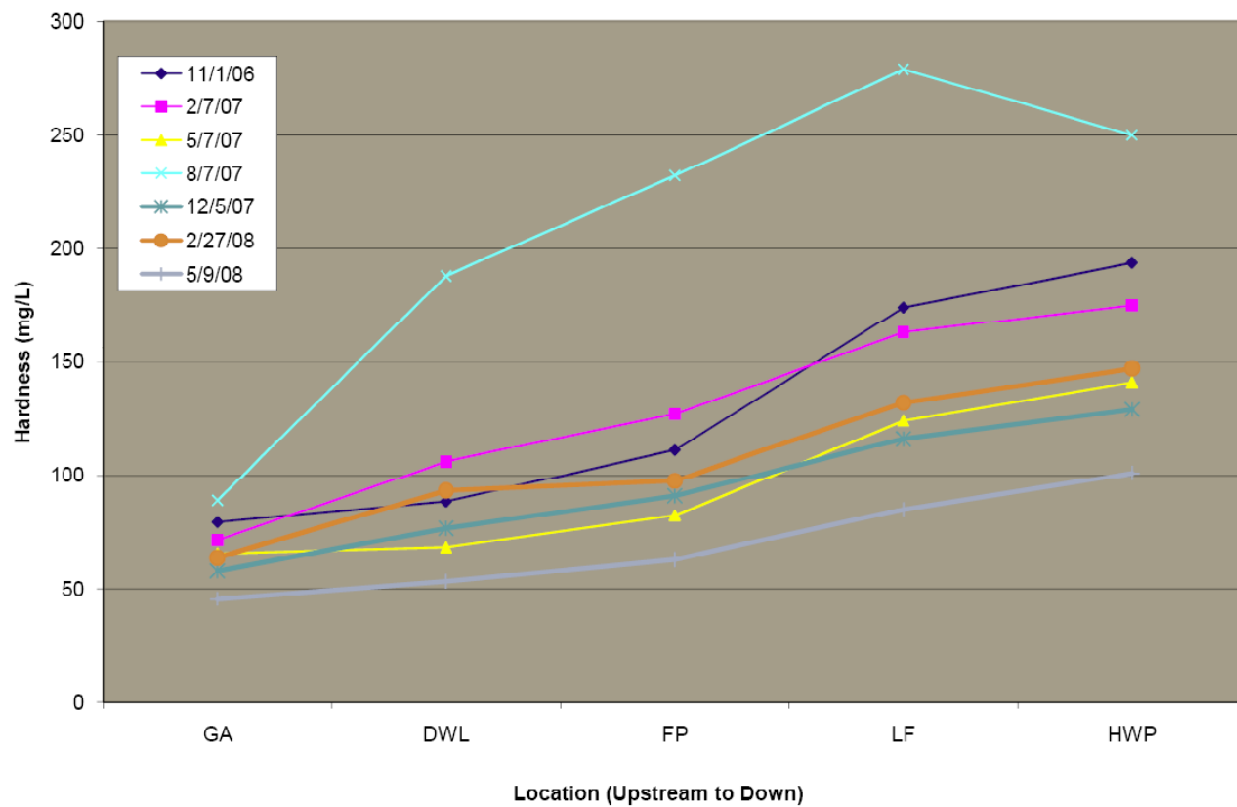
Figure 5.4 Hardness as a function of sample location and date.

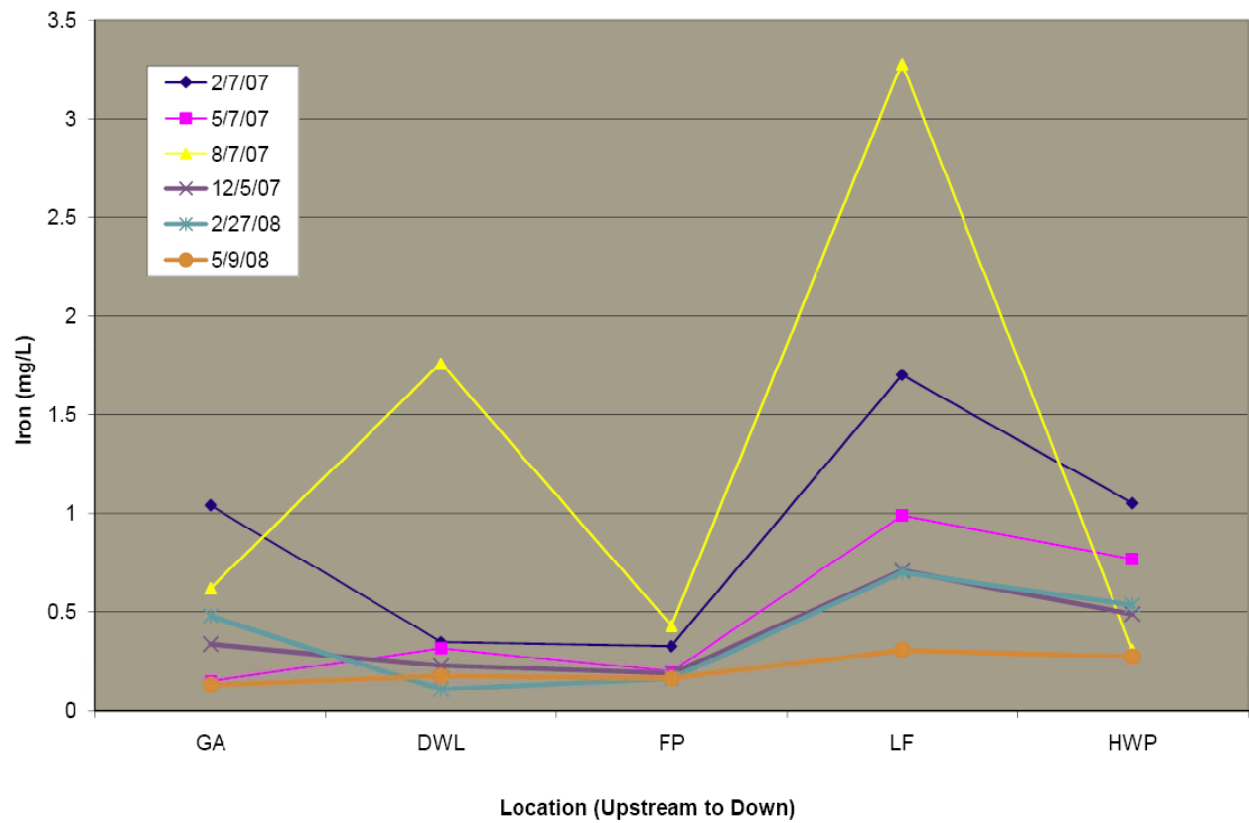
Figure 5.5 Total iron concentrations as a function of sample location and date.

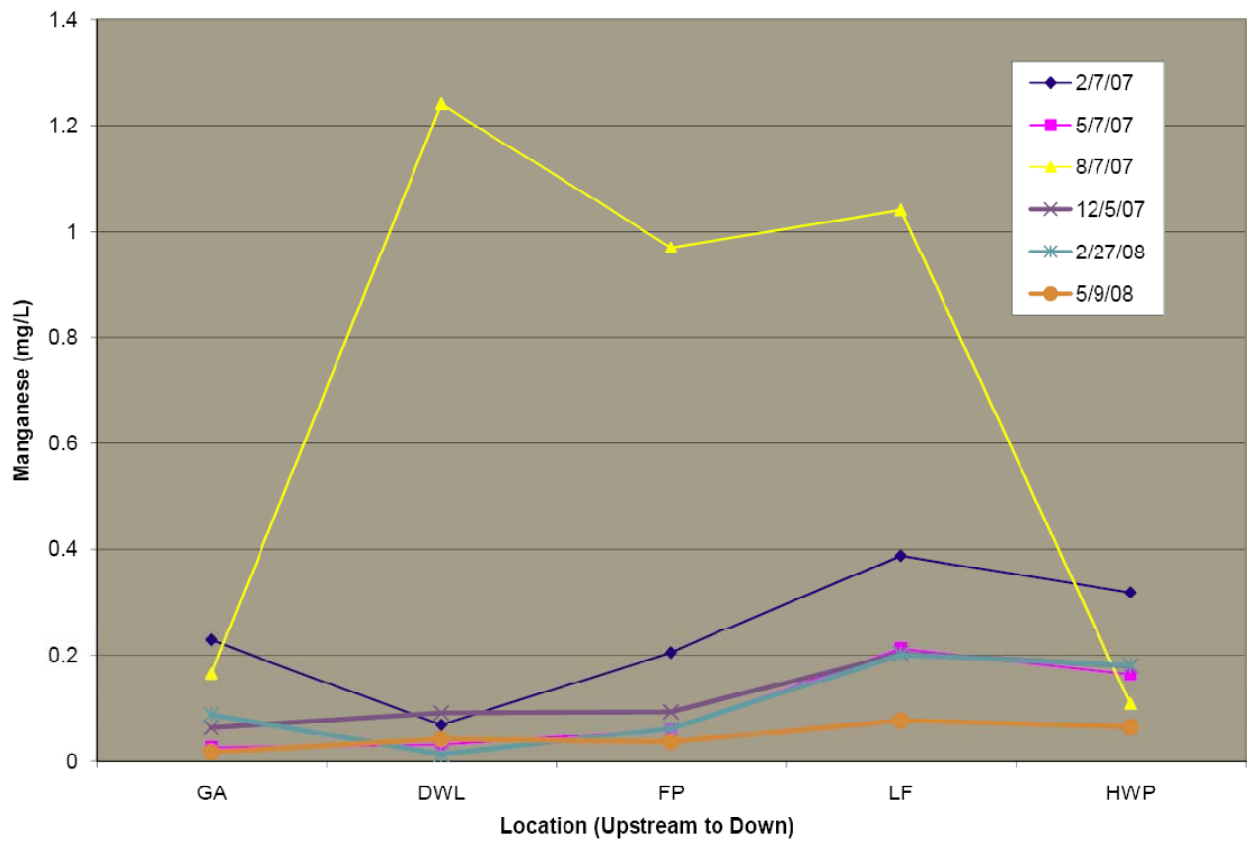
Figure 5.6 Total manganese concentrations as a function of sample location and date.

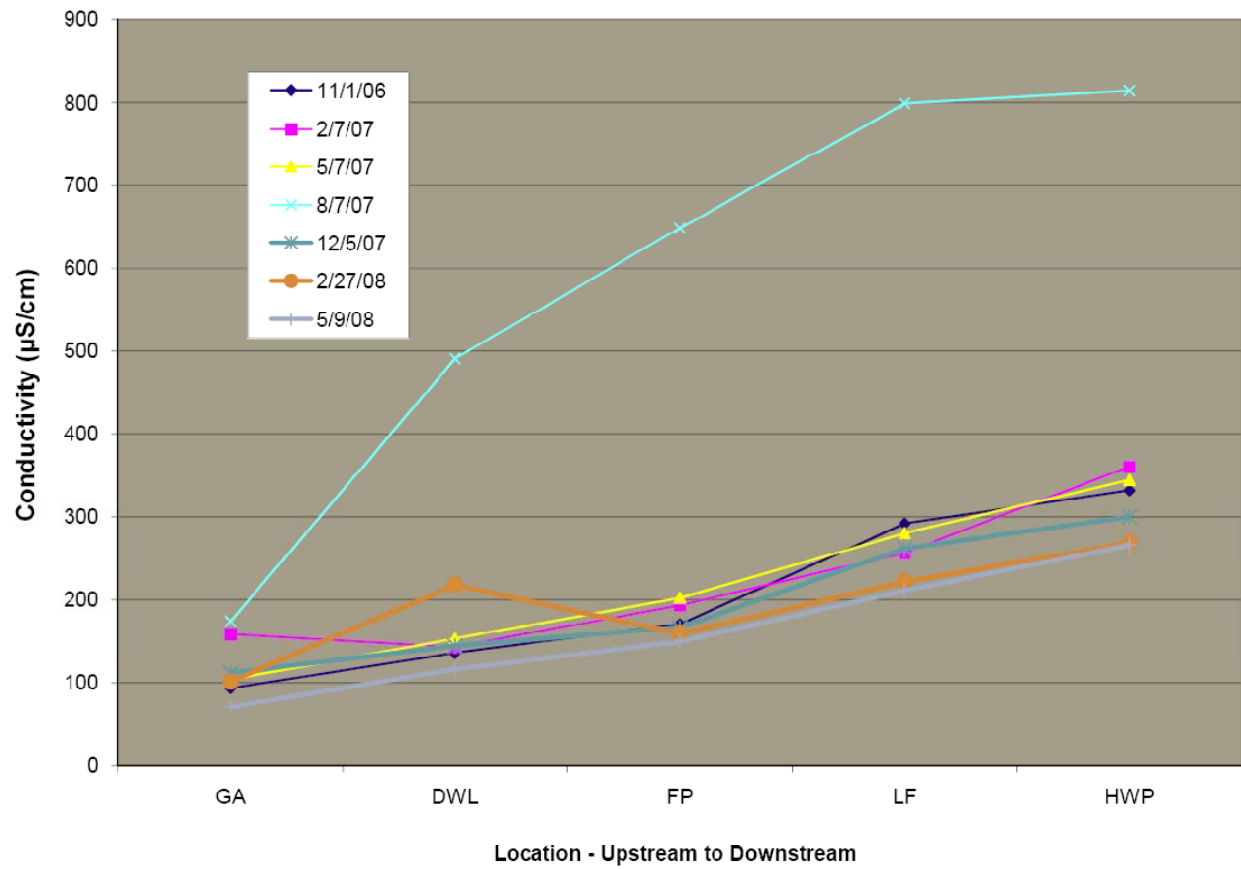
Figure 5.8 Conductivity as a function of sample location and date.

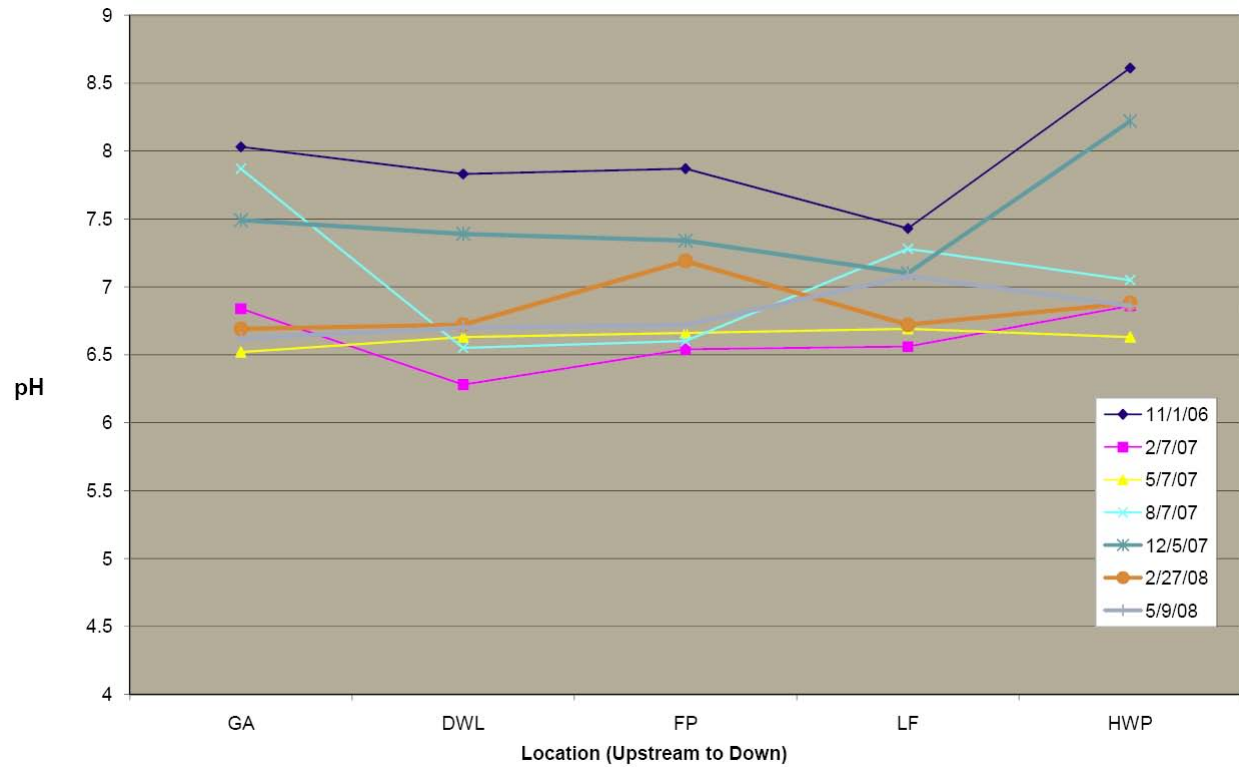
Figure 5.10 pH as a function of sample location and date.

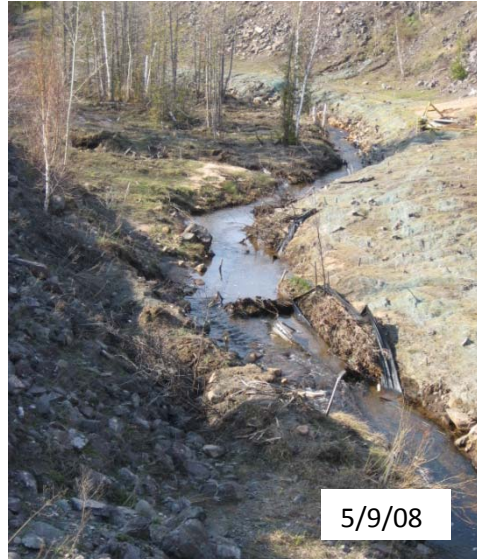
Figure 6.4 Huron Creek and leachate collection system installation area

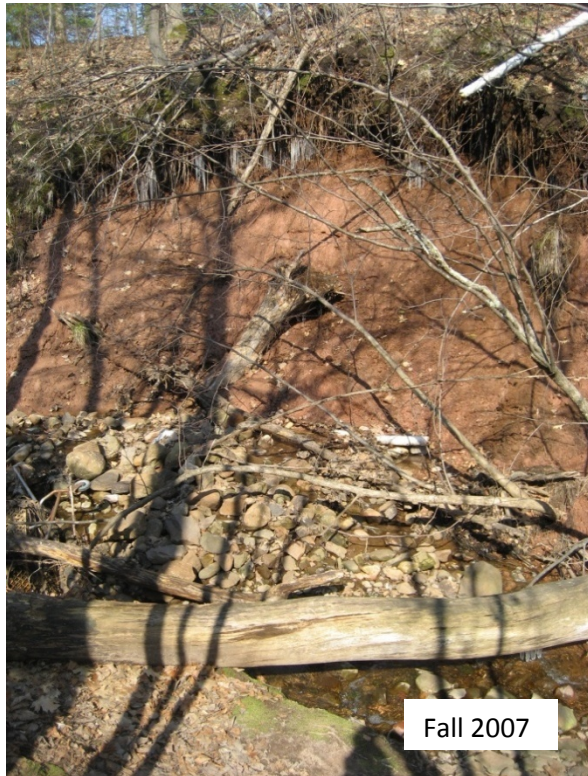
Critical Erosion Location “I”: This site is another prominent area of erosion in Critical Area 4. It is located only a few hundred feet downstream of the Copper Country Mall culverts and the Festival Foods area ditch. As shown in Figure 6.15, the bank of the creek has been eroded away leaving a bare soil and rock face that is approximately 6 to 8 feet high. If this area is not stabilized, it may continue to erode in an outward direction as it is located on the outside of a curve in the creek. As mentioned earlier, this erosion is most likely attributable to the increased peak flow rates and volumes that are generated by runoff from impervious surfaces such as the parking lots of the Copper Country Mall and the development area around Festival Foods.

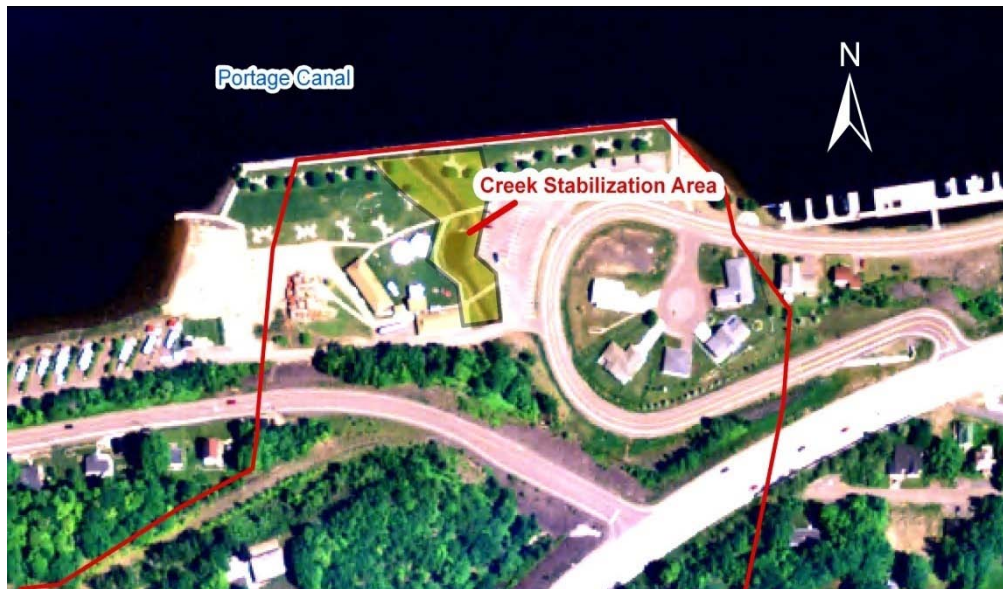
Figure 7.3 Stabilization area in the Kestner Waterfront Park

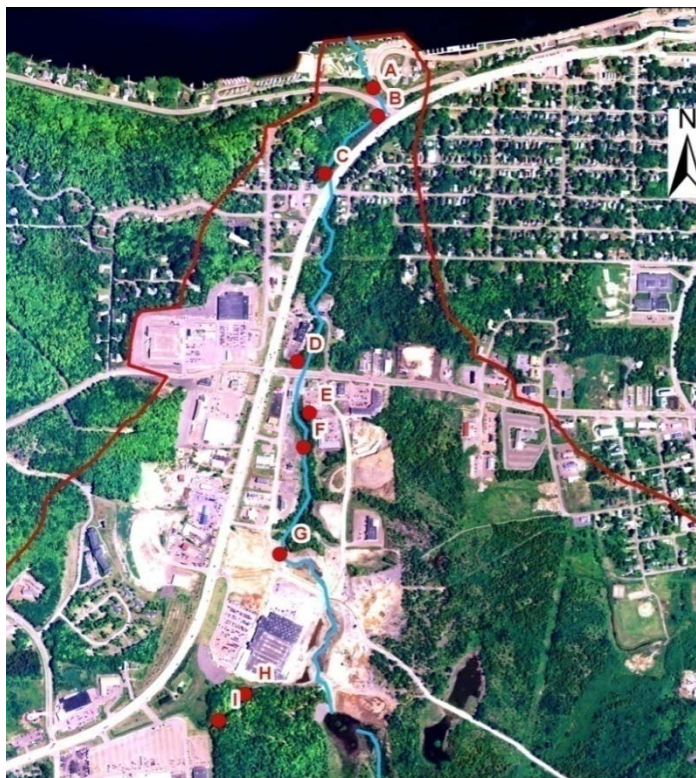
Figure 7.5 Critical erosion locations
