“State of the Stream Segment”

Sharon Avenue to Frog Pool

Prepared by Alex Mayer, 6/25/06

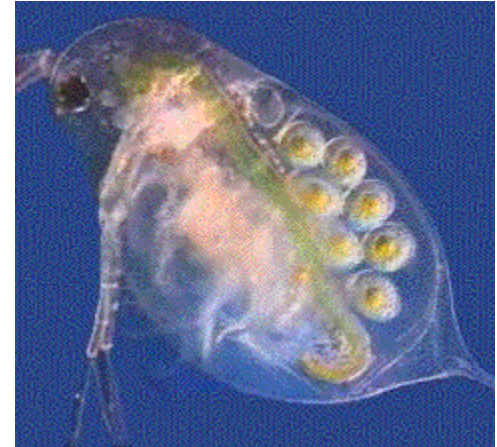
Landfill: Water toxicity*

- The toxicity of landfill leachate was assessed by placing a volume of the leachate water in an “aquarium” containing *Daphnia magna*, or “water flea.”
- The number of live and dead *Daphnia* are counted after a specified time and the results are translated to “toxicity units.”
- The results of the tests indicate that the Houghton City Landfill site 2 seep sample would not meet the aquatic toxicity requirements the Michigan Water Quality Standards.

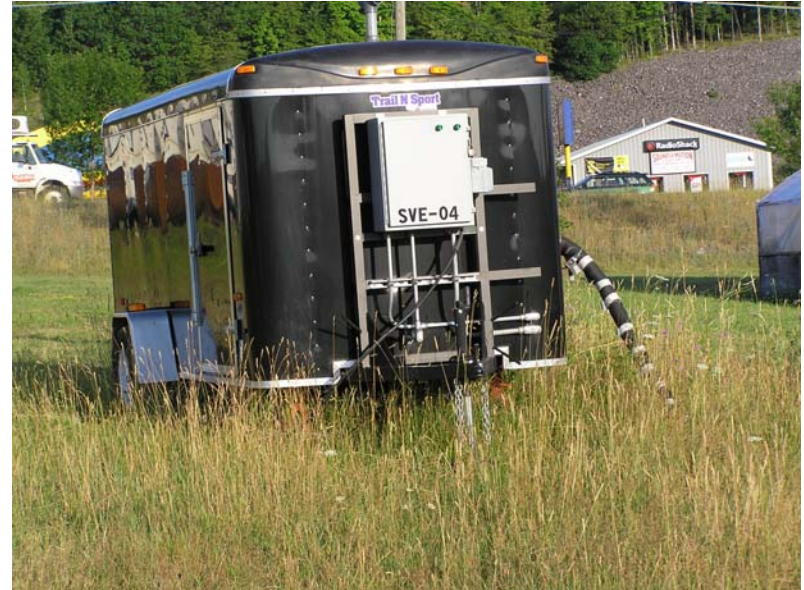
Landfill gas

- Samples of gas have been taken inside the landfill and analyzed.
- Methane gas has been detected at unacceptable levels.
- A soil vapor extraction unit has been installed and is operating.

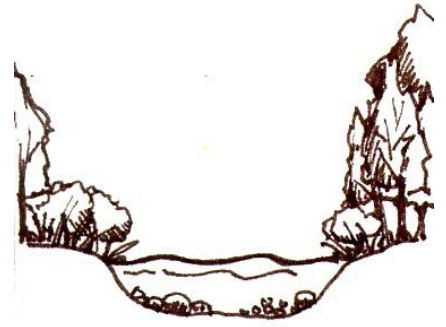
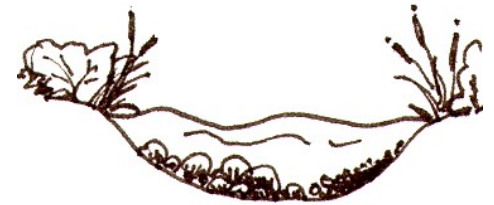
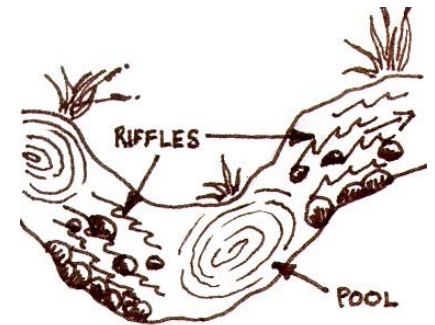
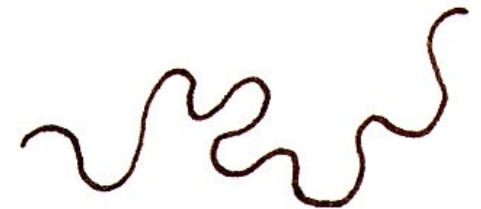
Habitat evaluation

- A general to specific evaluation of the physical conditions of a stream as they relate to aquatic habitat:
 - Stream bottom materials
 - Vegetation along stream banks: abundance, shading
 - Stream bank stability
 - Stream flow
 - Pools and riffles
 - Runs and bends

- Adjacent to Ming Garden
 - Excellent
- Upstream of Sharon Ave.:
 - Good
- For comparison: Pilgrim River
 - Excellent
