Water Distribution in Quebrada Pastor, Panama

Project Background

CE4916 International Senior Design Fall 2015

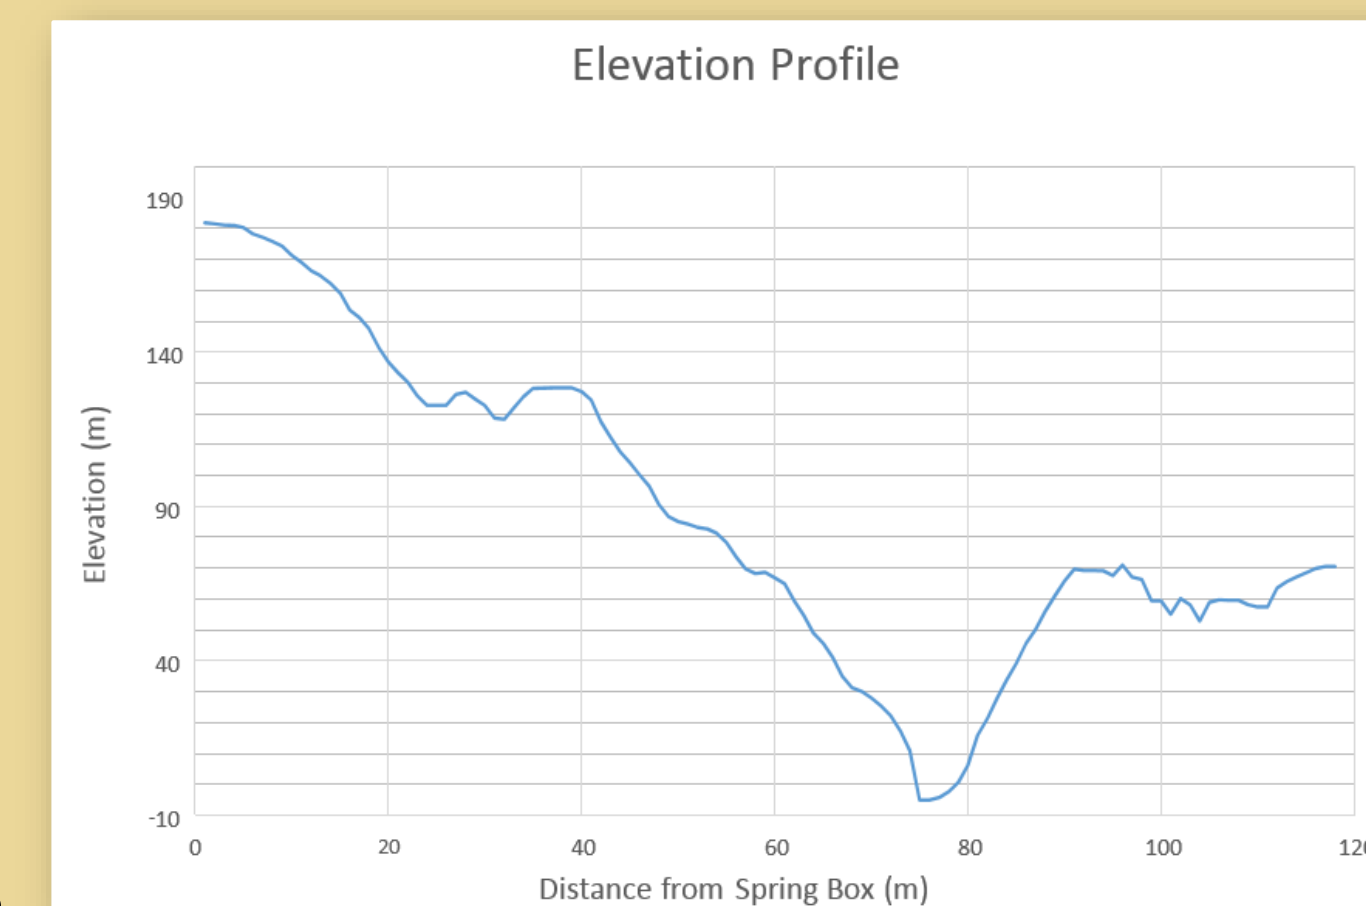
- Survey data input into EPANET to model entire aqueduct
- Model outputs pressure, flow rates, head loss and demand at any point in the system
- Used to make lifespan and system control improvements

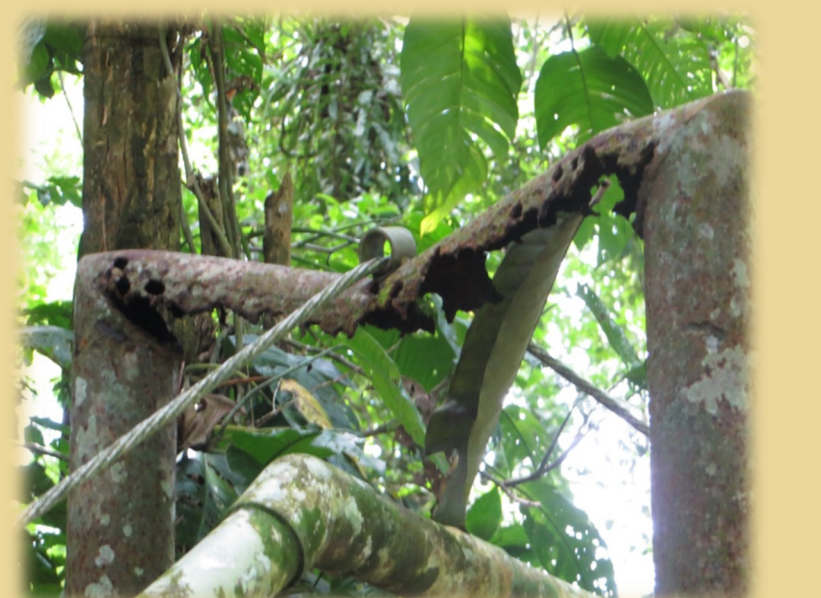
Figure 1. Degraded Metal Support

- Replace degraded metal support to prevent collapse of the aqueduct
- Utilize carrier pipes at stream crossings for UV and environmental protection
- Bury or paint exposed line to prevent UV degradation
- Provide pipe supports where the aqueduct rises 600 feet up a 30° incline
- Replace worn or weathered pipe with new pipe
- Educate community on sustainability. (I.e. teach kids to stay off pipes, educate water committee on maintenance and repairs)
