Quebrada Pastor Water Distribution System

International Senior Design – Summer 2015

AquaVenture Engineering Inc.

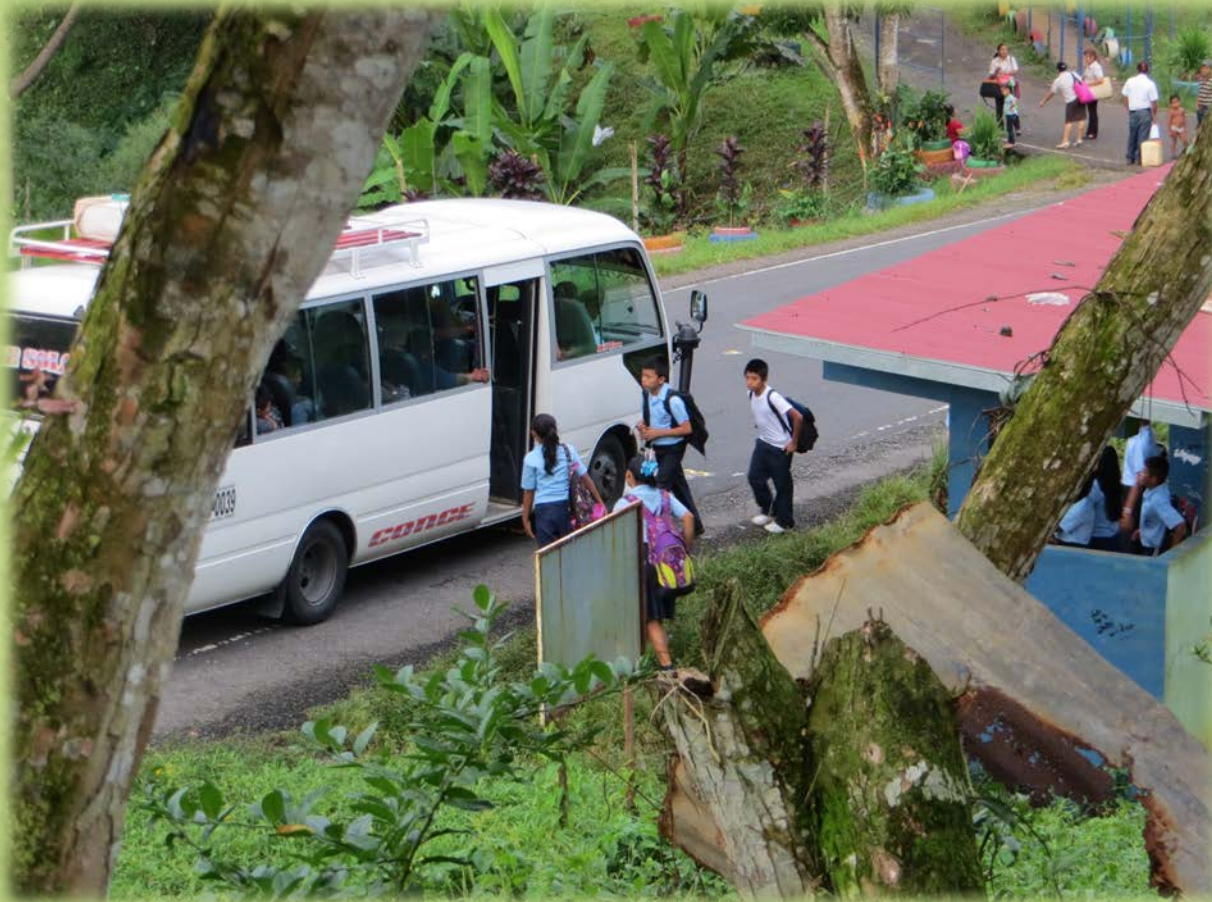
Background of Aqueduct

- Senior Design: Analyze the Aqueduct
- Originally built in 2002 by parents of school students and residential users
 - Funded by the government
 - Two Tomas (Spring Box)
 - Three 1,000-gallon storage tanks
- Built to service 8-10 connections including the school
- Currently serves 30 homes, as well as school, church, and Heidy Organic Chocolates
- Directiva controls it

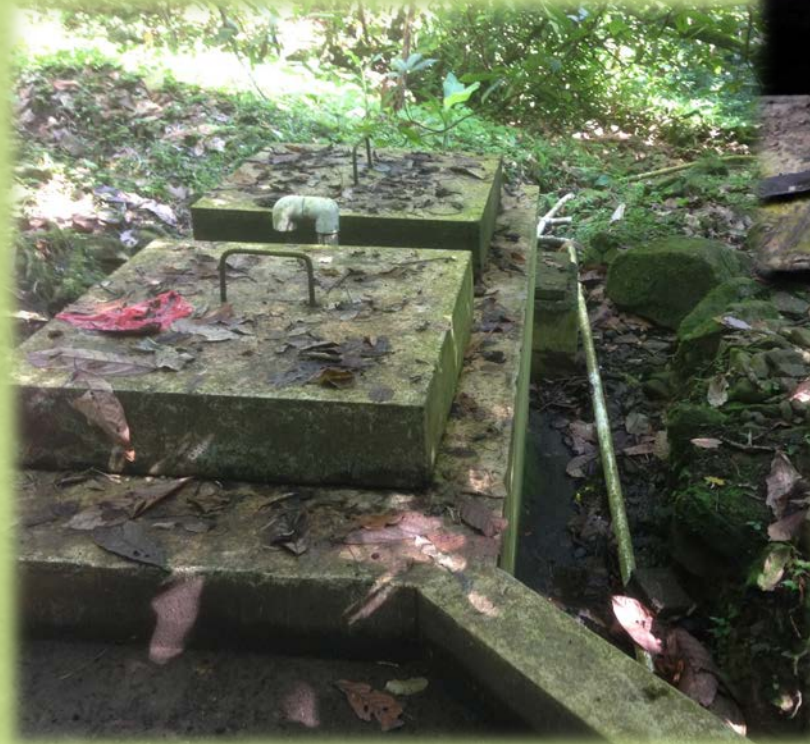
Toma 1

- Two Tomas feed entire aqueduct system
- First was built by the Panamanian government
- Second was constructed by the community

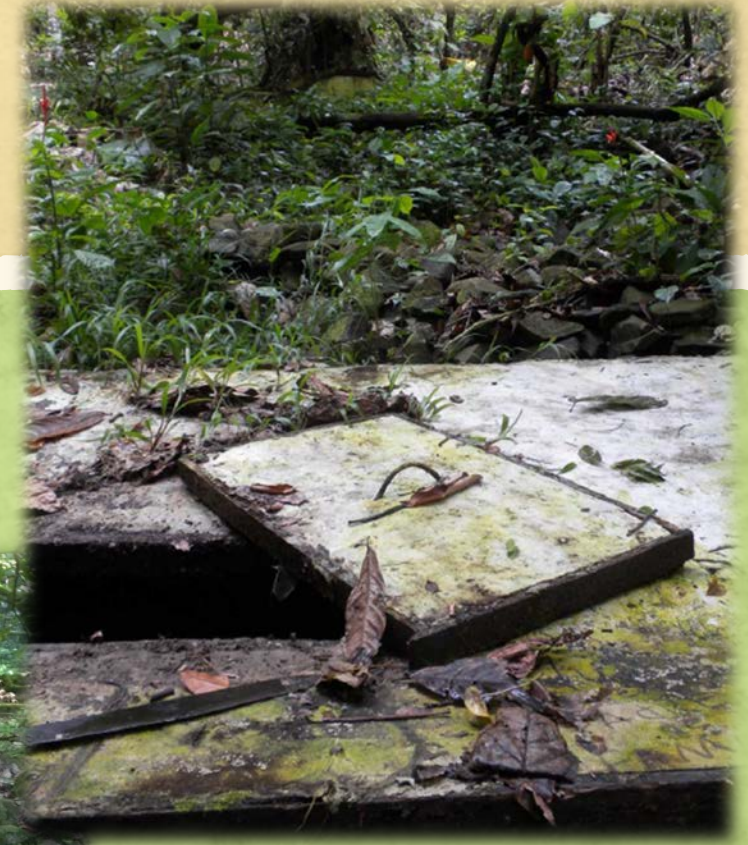
- Lacks proper sealing
- Sediment build up = turbid water
- Rapid coliform counts
 - Toma 1 Average: 12
 - Toma 2 Average: 44
- Design improvements will enhance quality and increase flow

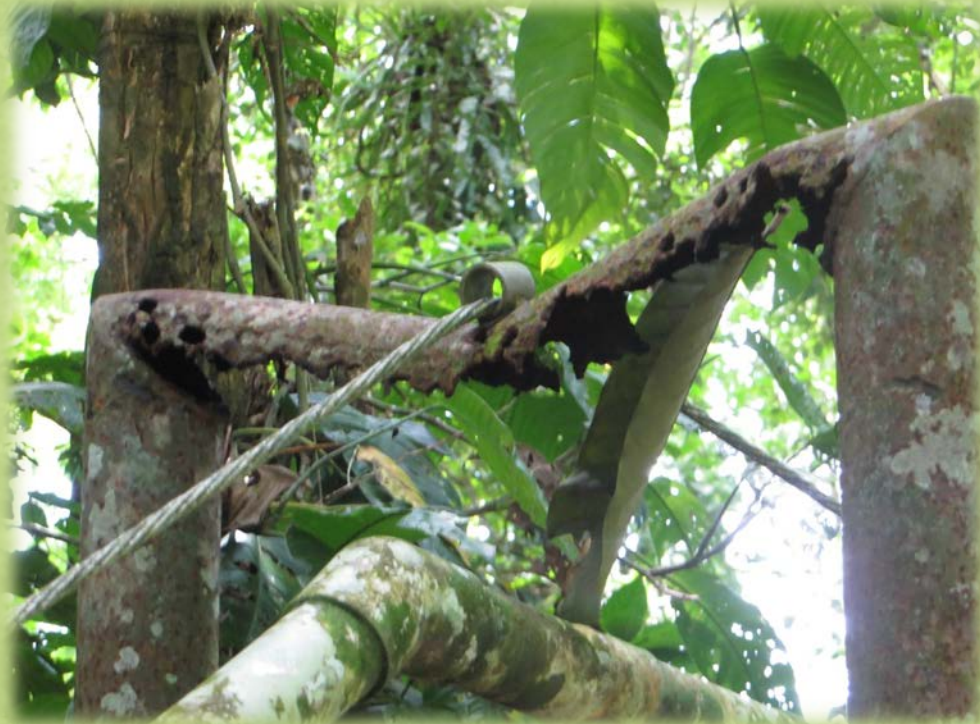
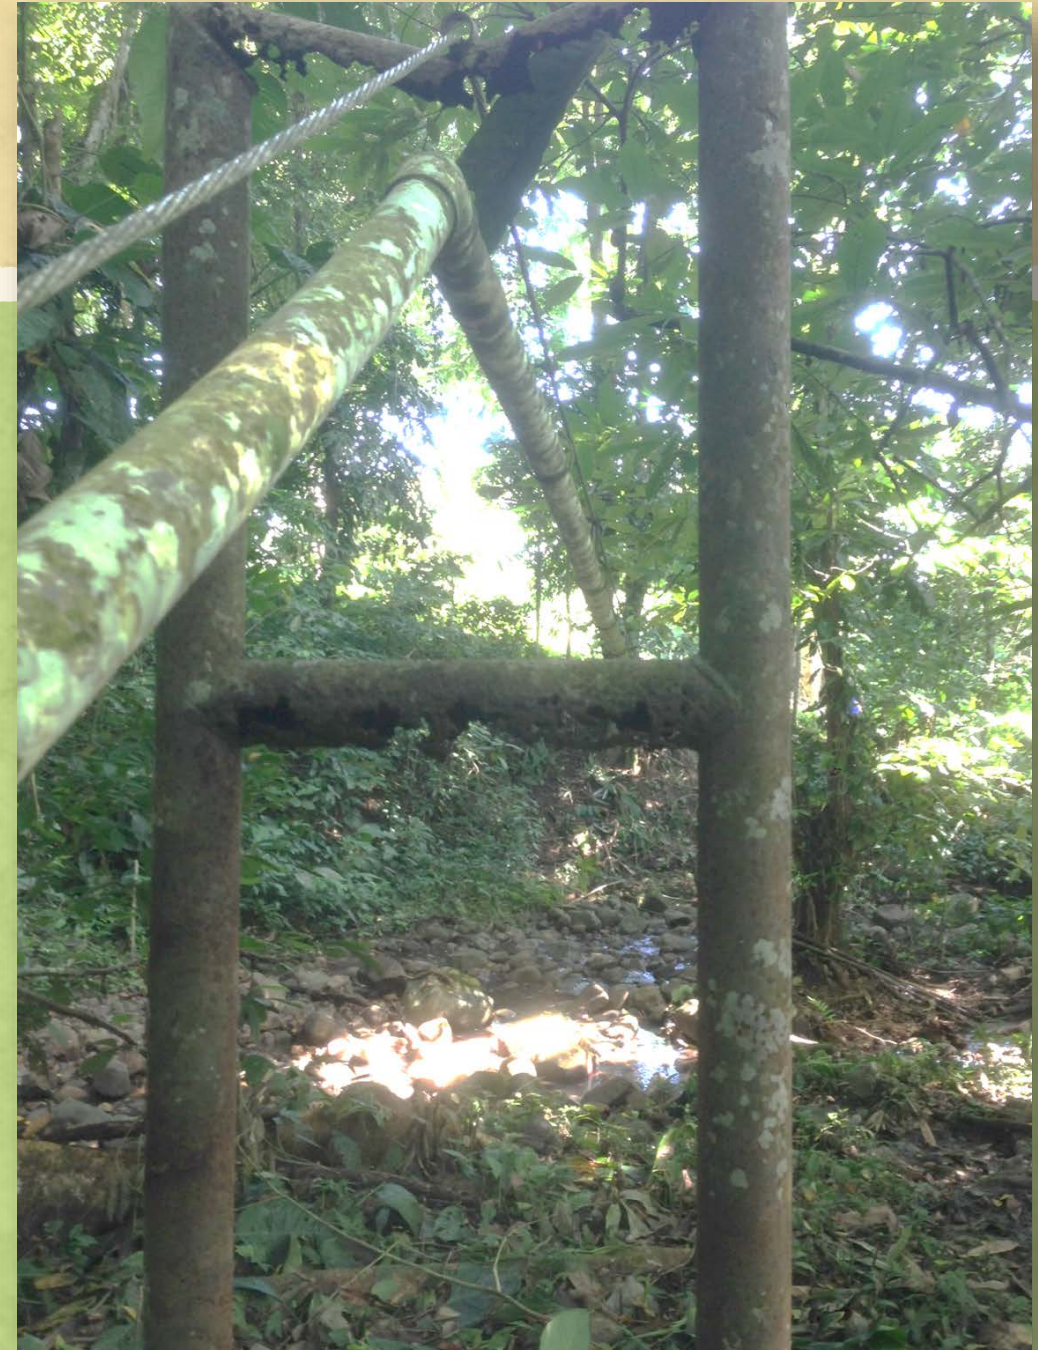
Stream Crossing Supports

- 2 Crossings
- 1st in worst shape
- New support design

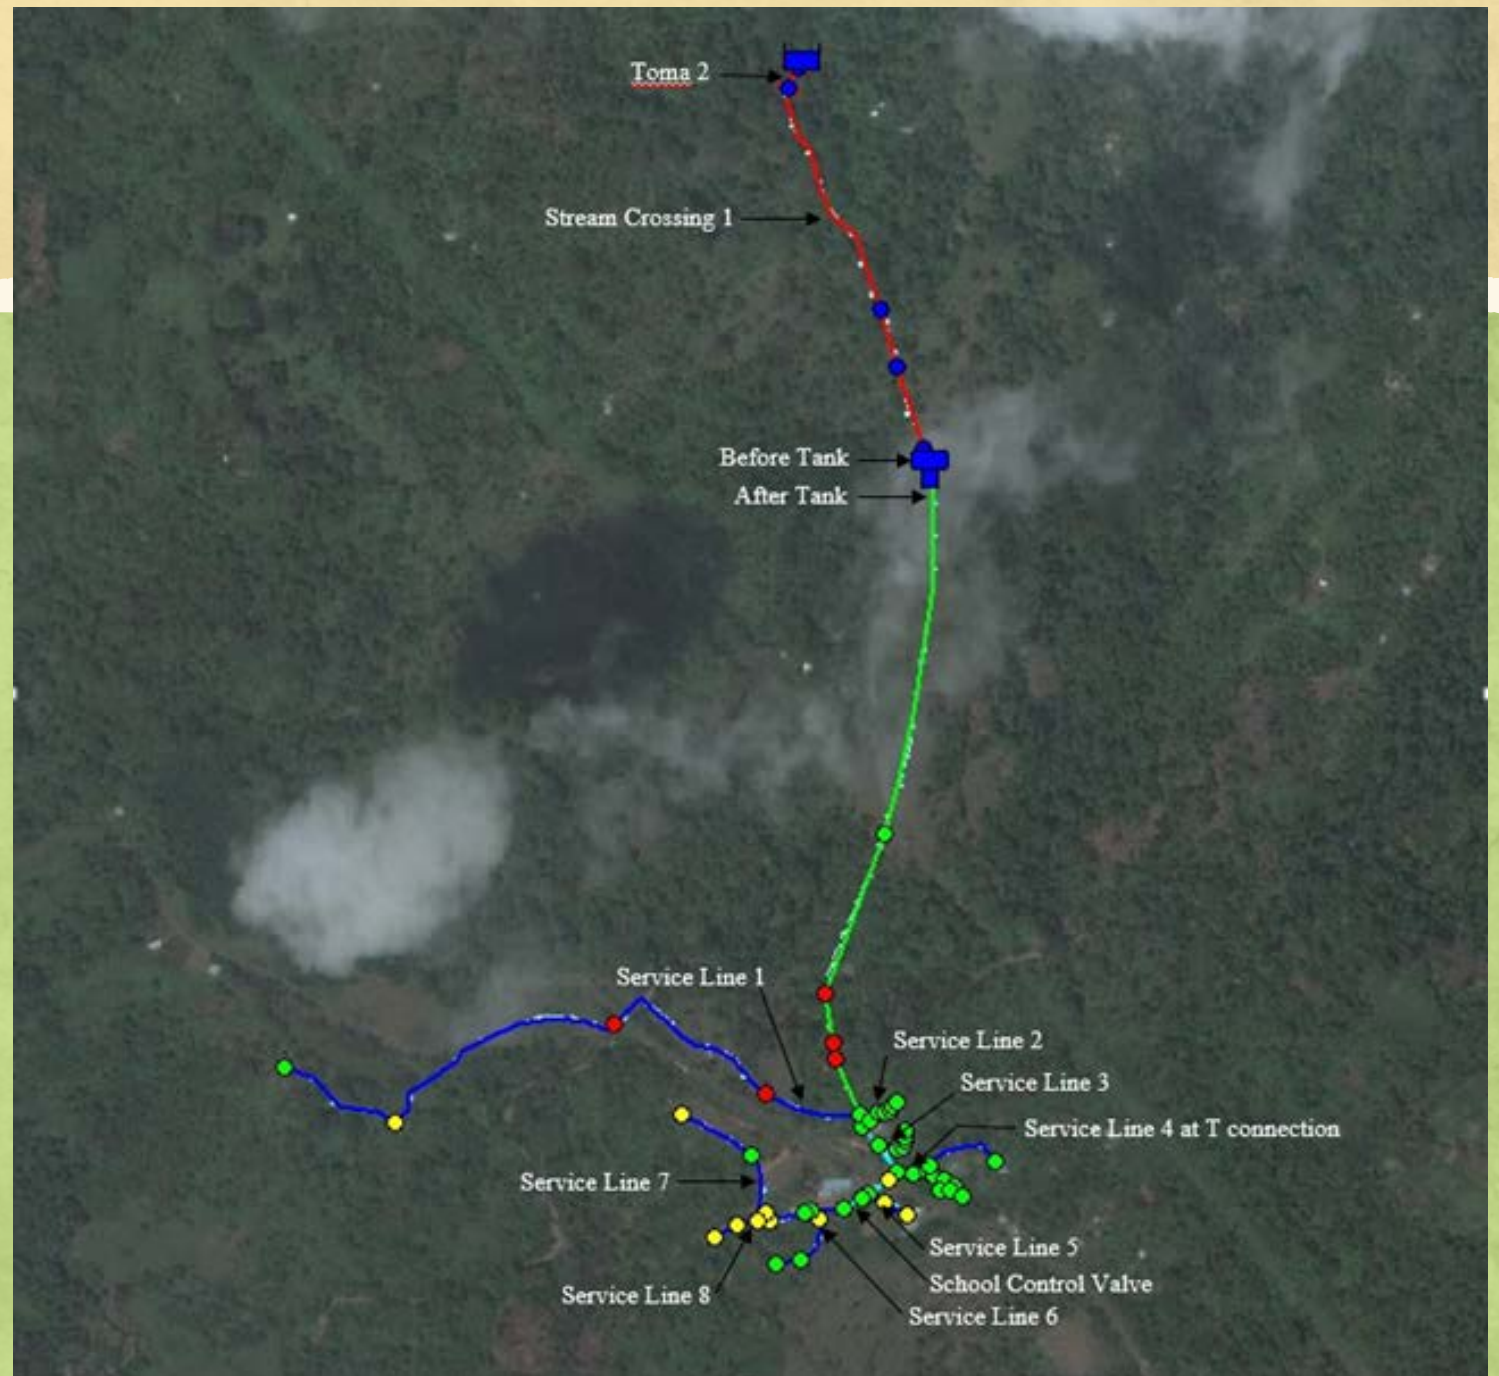
Control Valves

- 5 currently
- Add more valves
 - Before and after storage tanks
 - Service Lines shutoffs

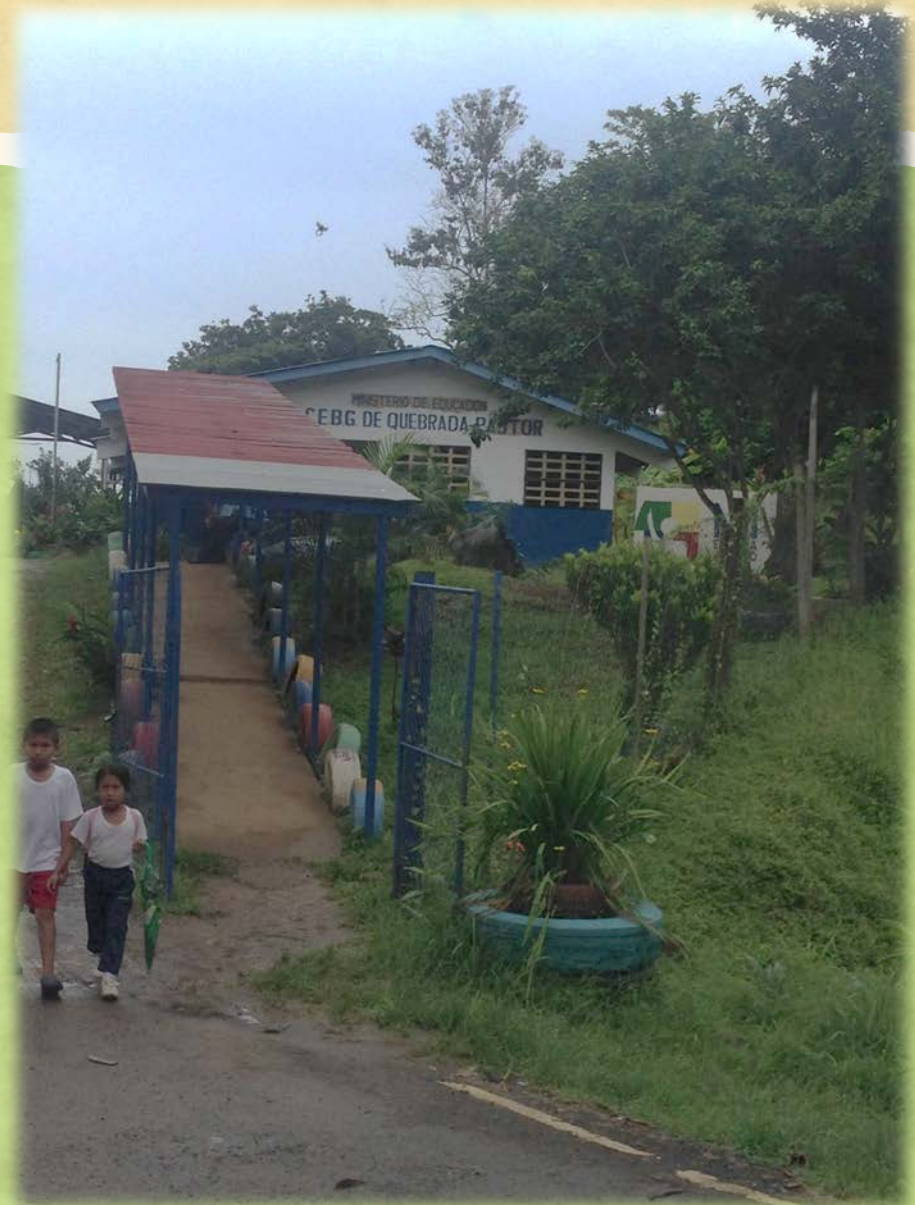
Rainwater Catchment Supplements

- School owns two 1,500-gallon rain catchment tanks
 - Not in service due to misuse
 - Demand: 1,000 gallons water/day
 - Average monthly rainfall: 209mm
- 46-year Rainfall Data used to determine potential supply and reliability of rain catchment system
- Analysis suggests that an average of 48% of water demands could be met each month

- Fencing with a lock to protect tanks
- Additional gutter to increase supply
- Screen to prevent debris from entering gutters
- First-flush system to increase water quality
- Recommend that school rely more on rain catchment than on the aqueduct
