WATER DISTRIBUTION IN QUEBRADA PASTOR, BOCAS DEL TORO, PANAMA

Michigan Tech Advisors:
Dr. David Watkins, PhD, PE
Mike Drewyor, PE, PS
December 2015

Derek Benoy
Colleen Carbary
Angelena Crispo
Maggie Ziols

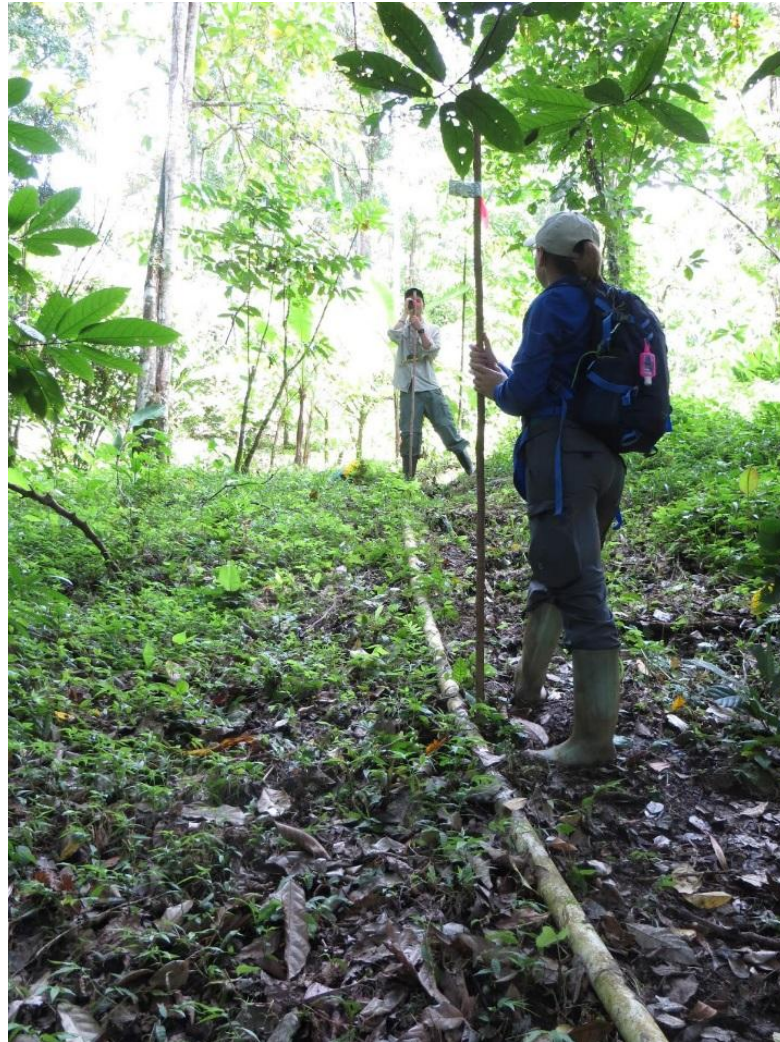
Figure 3: Field Surveying Techniques

AquaVenture was asked to complete an as-built survey of the current aqueduct system. Ground distance and angles of inclination or declination were measured with the range finder or the abney level and tape. As requested by the PCV, the distances would be measured in metric units, for ease of use by her and the community, and for purchasing local supplies. Roughly 260 GPS data points were taken which will illustrate the path of all the water lines and services from a plan view.

The location of the line was determined by members of the community who assisted AquaVenture during surveying. They cleared brush, made paths, and helped mark where the unexposed portions of the line were. Two sticks marked at eye height (1.76 m) were used to ensure the same rod height. If the point was especially difficult to sight, a cardboard piece covered in shiny duct tape was used to help the rangefinder take a reading. One crew member then walked down the line looking for any major changes to be the next point, usually taking points every 10-15 meters. An example of surveying can be seen in Figure 3. The key points surveyed included valves, junctions, or changes in pipe diameters. The tap heights in houses, the school, and the church were all measured, and a GPS point was also taken. Sometimes spiders, trees, plants, or treacherous terrain changes affected the location of the next point, and therefore turning points were used. The raw survey from the field book can be found in Appendix B.

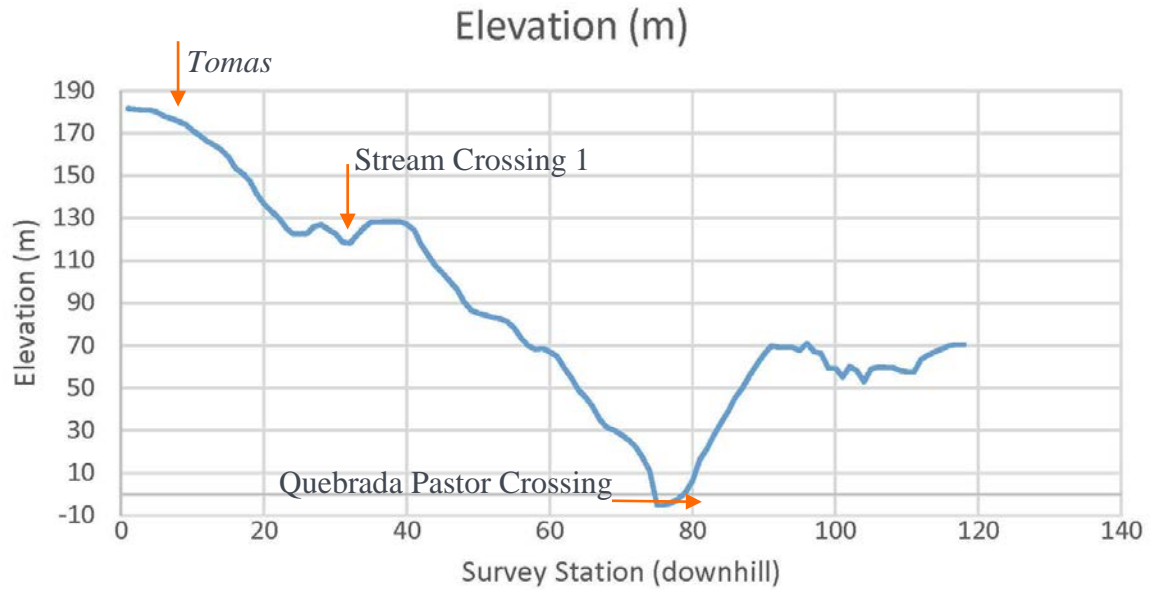
Figure 4: Elevation Profile of Main Transmission Line

Figure 4 shows a profile view of the changes in elevation of the main water line from the spring boxes, the highest point in the system, to the lowest point in the system, slightly past the school. There are two water crossings, which are low points in the system and

have been marked on the elevation profile. The first one is located before the storage tanks and the second at the lowest point in elevation in the system. The second water crossing has a steep grade on either side that contributes to a large amount of head and extra stress on the system. The weight of water in the pipes also has affect the strength and reliability of the pipes and pipe connections.

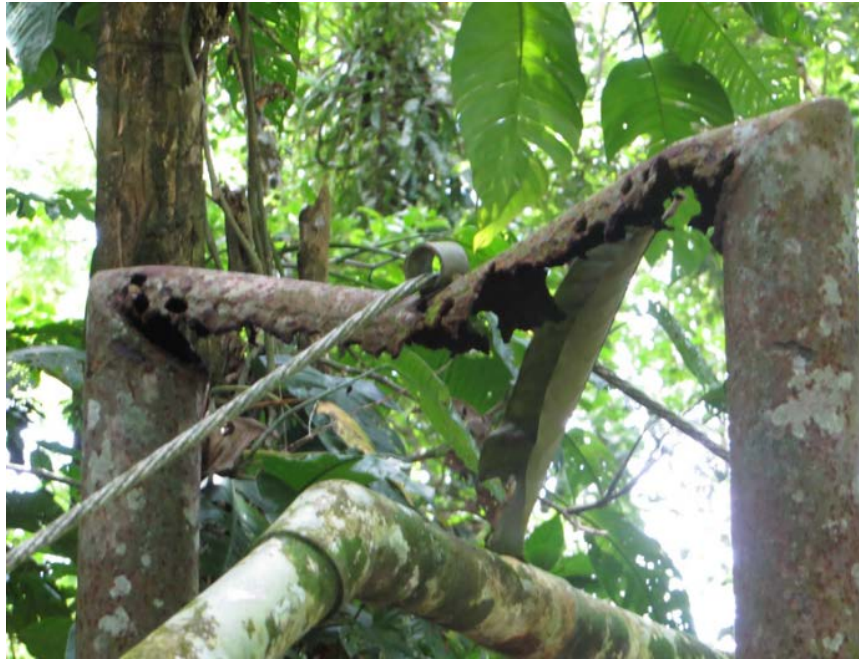
Figure 12: Degraded Metal Support

Due to the degradation of the metal support column, as seen in Figure 12, on the uphill (north) side of the first stream crossing, a concrete masonry unit (CMU) has been designed to replace it.

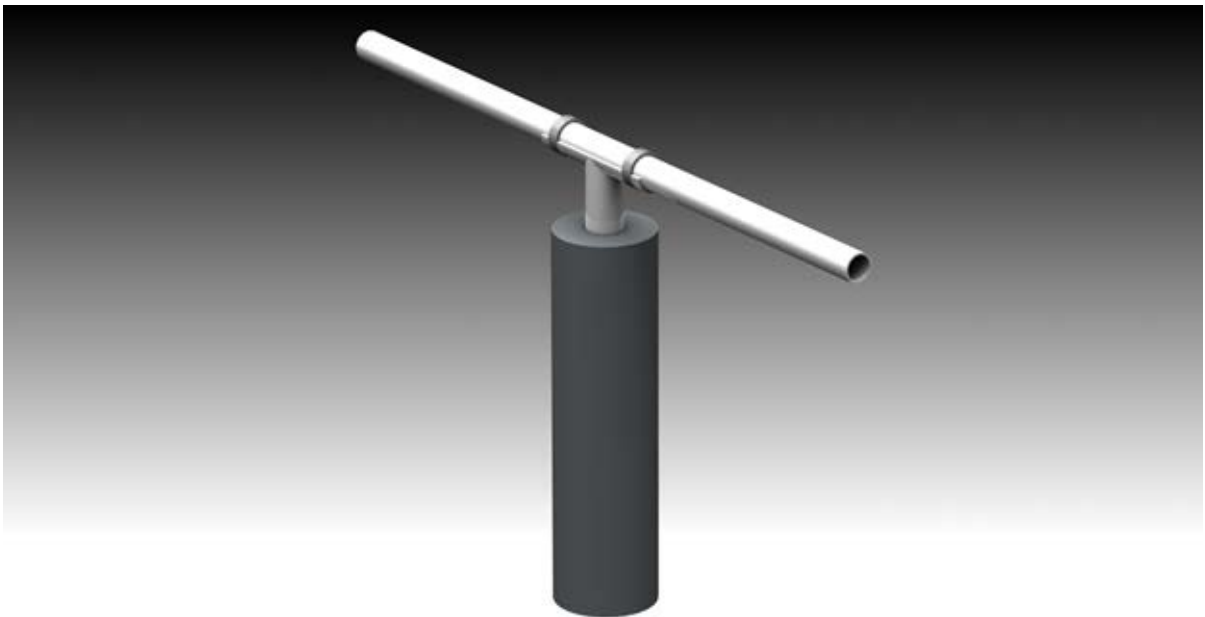
Figure 16: Uphill Pipe Supports

Additionally, to support the pipe as it travels up this incline, four equally spaced concrete footings 18” deep should be anchored into the side of the hill. Mounted in these footings will be 2” PVC T connections with the top half of the horizontal section cut off. This will create a cradle for the main line to sit in, as seen in Figure 16. The main line can then be attached to these T’s using metal pipe clamps which will support the weight of the line as it travels up hill.
