Operación de Agua Potable

Operation Clean Water
For the Community of Quebrada Caracol

Ngöbe–Buglé Comarca, Panama

Water Supply and Watershed Protection for Quebrada Caracol, Panama

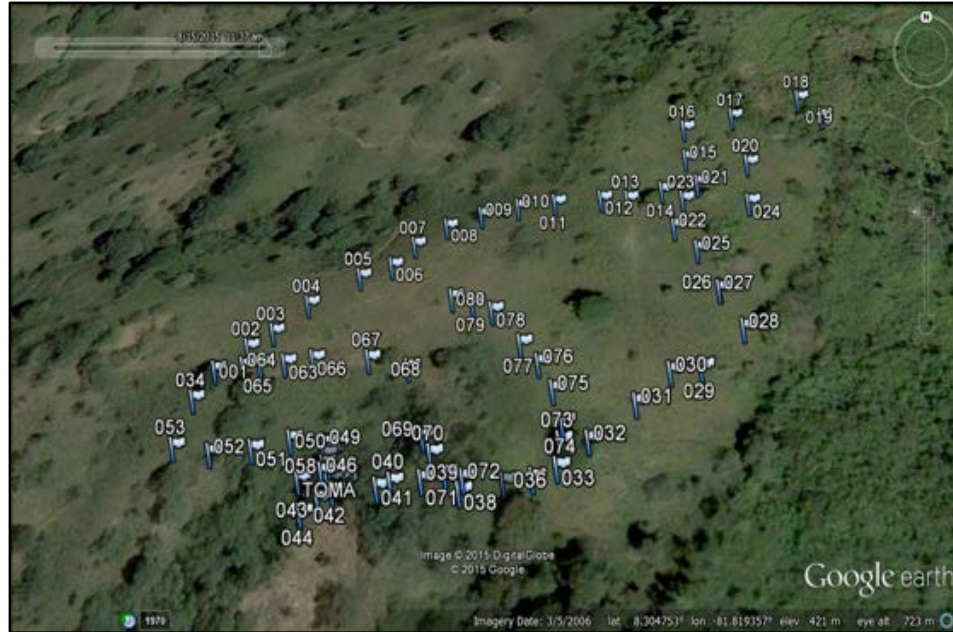
Figure 5: Waypoints collected outlining watershed area and geographic features

Listed in Table 9 of Appendix A is the data specific to each waypoint marked while surveying the watershed. The coordinates of each waypoint were all accepted as accurate, for the satellite signal near the top of the mountain was strong. The elevation given by GPS is based on barometric pressure, rather than satellite positioning, so there is a possibility of elevation fluctuations due to the weather. Recording the elevation changes at the spring box in five-minute intervals provided a means of determining the change in elevation with respect to time. The elevations from the control GPS at the spring box can be found in Appendix A. By recording the times at which each waypoint was marked, the plan was to adjust the elevations using readings from the control GPS. However, analyzing the elevations recorded from the control GPS revealed that the fluctuation in elevation occurred randomly, varying by ten meters over a period of ten minutes. The resulting conclusion is that adjusting the elevations to compensate for error in the GPS is not necessary, as the elevation changes did not display consistent variation with respect to time. Thus, the elevation data collected is accepted as accurate. An average of all of the elevations recorded at the spring box were used as the spring box’s elevation.

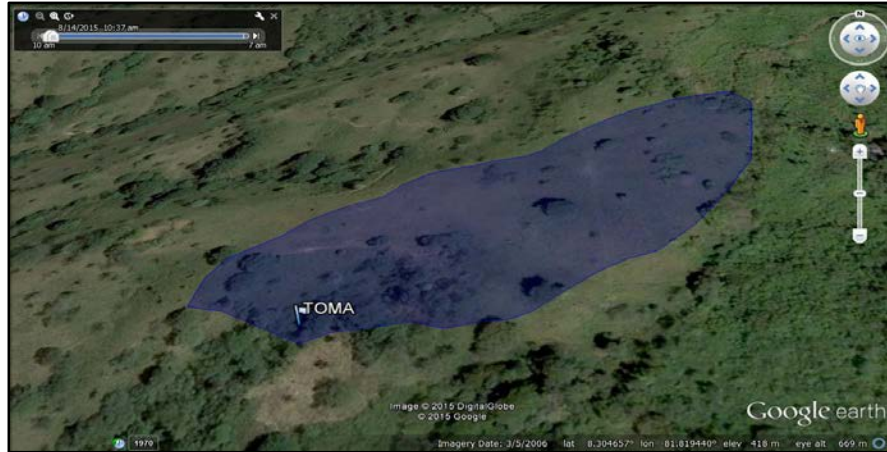
Figure 6: Area of Watershed Found Using Google Earth Polygon Feature

The waypoints gathered in Panama were mapped and converted to Google Earth using the software, EasyGPS. Additional waypoints were placed to identify boundaries which CWC was unable to reach by foot due to steep terrain and thick underbrush. The polygon feature in Google Earth was used to highlight the area of the watershed by selecting the waypoints that mark the perimeter of the watershed. Figure 5 displays the waypoints gathered for the watershed imported into Google Earth. Figure 6 represents the area of the watershed using the polygon feature. Once the watershed polygon was completed, its properties were copied and entered into *Earth Point*, which provides tools for analyzing Google Earth data. The *Earth Point* shapes tool yielded a perimeter of 943 meters and a total area of 54,734 square meters. The elevation difference between the highest point, Waypoint 18, and the spring box, Waypoint “TOMA”, is 100 meters. The waypoints along the ridgelines within the watershed were identified to illustrate various slopes that are present within the watershed. The fence-lines were located to identify the property boundaries to which the project is restrained. These boundaries may influence the feasibility of various methods used in protecting the watershed.

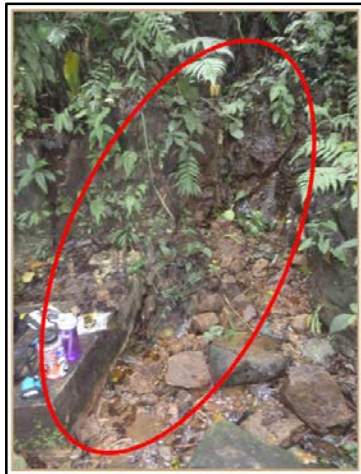
Figure 7: Runoff Water Identified by Red Oval

Testing the water quality was performed using 3M Petrifilm count plates. The first set of samples were taken in the morning of August 12th, 2015. These samples were taken from the water inside of the spring box, seen below in Figure 7, and runoff water flowing alongside the spring box, seen below in Figure 8.

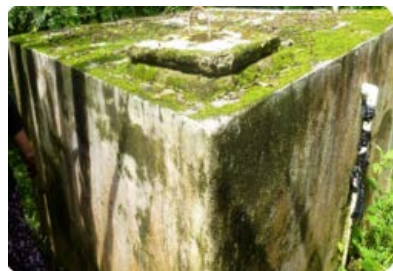
Figure 9: Broken pipe leading to inlet of water storage tank

The team observed poor condition of much of the PVC pipe throughout the system. Many points along the pipeline are exposed to the surface, increasing its vulnerability to damage by cattle and humans walking on it. There are also sections of pipe that are missing throughout the system as can be seen in Figure 29 in Appendix K. The pipe at the inlet of the storage tank had been damaged and was inadequately repaired with plastic bags. A picture taken in Panama showing the current state of this pipe can be seen in Figure 9.

Much of the PVC pipe of the current system is exposed to the surface thus much more vulnerable to damage. An unburied system PVC system is especially vulnerable in the village’s circumstances due to the regular storms and activity leading to occasional incidents damaging the system. Additionally, prolonged exposure to UV light could cause loss in impact strength [16]. Vinindex provides several guidelines for trench depth and width giving the outer diameter of the pipe [17]. Based off CWC recommends that damaged pipes need to be replaced and buried to improve the system’s productivity and integrity. By doing this, the pipes are not continually exposed to UV and overall damage.

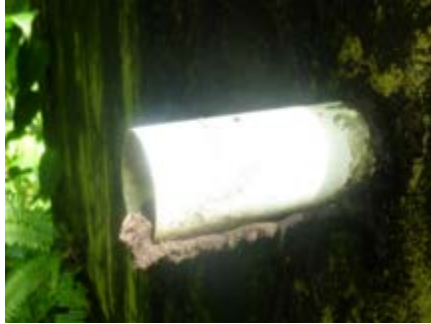
Figure 10: Termites entering water storage tank overflow pipe

Another observation CWC made while in Panama was that lids covering the spring box and storage tank were crumbling and did not completely cover the openings. CWC noticed that the overflow and ventilation pipes of the spring box and storage tank were not adequately screened. The lack of proper screening allows leaves, insects, and other vermin to enter the pipes. Figure 10 below shows how termites had entered the overflow pipe in the water storage tank.

The EPA recommends that the tank overflow and ventilation pipes should be screened with #24 stainless steel mesh to keep vermin out of the supply system [12]. Their recommendation is based on the fact that # 24 mesh is sufficient at keeping numerous pests from infiltrating the system while allowing air and excess water to exit. They emphasize this because insects carry pathogens and many are capable of infiltrating meshes with larger spacing [12].

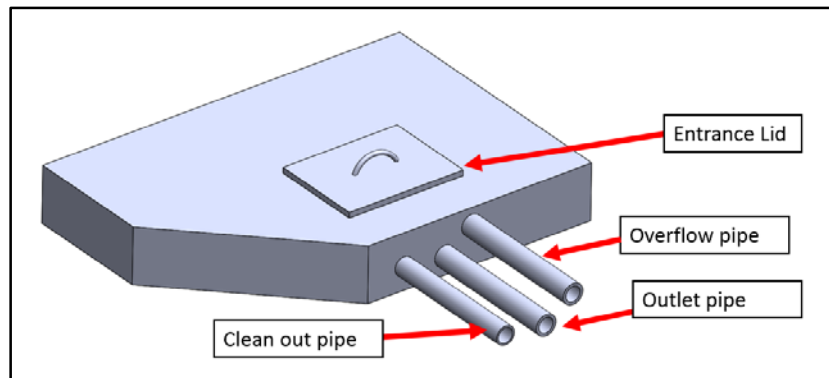
Figure 11: Spring box with pipe details

The current spring box is made of concrete and has an irregular opening on the top that can be accessed by removing the existing lid. Figure 11 below shows the spring box. A detailed dimension drawing can be seen in Appendix C. Measurements that the computer aided design and technical drawings were based upon were collected while CWC was in Quebrada Caracol.

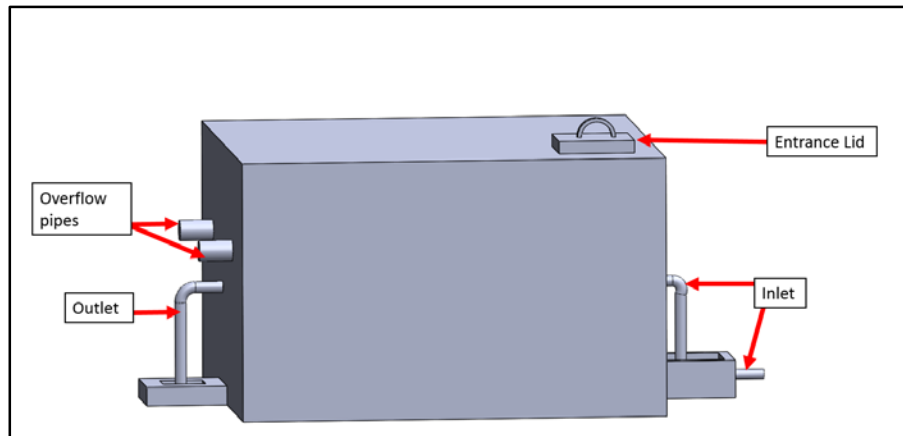
Figure 12: Storage tank with key components highlighted

The current holding tank it can be seen in Figure 12. Water runs through the pipe system from the spring box into an inlet pipe that is guarded by a concrete box without a lid. The water then drops from this inlet pipe into the 1104.5 gallon holding tank. There is a lid on the top of the holding tank, but it does not securely fit the opening. There is moss and other vegetation growing on the exterior surface of the storage tank's walls. From the measurements collected on site in Panama a detailed drawing of the storage tank was created and can be found in Appendix C.

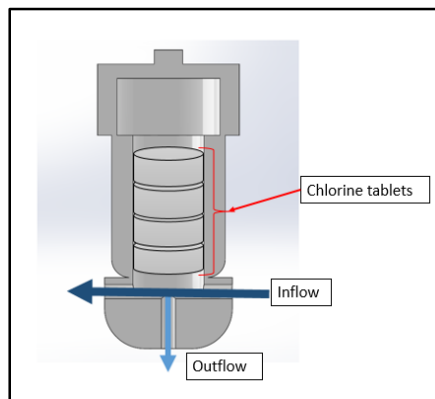
Figure 13: Current system for water chlorination

The current chlorinator is situated downstream of the storage tank so that the chlorination process occurs as it proceeds to the outlet. This chlorinator was supplied monthly with chlorine tablets, so that it could continue to chlorinate the water as it flows across the bottom of the bottom tablet and flows outward. According to the PCV, it has not been supplied with tablets for a substantial amount of time. The current system was created in SOLIDWORKS with the dimensions recorded in Panama. Figure 13 shows the model with key components labeled.

There are three holes around the circumference of the current chlorination system and a hole located at the bottom. Water flows from the storage tank outlet pipe to a Standard T style PVC pipe. Pictures CWC took of the current chlorination system can be found in Appendix K.

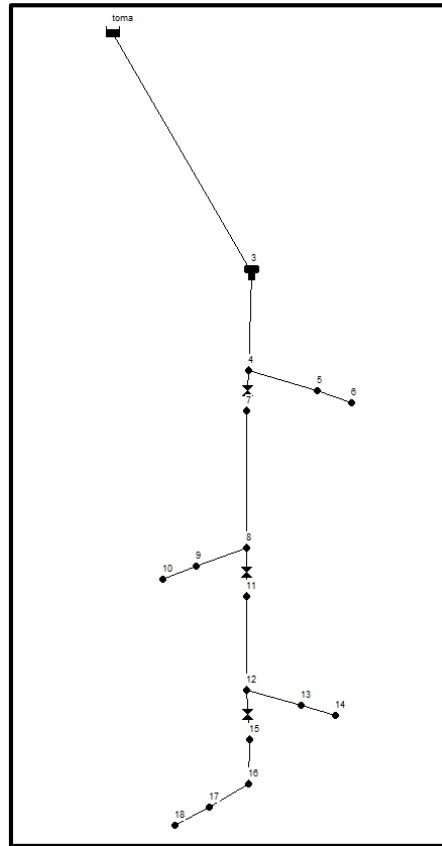
Figure 14: EPANET hydraulic model, network map of water distribution system

A hydraulic model of the water distribution system was created using EPANET, which is a software that simulates water movement over an extended period of time. Listed in Table 10 in Appendix A is the surveying data provided by the Peace Corps volunteer that was

used to design the distribution system. The system schematic of the EPANET hydraulic model can be seen in Figure 12.

Household water demands were calculated based on eight people per house using 30 gallons per day per person, as suggested by MINSA [8]. This usage was converted to liters per minute (Lpm) per household as demonstrated in the equation below. This yields a base demand of 0.63 Lpm per household. It should be noted that the spring is capable of supplying this demand during the rainy season, with a discharge of 17.22 Lpm. The discharge from the spring in the dry season is only 0.34 Lpm; thus, the spring is not capable of supplying the suggested base demand.

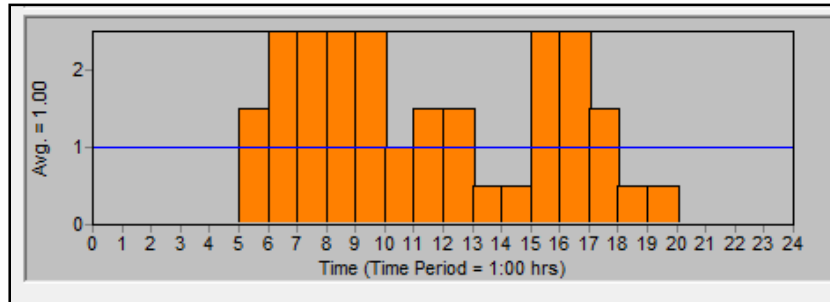
Figure 15: Water demand pattern over 24-hour period

A demand pattern that represents the water usage during a typical day is another useful parameter of EPANET. The demand pattern was determined based upon observations made during CWC's stay in the village. It was noted that water collection generally occurred during the morning after sunrise and again in the evening before sunset. As displayed in Figure 13, the demand pattern was determined to account for these peak water usages.

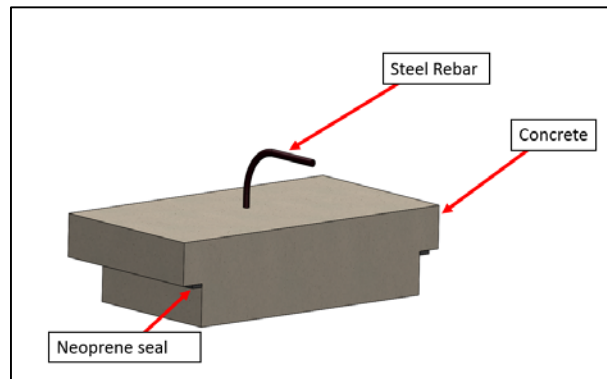
Figure 16: Cross section of new lid with key components outlined

To replace the deteriorating lids, CWC designed a new lid to prevent contamination within the storage tank and spring box. The lid design was made following EPA's recommendations on hatches for drinking water. They recommend a frame around the opening at least 4 inches tall and a water tight seal on the lid. [Environmental Protection Agency, "EPA Region 8 Drinking Water Unit Tech Tips: Sanitary Protection of Reservoirs: Hatches] The new lid design entails the addition of a four-inch tall frame surrounding the opening of the storage tank. This frame is designed to prevent pooling water from entering the storage tank at the lid. The bottom portion of the lid will extend into the opening of the storage tank to ensure that it is positioned properly. A two-inch wide by half-inch thick neoprene gasket will be fixed around the lid to prevent water and vermin from entering. Finally, a handle is constructed from No. 4 rebar will enable easy removal of the lid.

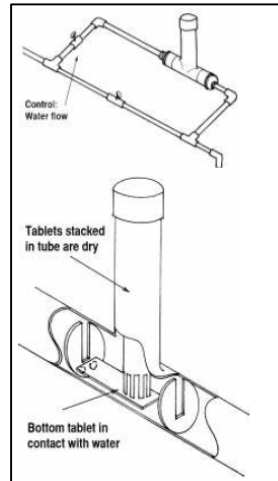
Figure 18: CTI chlorinator system schematic

bacteria, and greatly reduced the Acute Diarrheal Disease incidents. The system can be seen in Figure 14.

This new chlorination apparatus will be installed upstream of the storage tank so the chlorine will have more contact time with the water. After the new chlorinator is in place, the old chlorinator will be properly disposed. The concentration time of chlorine was found to be 83.93 mg-min/L. This is more than adequate time to decontaminate the water of common harmful bacteria such as E. coli and other fecal bacteria. This calculation can be found in Appendix F. After installation, CWC recommends to the village to maintain the chlorine tablet count in the chlorinator to insure that it won't open the possibility of leaving water untreated.

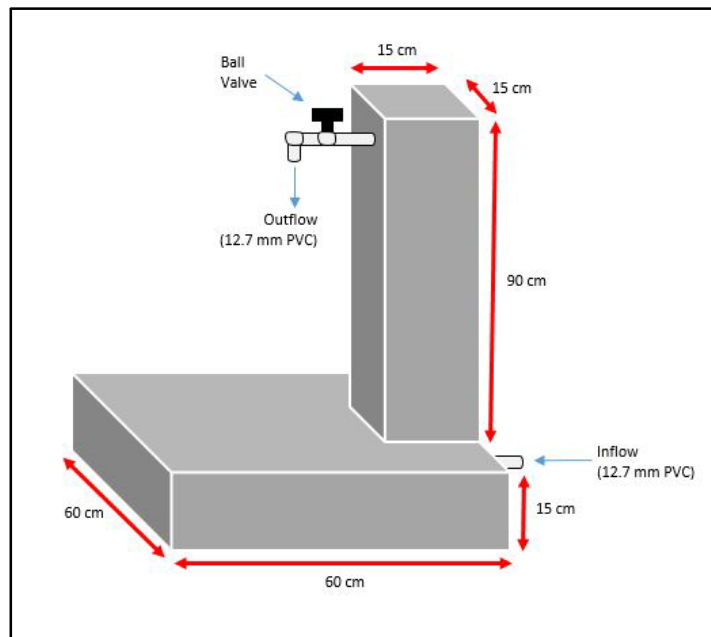
Figure 20: Proposed tap stand design

In order to ensure that the community members could obtain water from the aqueduct system CWC designed tap stands to be placed at the end of each branch of the aqueduct system. The tap stands will also ensure that the chlorinated water is being properly used, and not just left to run onto the ground. These tap stands will consist of PVC pipe, a ball valve, and concrete. Figure 20 shows a schematic of CWC's proposed tap stand design. This design was created because the basic geometric shapes will be easy to construct, and because the ball valve and PVC pipe are economically feasible and easy to replace if needed. In order to shape the concrete wooden molds will be used. A detailed procedure outlining the construction of the tap stands can be found in Appendix I. Care was taken to ensure that the outflow from the tap stands is adequate for the community members by having the outflow pipe diameter measure 12.7 mm.

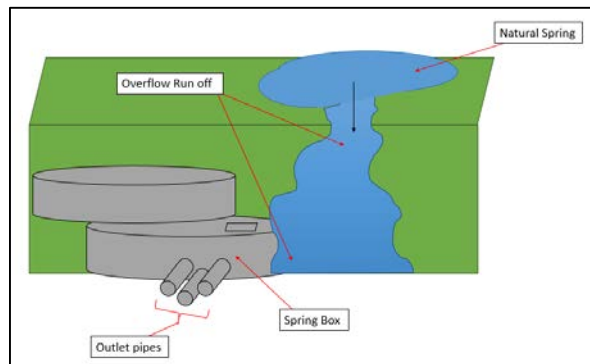
Figure 21: Current state of above spring runoff

Due to runoff water running alongside and on top of the spring box, CWC fears that it will contaminate the spring water used for the community. For this reason they wish to divert it away from the spring box. Figure 21 shows the current state of the system. Figure 22 shows a conceptual sketch of what the team proposes to be done.

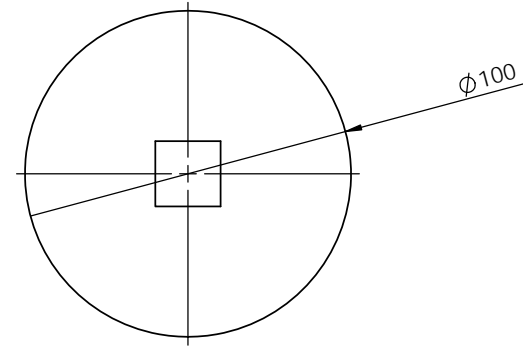
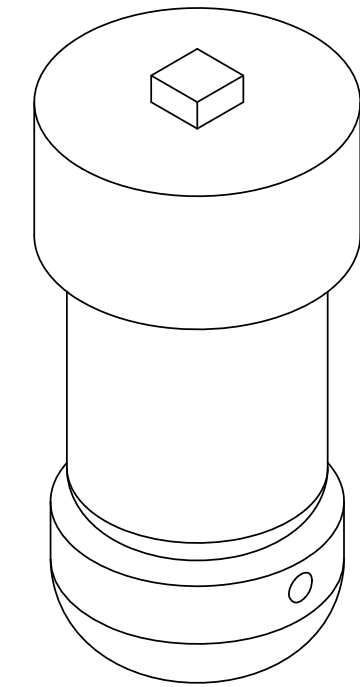
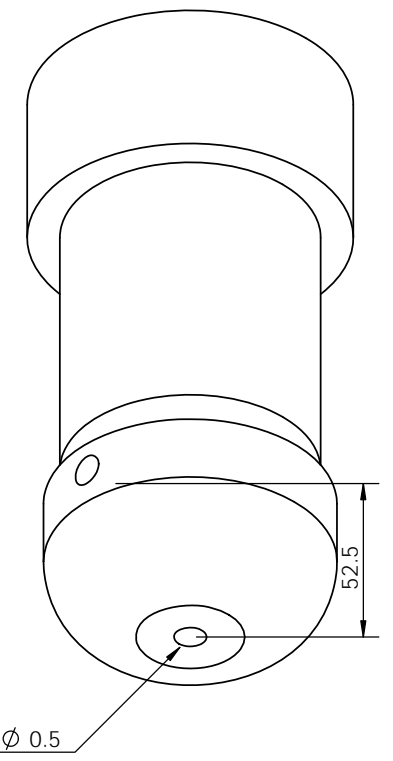
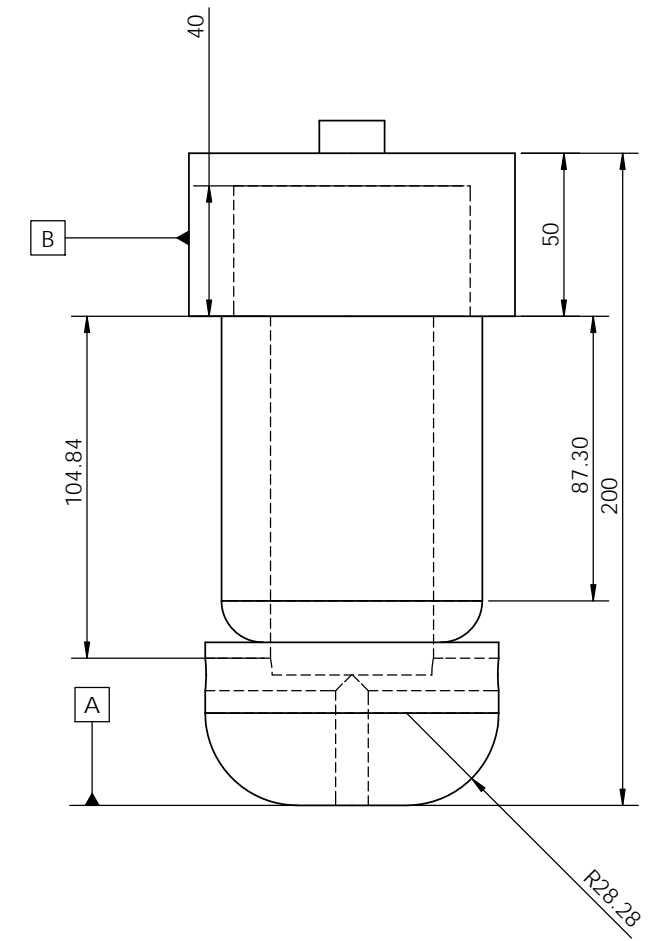
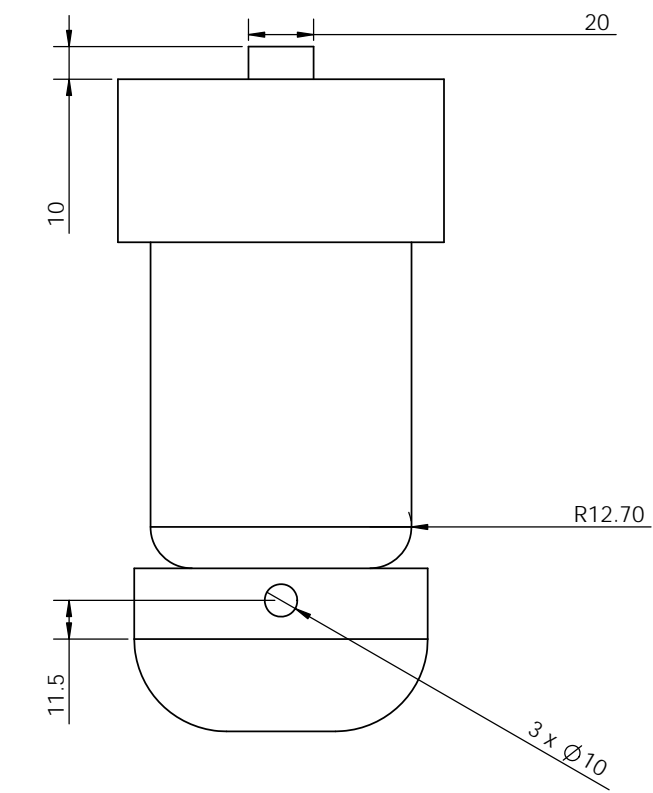
TITLE:		
SIZE	DWG. NO.	REV
C	ChlorineTabletHolder	
SCALE: 1:4	WEIGHT:	SHEET 1 OF 1

1. User drops tablets by unscrewing the top of the Chlorine Tablet. There is room for maximum of two tablets at a time.
2. Water enters chamber through holes on side of the holder. There are a total of three of these holes.
3. Chlorinated water exits the chamber from the bottom of the holder.
4. Water with chlorine continues to flow down the pipe system.

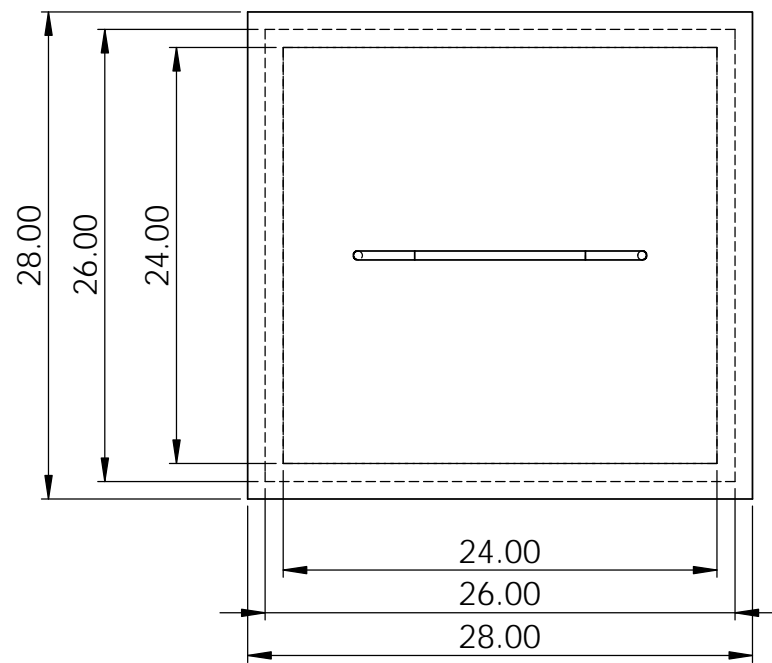
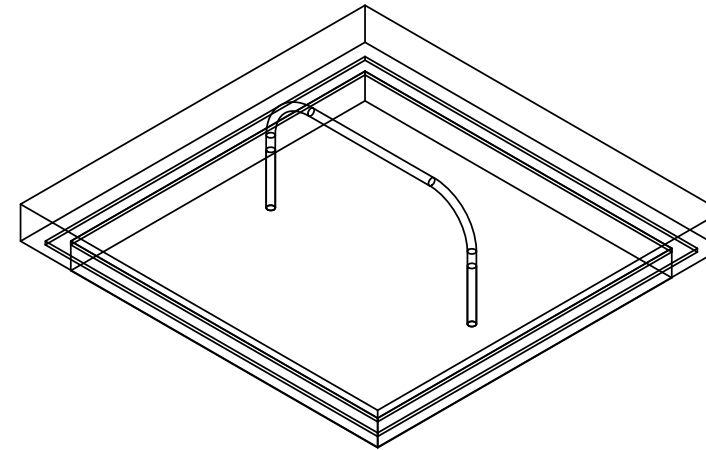
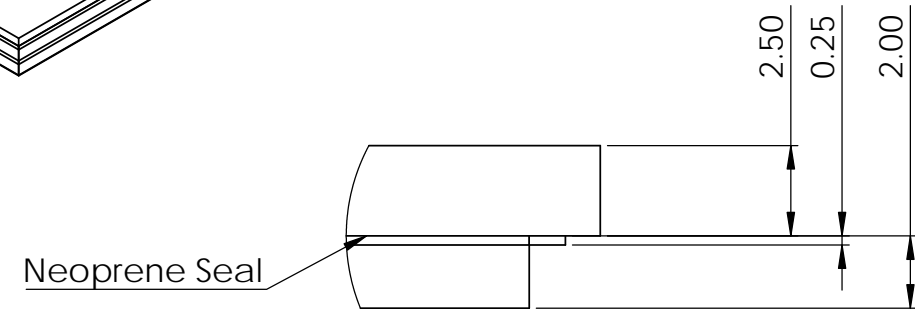
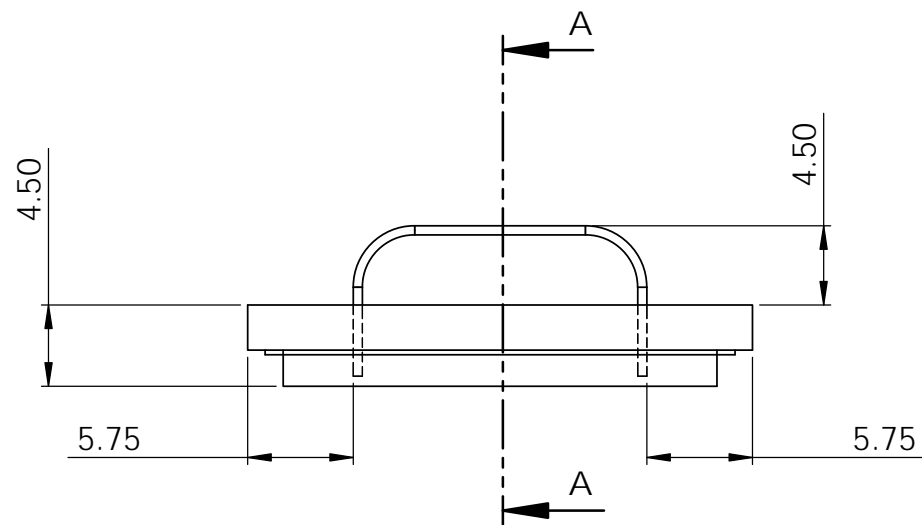
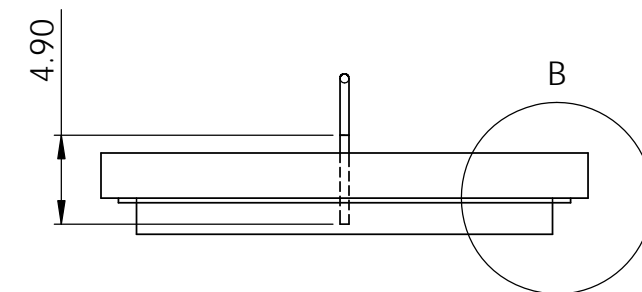
DETAIL B
SCALE 1 : 5

Note: Lid will be constructed using lightweight concrete that has a density of 63 pounds per cubic foot leading to the overall lid weight being 67 pounds. The handle of the lid will be made out of steel rebar. There is a Neoprene seal around the edge of the lid. Lid will be constructed using wooden frames created at cite. See final report for details.

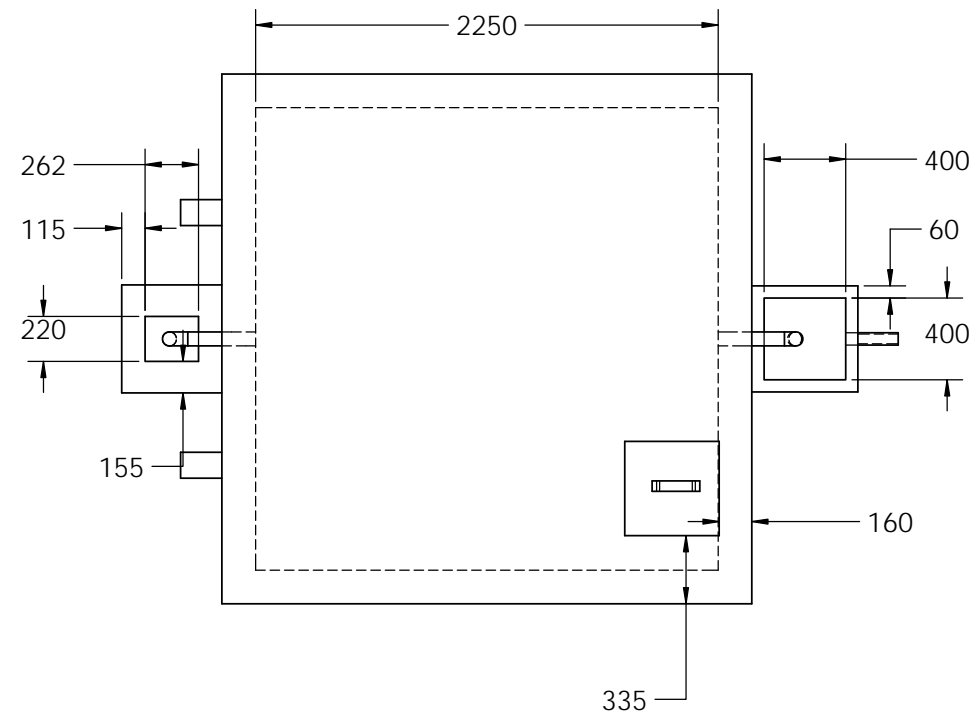
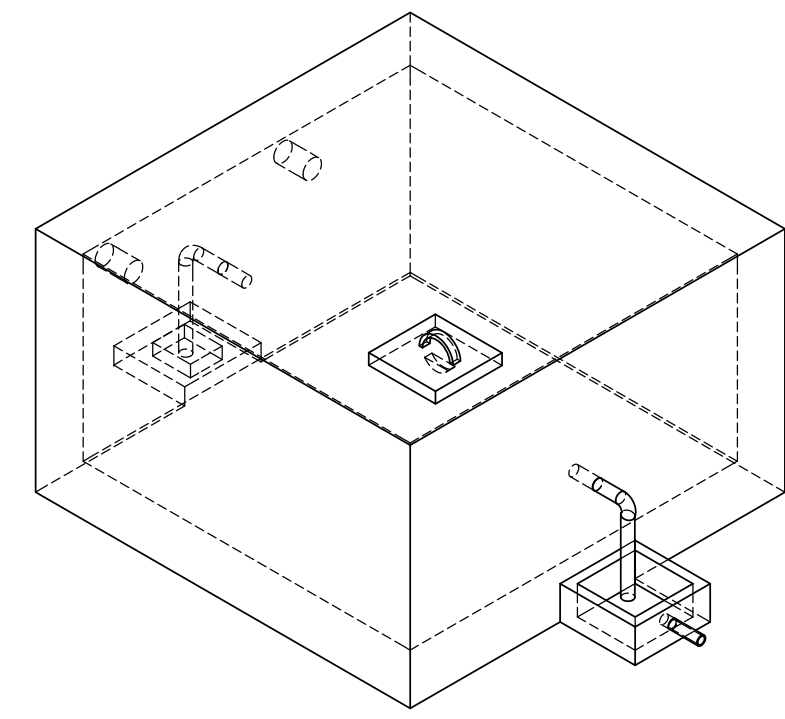
Note: this is the outlet pipe leading to the main line of the system

Note: This pipe is the inlet pipe with the water flowing in from the natural spring
