# Water Resource Development—Valle Escondido, Panama

## Project Background

Student teams spent two weeks in Panama, most of which was in indigenous villages collecting data for analysis during the fall semester. Groups of 4-5 students went to villages throughout the country, each with a unique problem to assess. ‘Todo Debe Engineering’ went to the village of Valle Escondido.

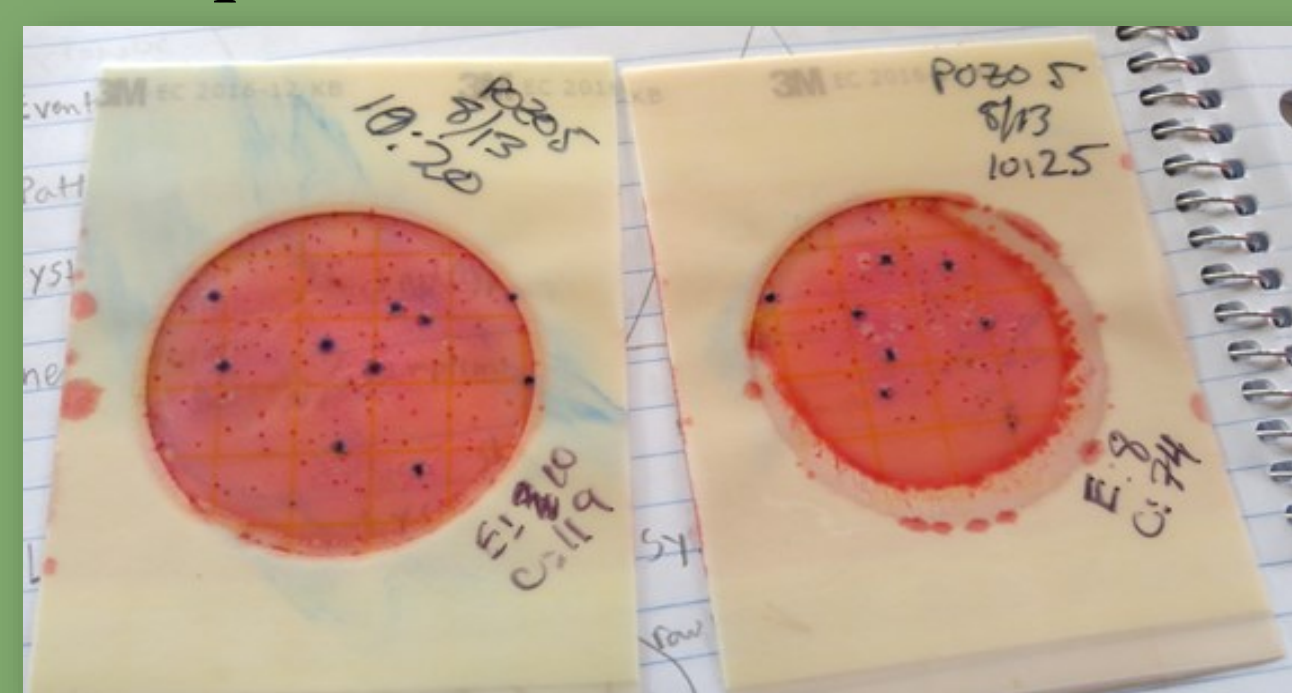
Figure 2. 3M Petrifilm - High E. coli

- Survey of Aqueduct
- 3M Petrifilm & Nitrate Tests
- Pressure/Pipe Size/Tank Assessment

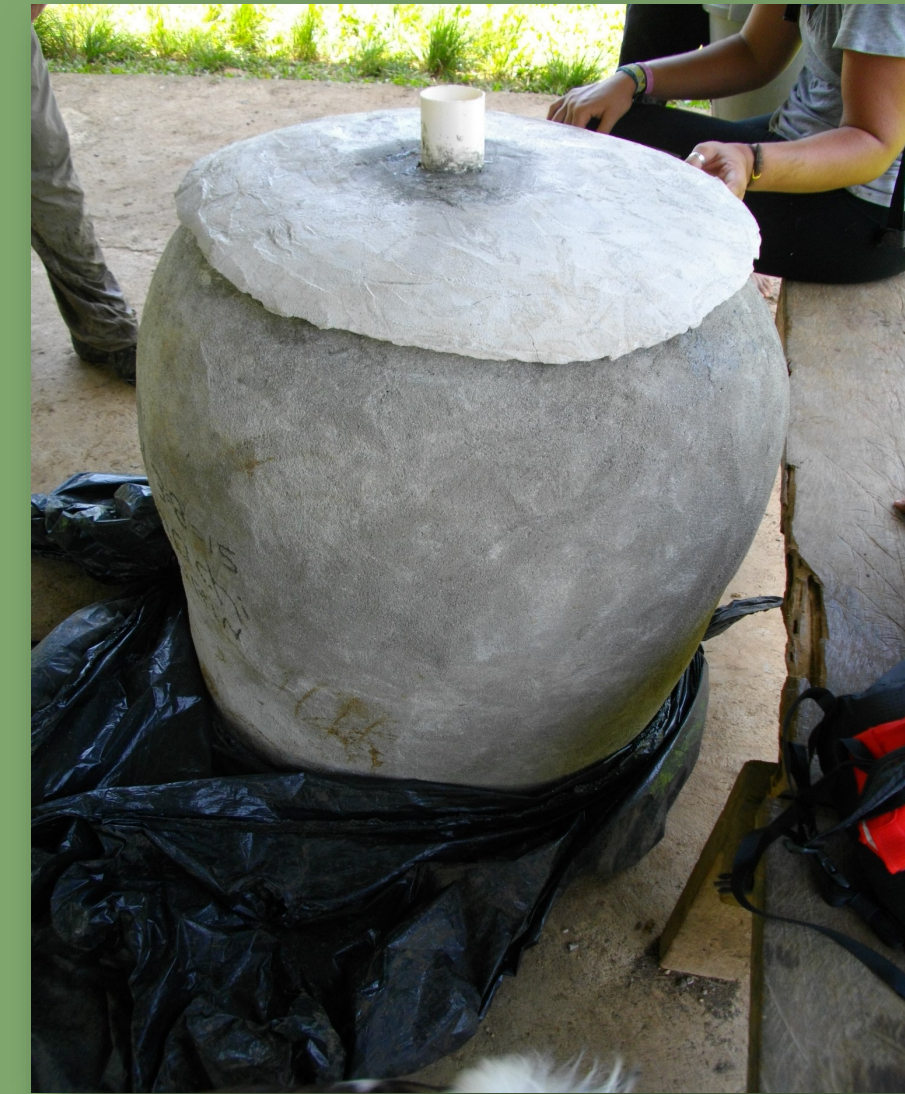
- 85 Gallon Ferrocement Tank
- Wooden Stand
- PVC Gutter Pipe for Water Collection
- Mesh Filter removes large roof debris
- First Flush System removes smaller roof contaminants

Figure 3. Sample Tank In Community
