Las Trancas Bridge Project

Trancas Associates

Michigan Technological University - International Senior Design

December 16, 2016

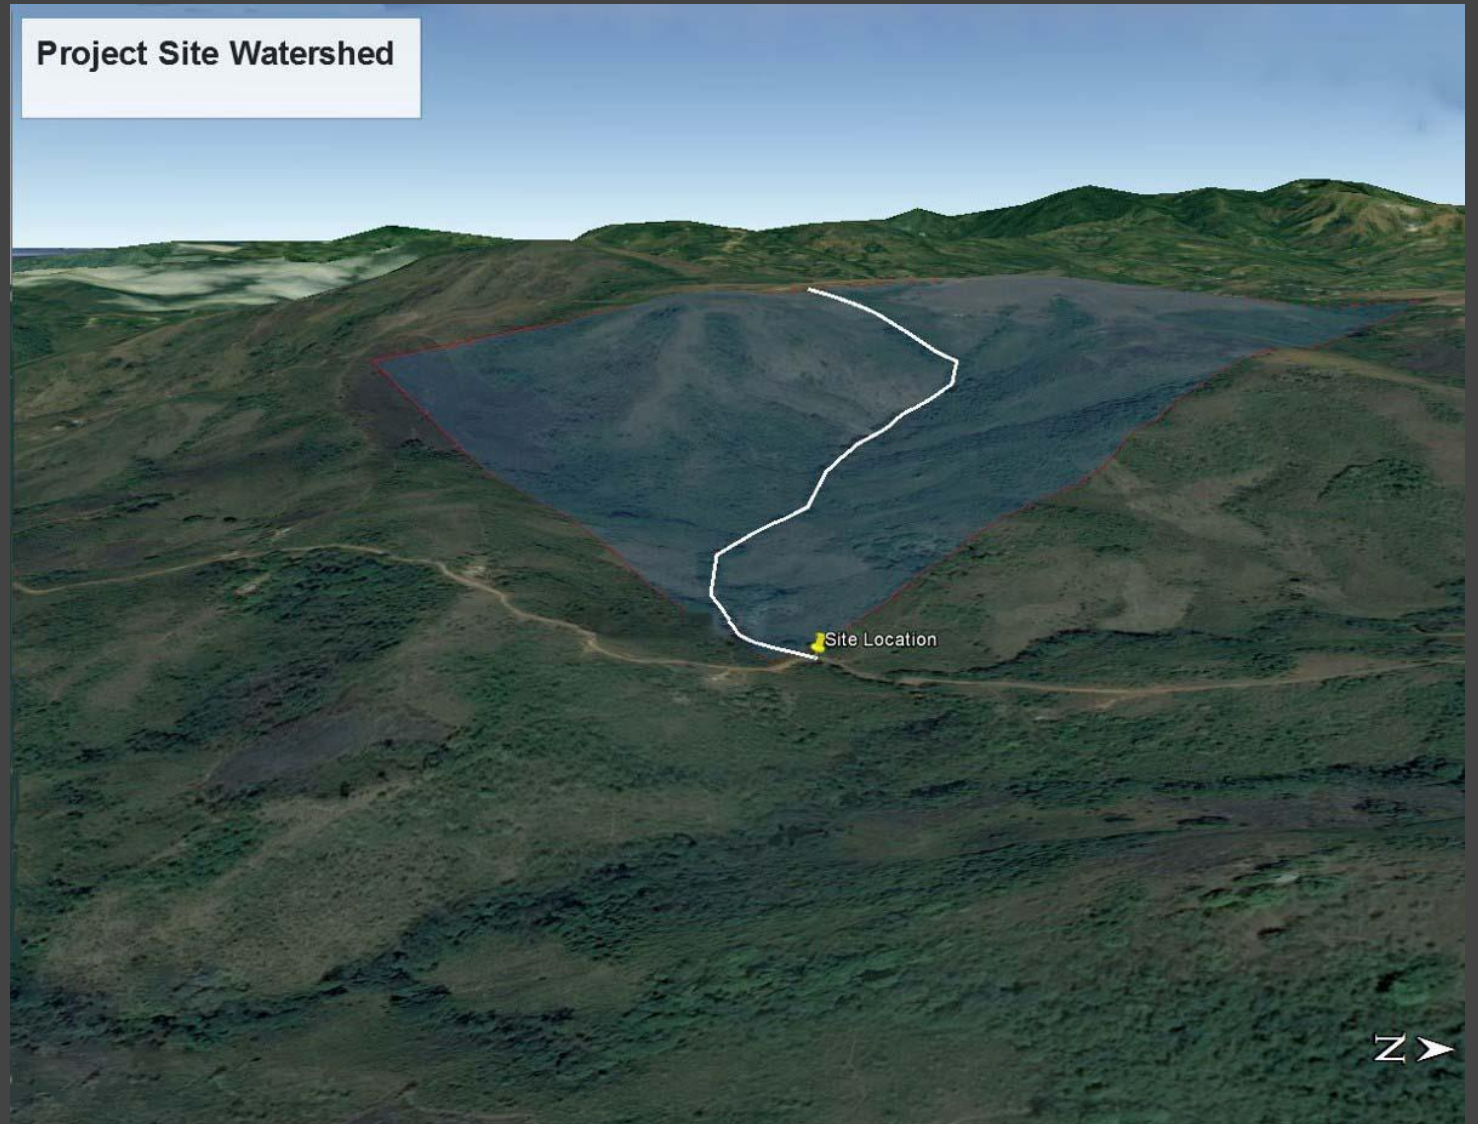
Hydrology - Watershed

- 0.33 mi^2 approximated watershed area
- $\sim 4300'$ channel length leading into the site location
- NRCS Peak Discharge Method was used:
 - Runoff Curve Number: 83

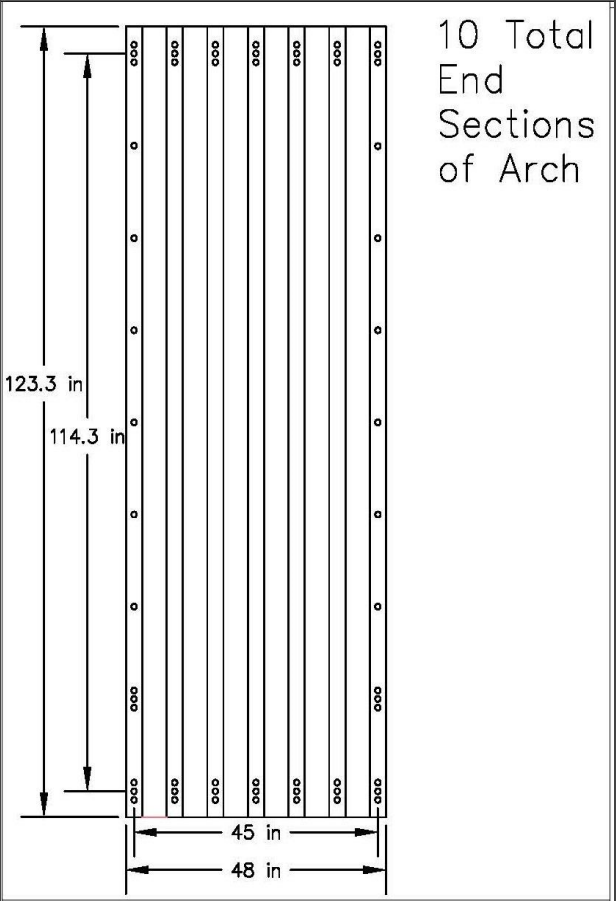
Bridge Plates

Corrugated Steel Plate
(15 in x 5.5 in)

HS-20 Loading

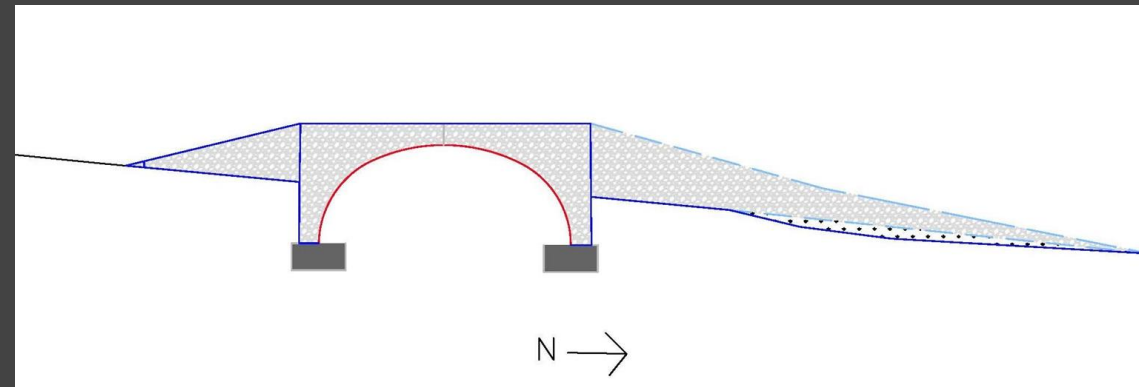
- 1 in Crushed, Angular Gravel
- 6" - 8" Lifts and Compacted to 90%
- Vertical Road Grades of 16% and 20%
