# CERRO ORTIGA II GRAVITY-FED WATER SYSTEM CERRO ORTIGA, NGÖBE-BUGLÉ PANAMA

# **Project Description**

# Design a gravity fed water system

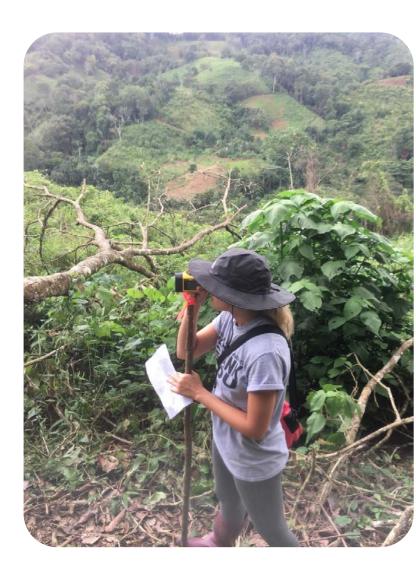
Figure 5. Surveying using the digital range finder

- Surveyed distances and elevations of the system.
- Steep hills and thick vegetation
- Equipment
- digital rangefinder
- abney level
- tape measure
- GPS

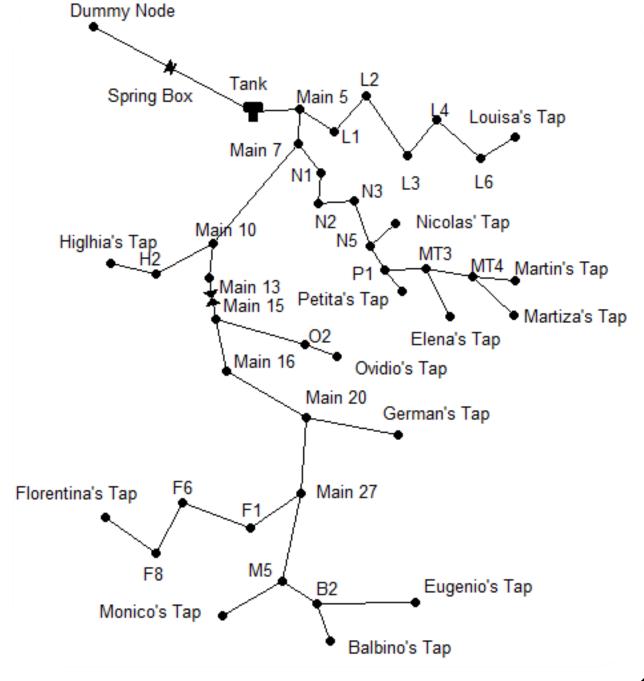
# Hydraulic Grade Lines (HGL)

• Ensure within safe pressure limits

Ensure no negative pressures
