CERRO ORTIGA II

Pluma Inc.

PROBLEM DESCRIPTION

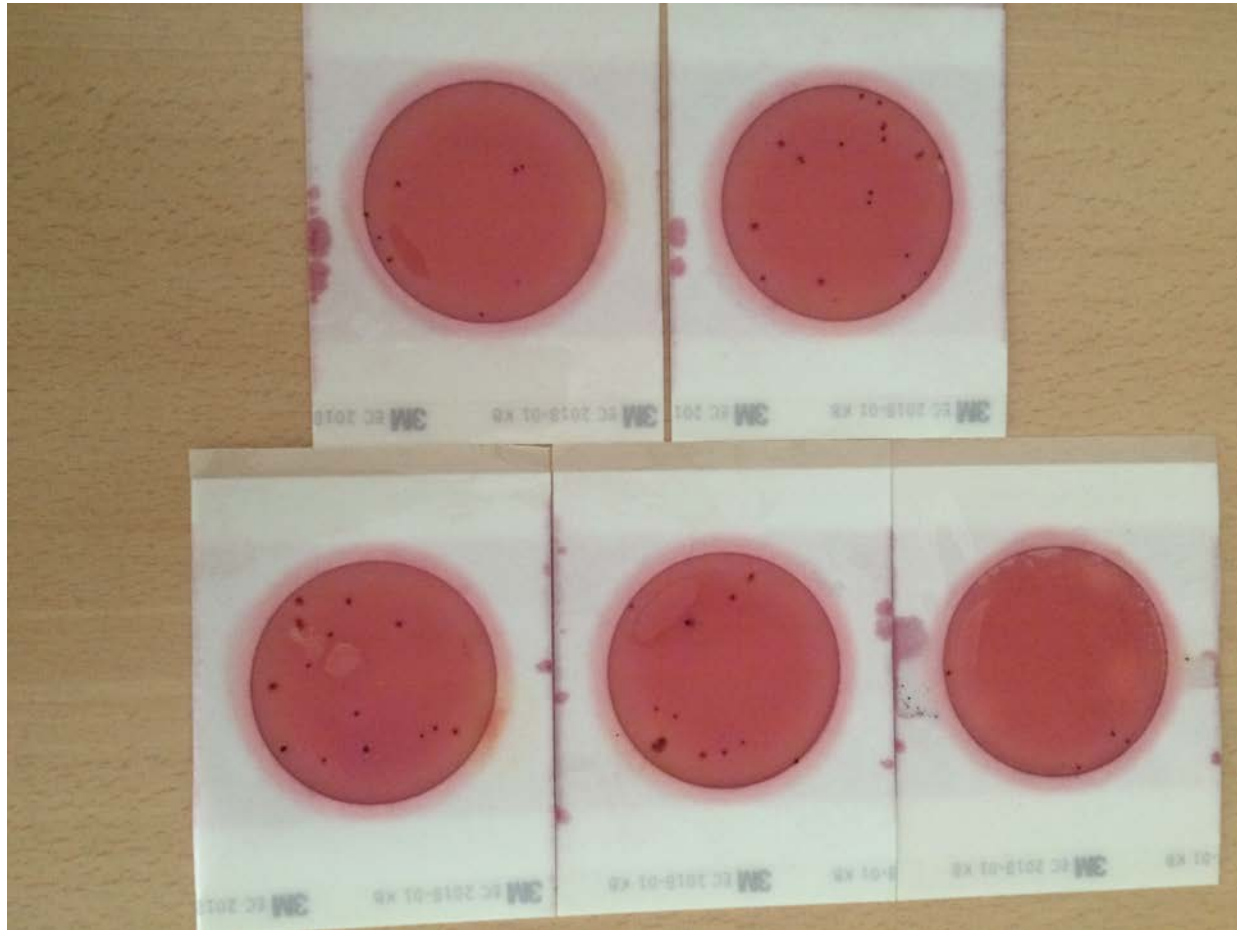
WATER QUALITY

Quality Test	Number of Coliforms
1	19
2	9
3	4
4	12
5	14
Avg.	11.6

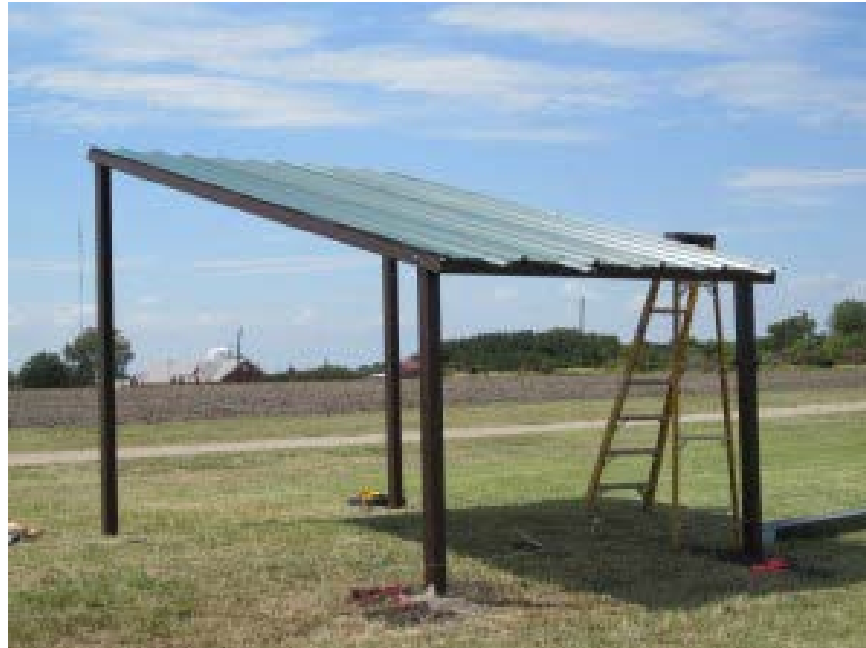
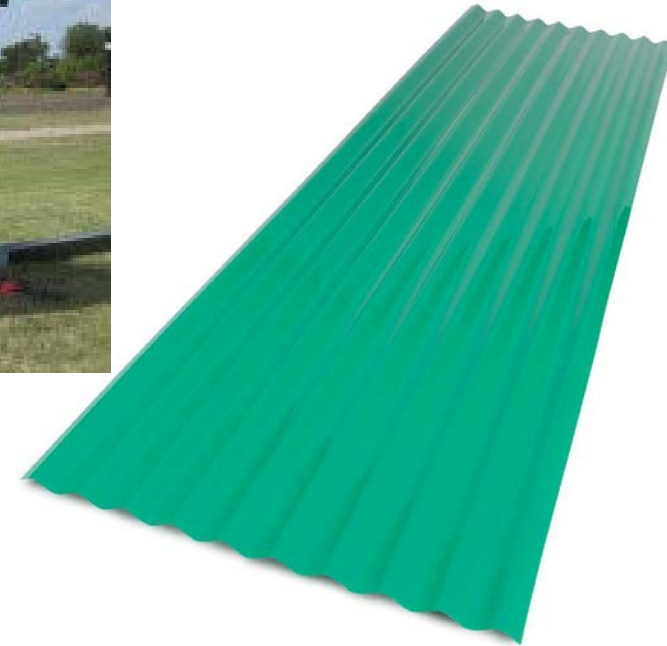
RAINWATER CATCHMENT

- System for laundry area
- Area will be dammed
- Roof area: 25 ft²
- Captures an average of 170 gallons/month
- Materials:
 - Corrugated PVC
 - 4 x 4 Wooden Posts

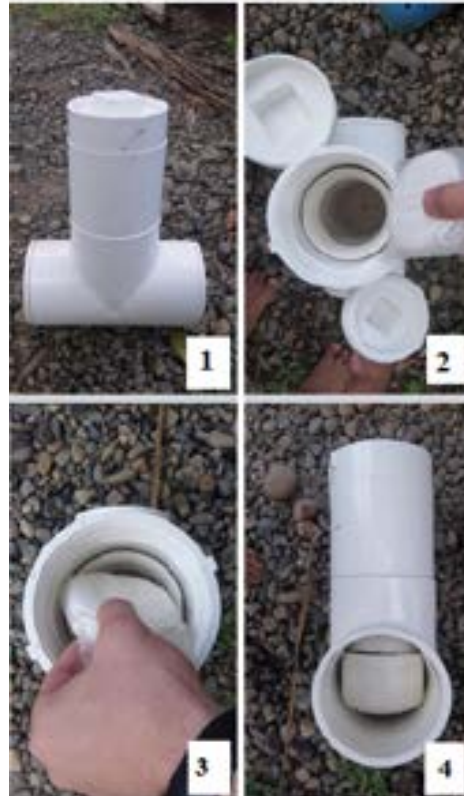
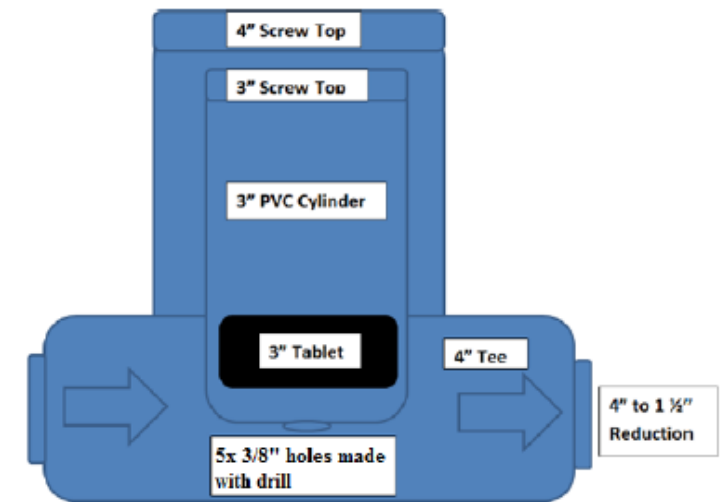
CHLORINATOR

- Recommend: Insert 3 tablets every 1-2 weeks
- Tablets:
 - 200 grams
 - 3 inch in diameter
 - 70-90% available free chlorine
- Tablet dissolution rate: 5-7 days
 - Study flowrate: 1.2 gpm
 - Cerro Ortiga flowrate: 1.13 gpm
- Cost: \$25
 - 15 tablets/visit

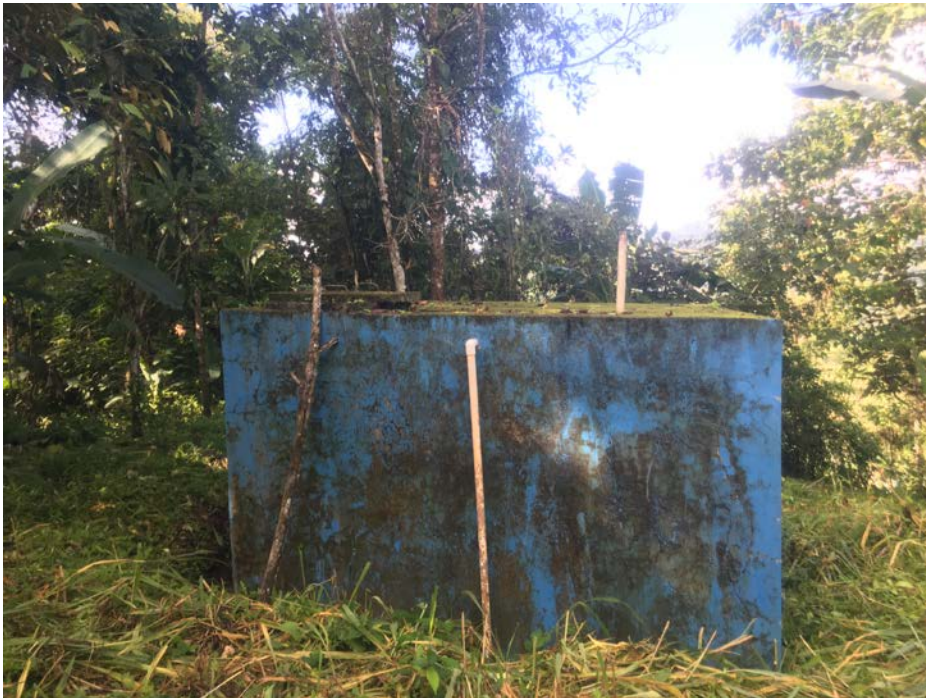
Old Infrastructure

- 4,500 gallon

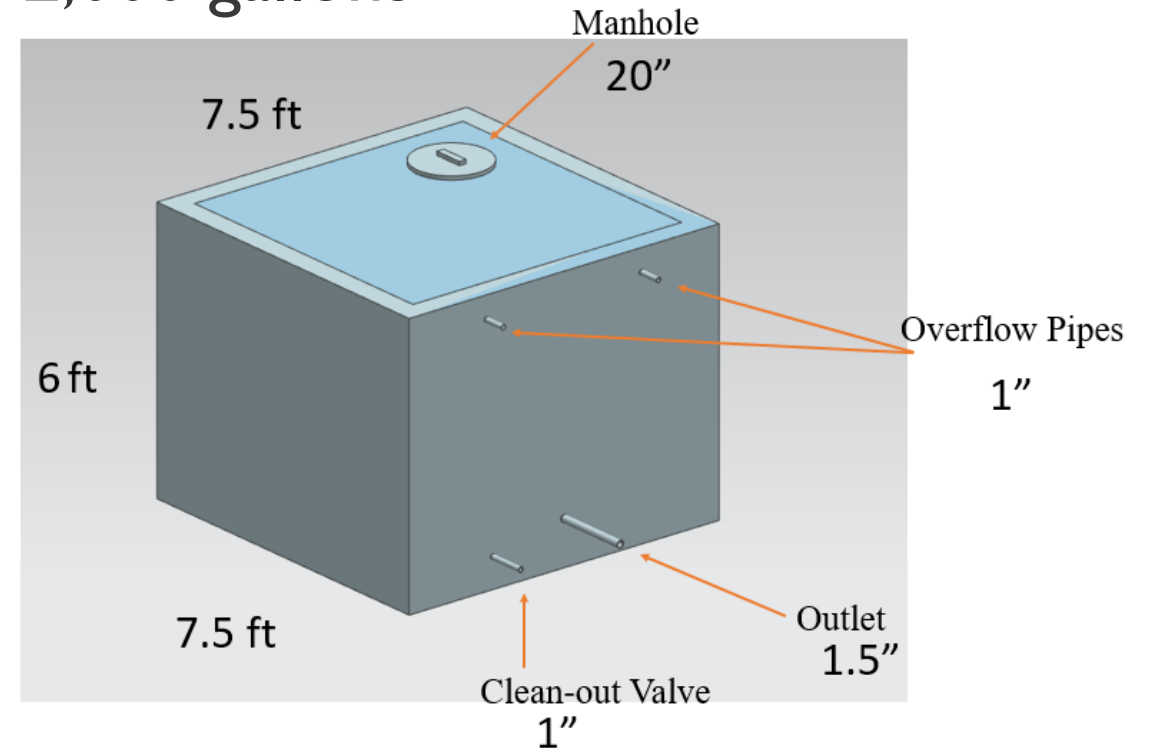
New Design

- 2,000 gallons

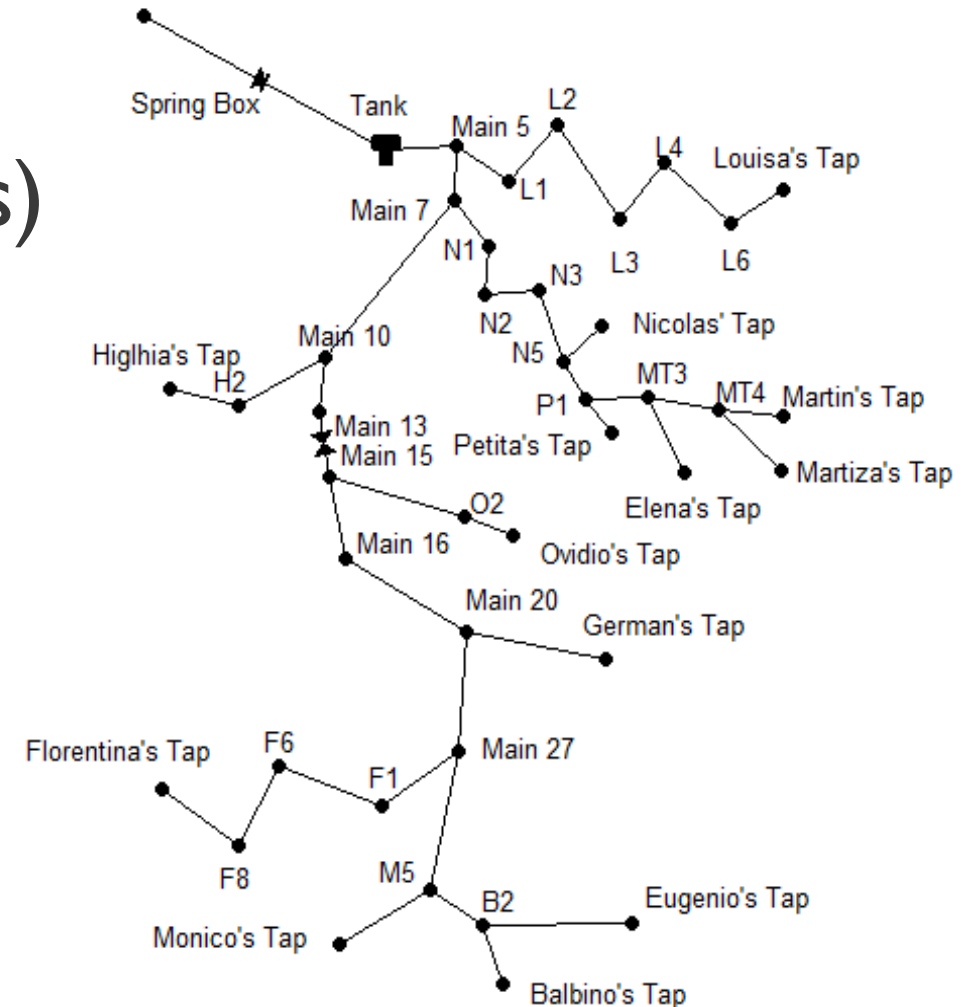
PIPELINE

- Total Pipeline: 8,180 ft (1.5 miles)
- Main Line: 2,500 ft
- Pipe Diameter
 - 1.5 inch on main line
 - 1 inch on branches
- Pipe material is SDR 26

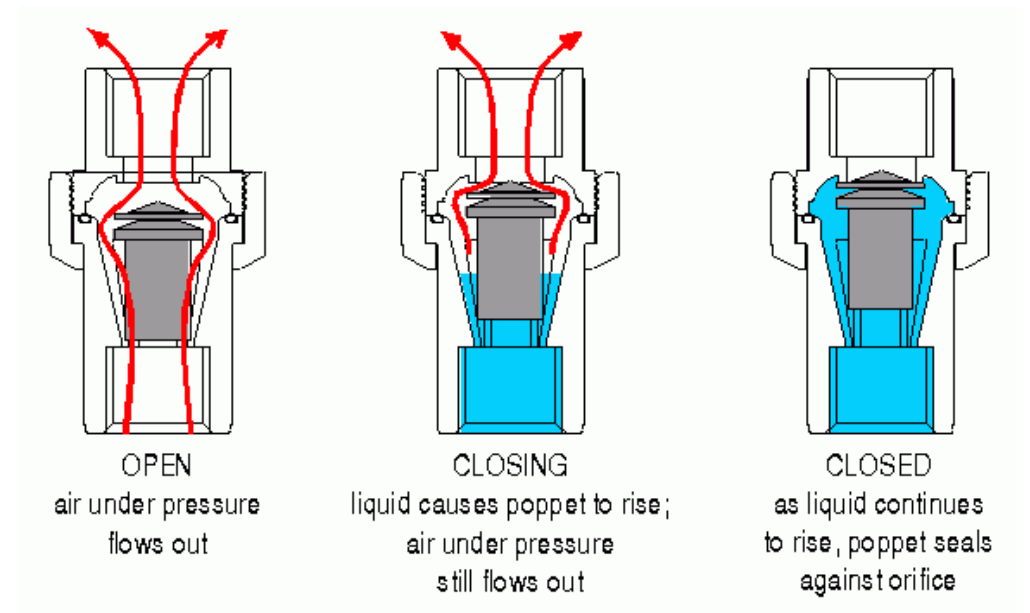
AIR VALVE

- Air blockages can occur within a gravity fed water system
 - Changes in elevation
 - High pressures
- Air valve will be placed on Louisa's branch
- The valve is closed when the system is running normally

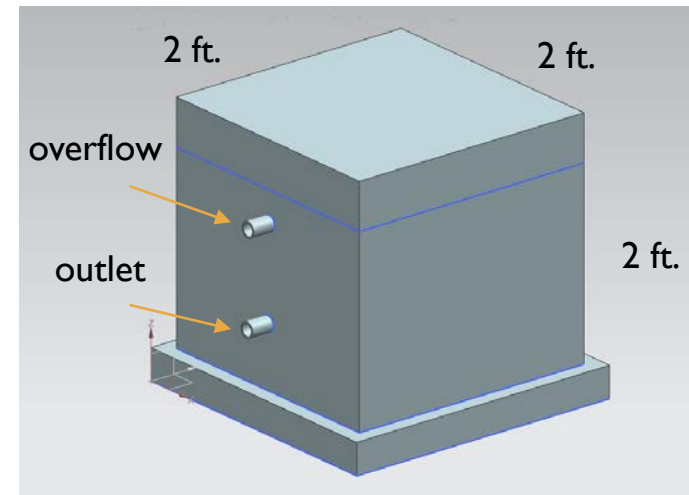
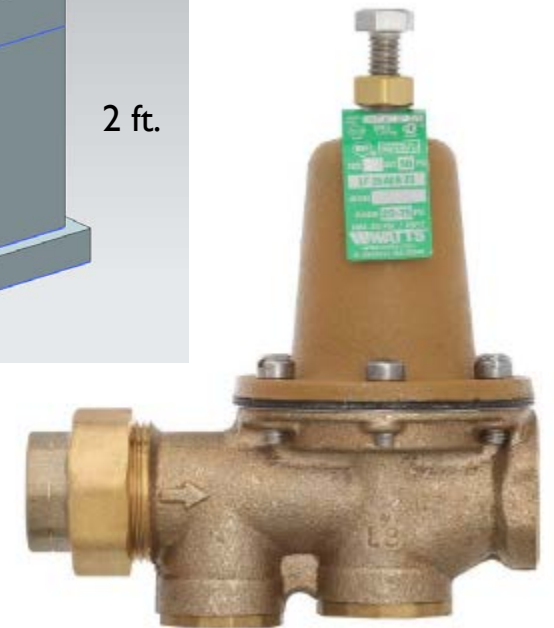
PRESSURE REDUCING VALVE/PRESSURE BREAK TANK

- High pressures occur at the lower end of the system
 - Overall elevation change of 375 feet
 - Pressures between 100 and 150 psi
- Pressure release valve
 - Reduces pressure to 25 to 75 psi
- Pressure break tank
 - Reduces pressure to atmospheric

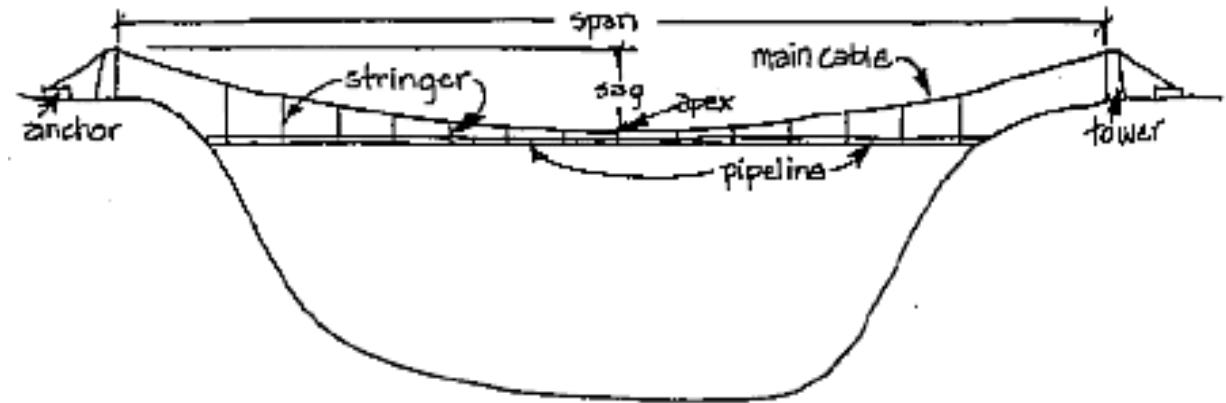
PIPE CROSSINGS

Crossing	Length of Span (ft)	Total Tension (lbs)
1	38	395
2	83	985
3	26	250
4	25	233
5	34	322
