[Three] Examples of Ferroresonance in Distribution Systems

Roger C. Dugan Sr. Consultant Electrotek Concepts, Inc.

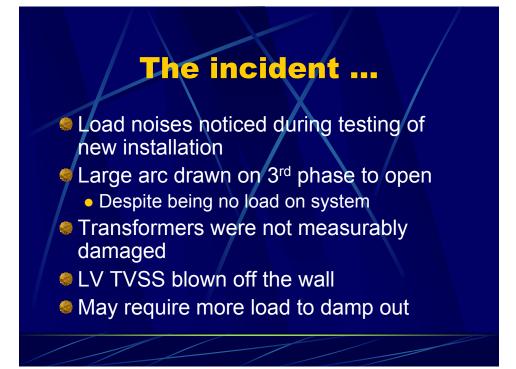
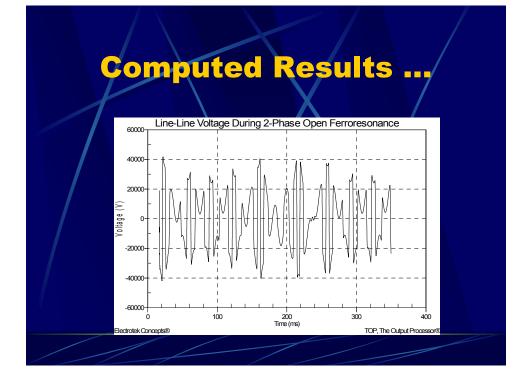
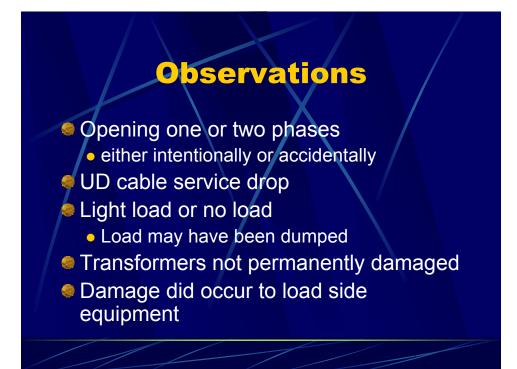
12 kV Padmounts...

- Ferroresonance less likely at 12 kV than at 25 or 35 kV
- Grd Wye-wye transformers the norm at 25 and 35 kV
- Many utilities continue to use deltaconnection in 12 kV systems without many known problems

- 3-phase switchgear
- Open or close all three cutouts as
 - simultaneously as possible
- Ensure the transformer is loaded while being switched.
- Eliminate fuses
- Prevent inadvertent fuse operation
 - Animal guards, etc.
