6. Priority Pollutants and Critical Areas

6.2. Critical Areas

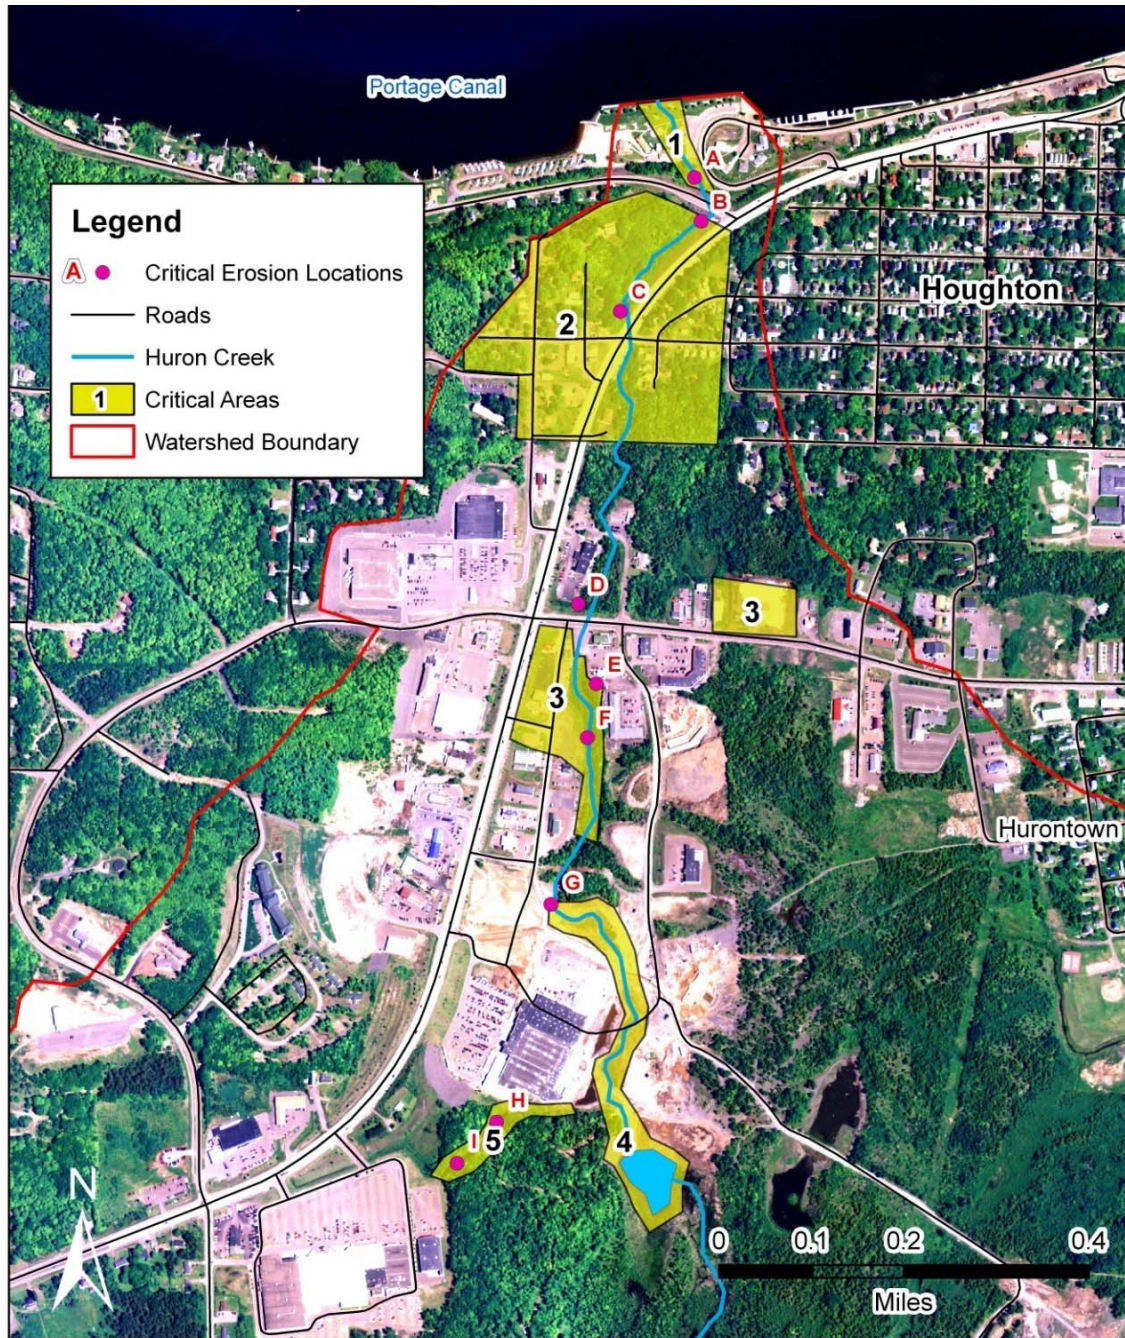
Figure 6.1 Critical areas and erosion locations.

Critical areas were identified through meetings of the Huron Creek Watershed Advisory Council and through results of data collection via the water quality, geomorphology and vegetation surveys. Figure 6.1 illustrates the locations and extents of the critical areas, each of which is labeled with a number. In addition, “critical erosion locations” are also identified on Figure 6.1, and are labeled with letters. The “critical erosion locations” are relatively small areas outside of the critical areas where erosion is occurring. Each critical area and erosion location is described below.

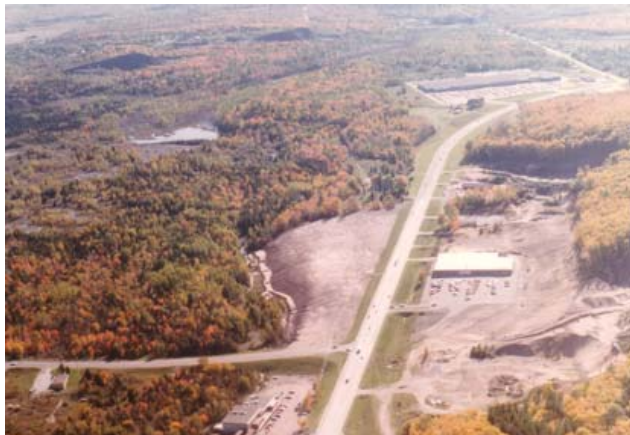
Figure 6.3 Ridge Road Landfill in the mid-1980's.

This second landfill was opened shortly after the close of the first, and is located under Ridge Road, extending south from Sharon Avenue to approximately the location of the current Miner's State Bank. The locations of the landfills are indicated on Figure 6.1. This second landfill was only operated for a few years before it was closed (Greer, 2006). Neither landfill was constructed by today's environmental standards, which would include having impervious liners, caps and leachate and methane collection systems. Therefore there has been concern regarding the environmental impact they are having on soil, groundwater and surface waters.

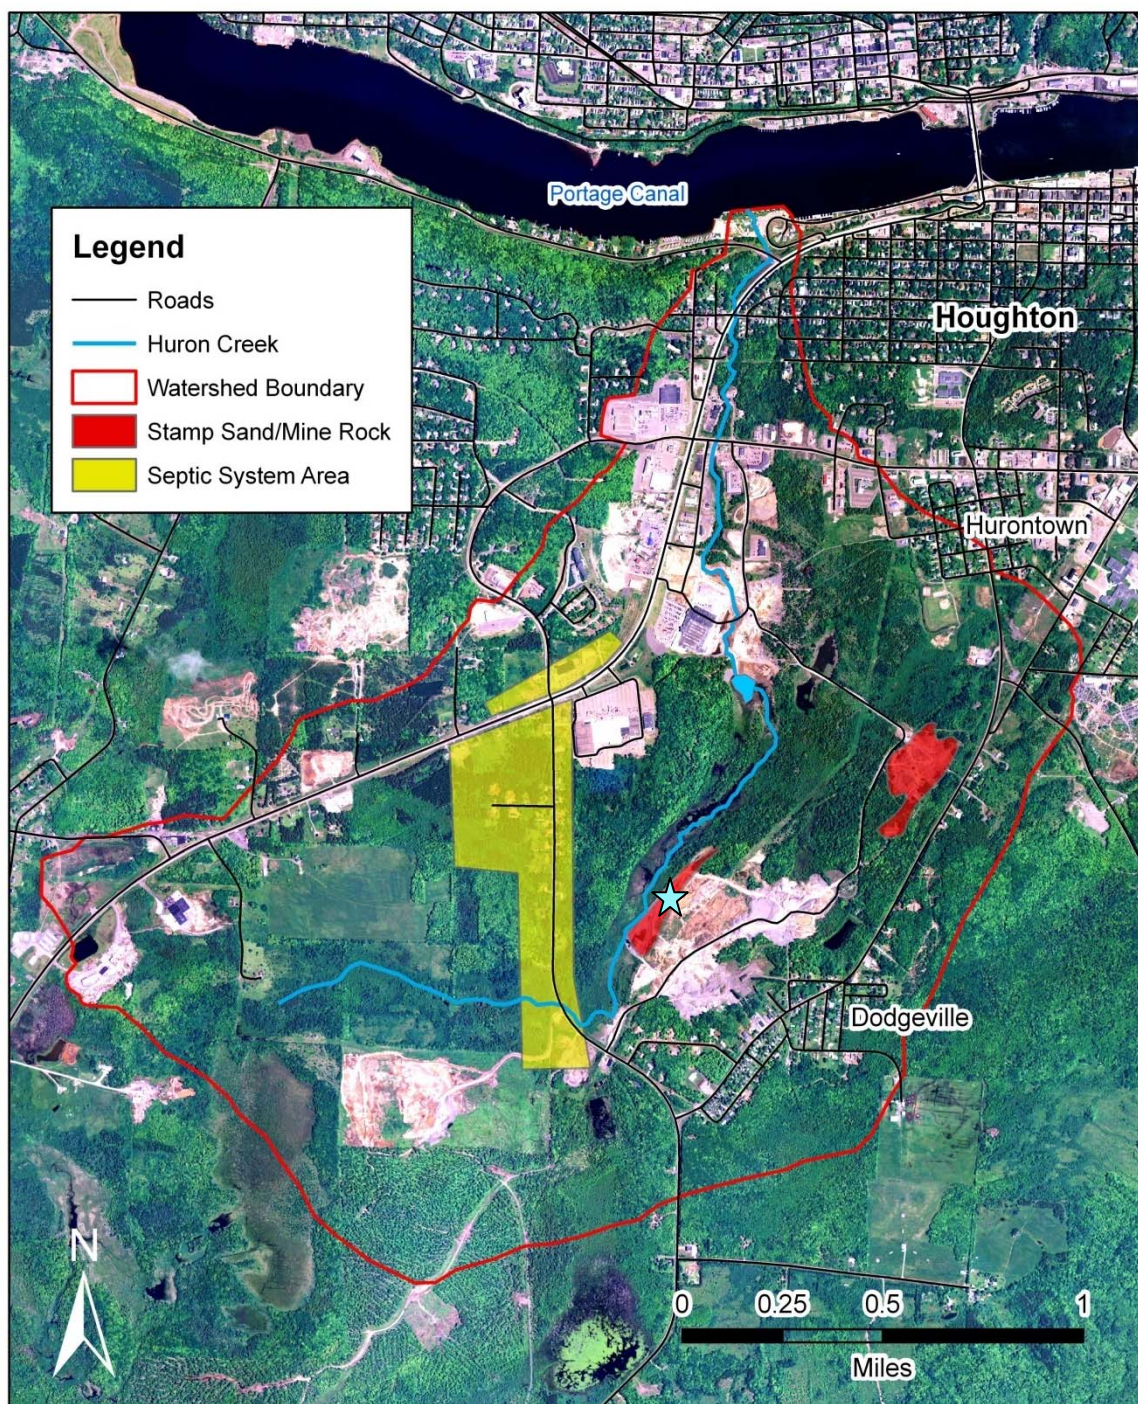
Figure 6.16 Non-critical septic system and stamp sand areas

There are a few areas that have similar environmental concerns as the Critical Areas listed above, but have not been designated as Critical Areas (Figure 6.16 shows these areas).

- The stamp sand locations are located relatively far from Huron Creek (on the order of thousands of feet from the creek) and/or do not appear to be eroding. The exception, in terms of distance from the creek, is the area shown in Figure 6.16 indicated with a star. However, the size of the majority of the materials in this area is relatively large (diameter on the order of several inches). The large size of these materials should preclude significant leaching of metals such as copper.
- Due to their significant extent (on the order of tens to hundreds of thousands of square feet), removal or remediation would require large-scale efforts, financing and multiple-property owner collaboration.
