FERRORESONANCE

- Case Study #1.: 3Ø transformer in ferroresonance with secondary side cable.
 Case Study #2.: Delta primary wound transformer in ferroresonance with primary underground cable.
 Case Study #3.: Cable in ferroresonance with transformer that has a delta secondary winding
 Case Study #4.: Overhead capacitor in resonance with improperly grounded overhead transformer bank (3-1Ø transformers) with a delta secondary connection
 Case Study #5.: Primary side circuit in ferroresonance with primary flux leakage of grounded y-grounded y 5 legged core & coil transformers
 Case Study #6.: 3Ø overhead transformer bank of 3-1Ø amorphous core transformers in ferroresonance with itself
 Case Study #7.: 1Ø secondary ferroresonance with customer step up transformer - cable - step down transformer
 Case Study #8.: Cable Ferroresonance feeding a Scott T connected 3Ø pad mount transformer.

APPROVALS	FERRORESONANCE	Article	Revision
Sponsor Engineer:		TS-60	
Engineering Best Practices Chairman:	  Ameren Electrical Distribution Design	Sheet	
Date: 05/11/04		1 of 23

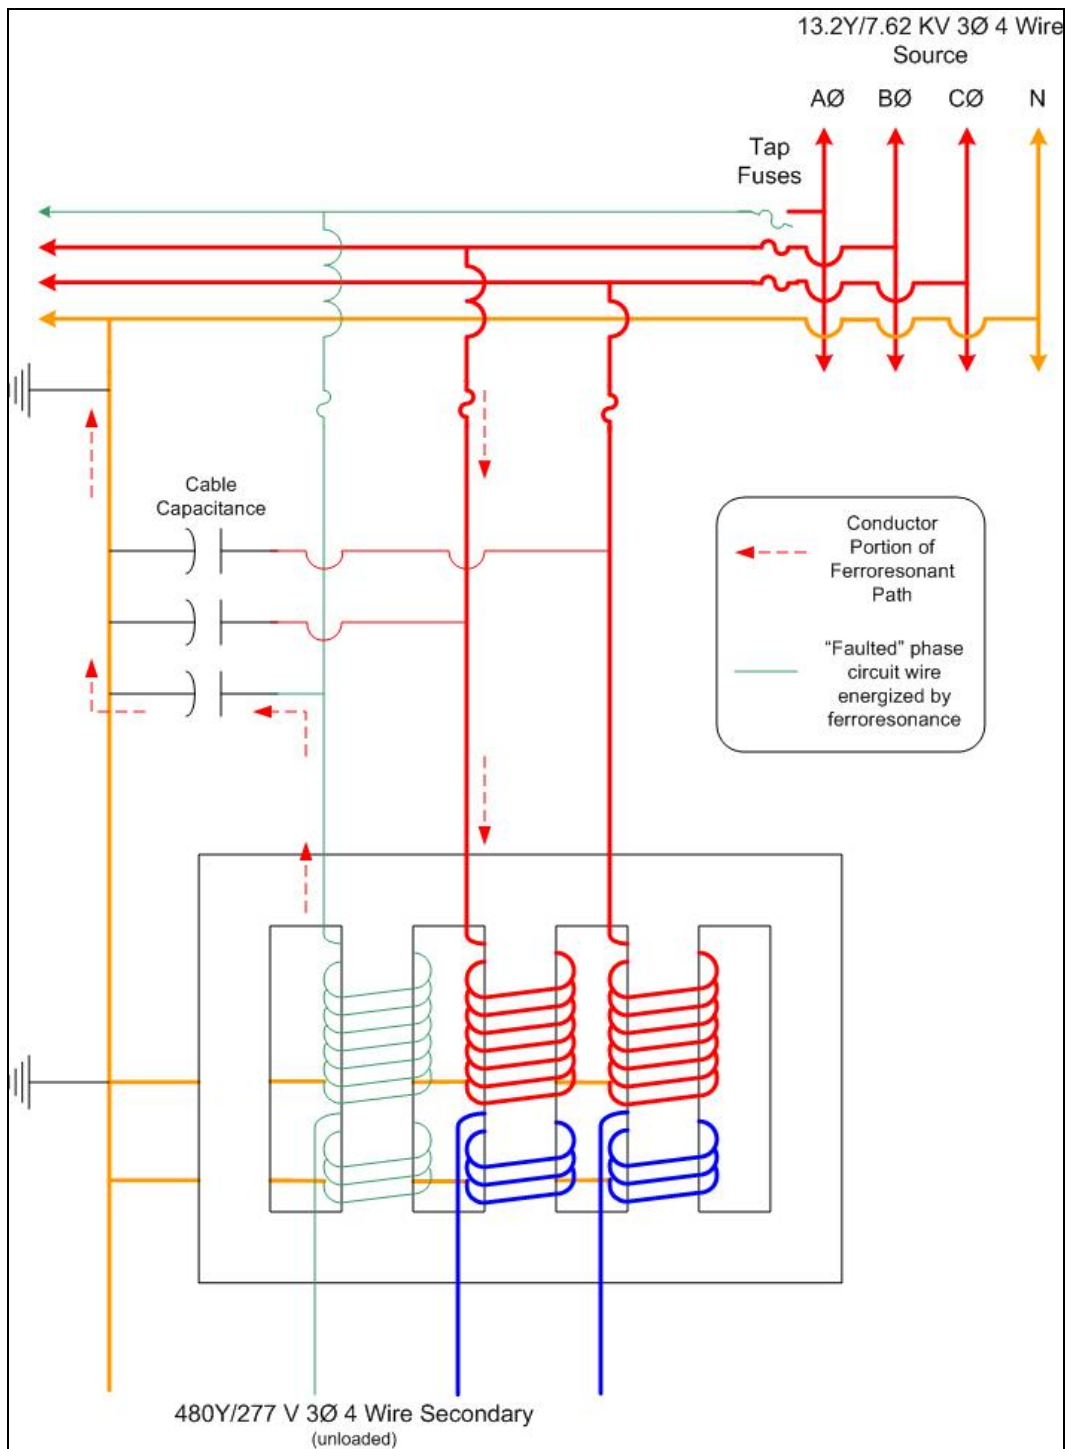
Figure № 6 Wye-Wye 5 Legged Core & Coil Transformer, Ignoring Magnetic Flux Paths

Stray flux leakage between the primary windings of the 3Ø pad mount transformers was energizing the “faulted” phase which in turn was going into ferroresonance with the cable charging capacitance of the cables feeding each transformer.

Figure № 6 shows a 5 legged core and coil transformer, ignoring the magnetic flux paths. It is difficult to see the mechanism by which the inductance of the “faulted” phase is going into ferroresonance with the capacitance of the cable.

Replace the 3Ø 5 legged core and coil transformers with the less ferroresonant susceptible triplex core and coil design.
