Norman Kerle · Benjamin van Wyk de Vries ·  
Clive Oppenheimer

## New insight into the factors leading to the 1998 flank collapse and lahar disaster at Casita volcano, Nicaragua

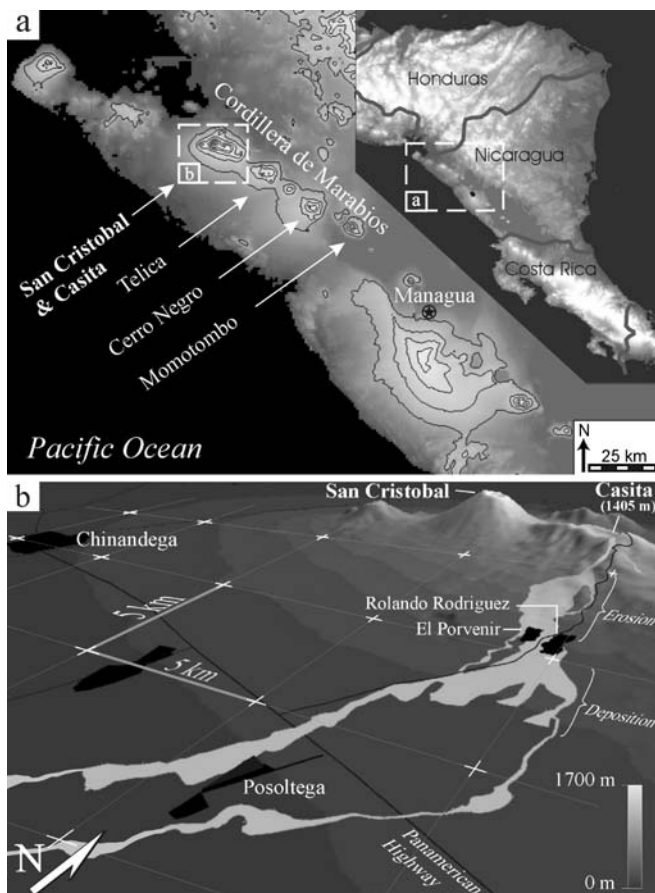
**Fig. 1** **a** Map of Casita volcano within the Cordillera de Marabios. **b** Illustration of the extent of the 1998 debris avalanche and lahar event. The flow destroyed the towns of El Porvenir and Rolando Rodriguez (>2,500 fatalities), several bridges along the Panamerican highway and led to further fatalities in Posoltega. Rainfall data during Hurricane Mitch were collected at the Chinandega weather station, located approximately 20 km west and 1,300 m below the Casita summit

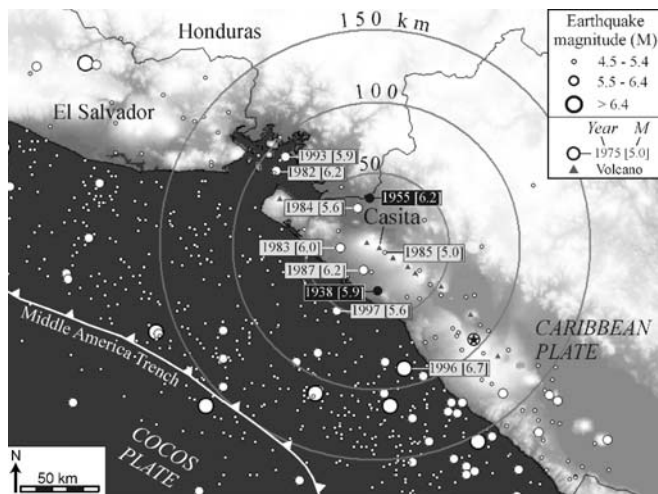
**Fig. 6** Seismic events (magnitude  $\geq 4.5$ ) around north-west Nicaragua between 1982 and 1996. Earthquakes, as well as the volcanic chain indicated, result from subduction of the Cocos beneath the Caribbean Plate at the Middle America Trench. Several moderate to strong earthquakes had their epicentres in the vicinity of Casita volcano

Seismic events with magnitudes of 4.5 or higher, which affected north-western Nicaragua between 1982 (post-Allela) and 1996 (pre-Mitch) are plotted in Fig. 6. Several of those events occurred close to Casita, including a 5.0 event in 1985 with an epicentre only 8 km away (USGS, National Earthquake Information Centre). Much of this time period coincides with the Sandinista revolution and Contra war in Nicaragua, which only ended in 1990, and resulted in limited scientific data and reports of damage caused by natural events. No seismic data were archived by the responsible national research institute (Instituto Nicaragüense de Estudios Territoriales; INETER) between 1982 and 1993, and, to our knowledge, no reports of earthquake-induced damage in the Casita area exist for this time. Additionally, the temporal resolution of the Casita photo-series is not sufficient to correlate consequences of seismic activity, such as shallow landslides, with recorded earthquakes, especially given the rapid revegetation observed following the 1998 lahar.

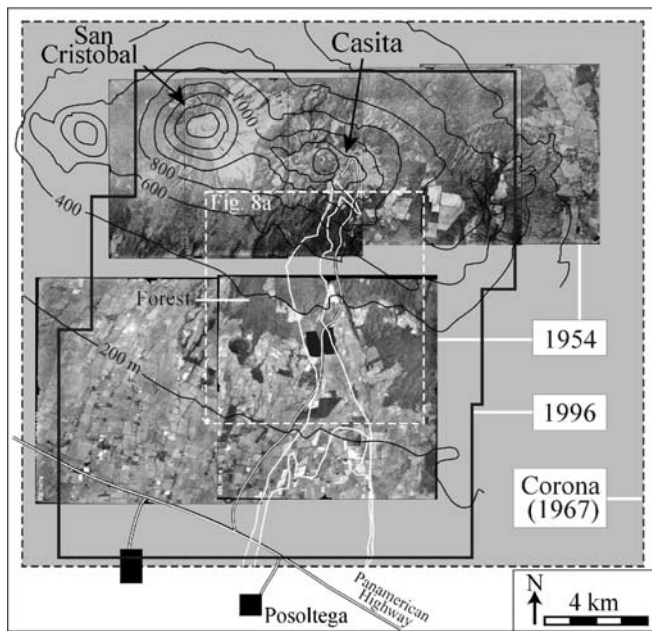
**Fig. 8** Overview of images used in the assessment of land-cover change. The 1954 aerial photographs are shown, while the 1996 photos, and 1967 Corona satellite image are outlined in *solid* and *hatched* lines, respectively. Note that the 1954 photo set is of variable scale and incomplete, with a missing flight line resulting in a 1-km horizontal gap. The photos show, however, that extensive deforestation south of the Casita and San Cristobal volcanoes had already occurred by 1954

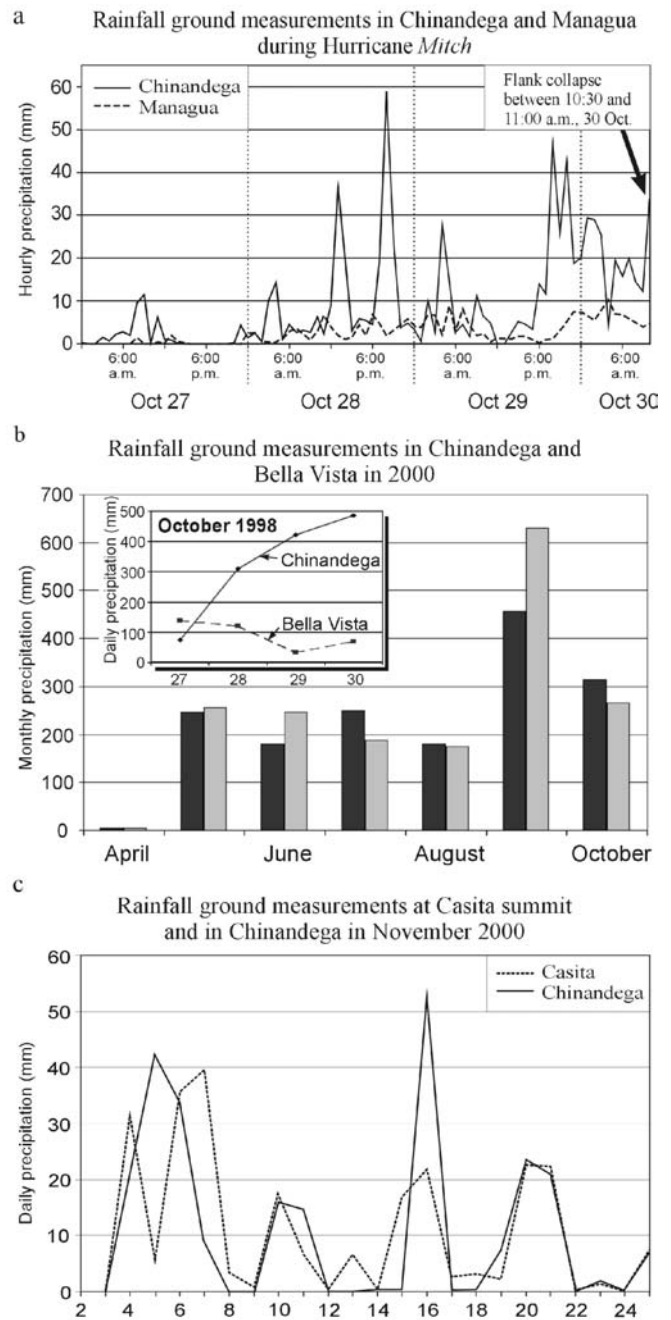
westerly flow spawned by Mitch's broad circulation (Ferraro et al. 1999; Fig. 9a). With the flank collapse occurring between 10:30 and 11:00 a.m. on 30 October, approximately 750 mm of rain were recorded over some 83 hurricane-affected hours before the disaster. The graph

In an attempt to calibrate the Chinandega data for any orographic effect, a weather station was deployed at Casita's summit in September 2000 (Fig. 9c). Despite one outlier and some temporal offsets, there is very good agreement between the Chinandega and Casita data for the 25-day observation period (257 vs 249 mm, respectively). Both outlier and offsets are likely artefacts of manual transcription of rain gauge data-strips, where sustained precipitation can be attributed either to the beginning- or the end-day of a rainfall event.

**Fig. 9** **a** Hourly precipitation values recorded during Hurricane Mitch in Chinandega and Managua. For approximately 83 h before the collapse on 30 October, 1998, hurricane-related rainfall was recorded in Chinandega, while Managua was largely unaffected. **b** Monthly rainfall recorded in Chinandega and at Bella Vista (located above 700 m on Casita's south flank) during the 2000 rainy season. The data show good agreement, suggesting a limited orographic effect at Casita. However, daily values recorded at Bella Vista during Mitch are significantly lower than at Chinandega (for example 34 mm on 20 October, compared with more than 420 mm at Chinandega), casting doubt on their reliability (inset; source: INETER 1999). **c** Daily rainfall at Casita weather station and in Chinandega

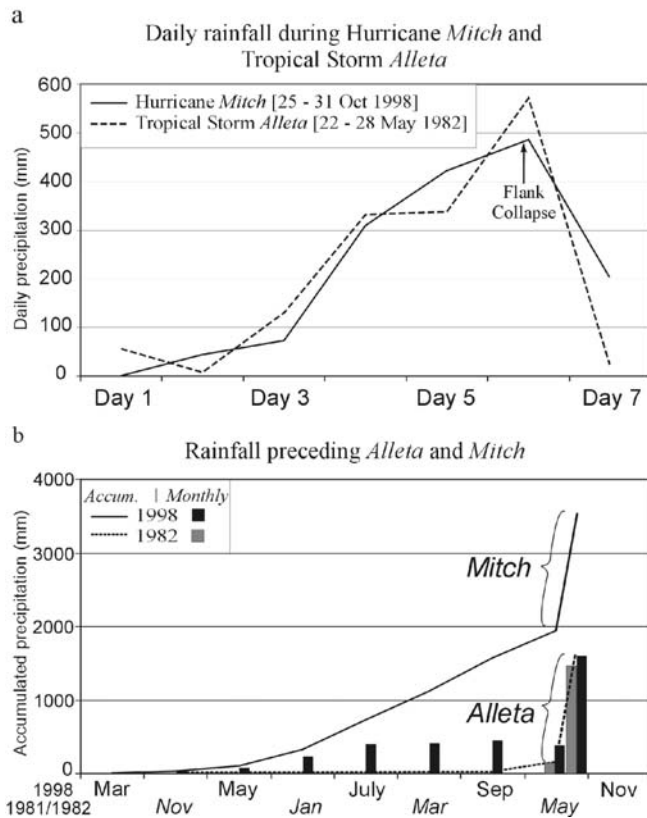
**Fig. 10** **a** Normalised daily rainfall during Tropical Storm Alleta and Hurricane Mitch. Note that rainfall during both events was comparable (a total of 1457 vs 1,538 mm, respectively). **b** Accumulated rainfall in the months preceding Mitch and Alleta, plotted on a normalised, monthly scale. A total of 164 mm fell before Alleta, and more than 1,900 mm before Mitch (source: INETER 1999). Note the horizontal chronological offset in **b** for the 1981/1982 and 1998 data

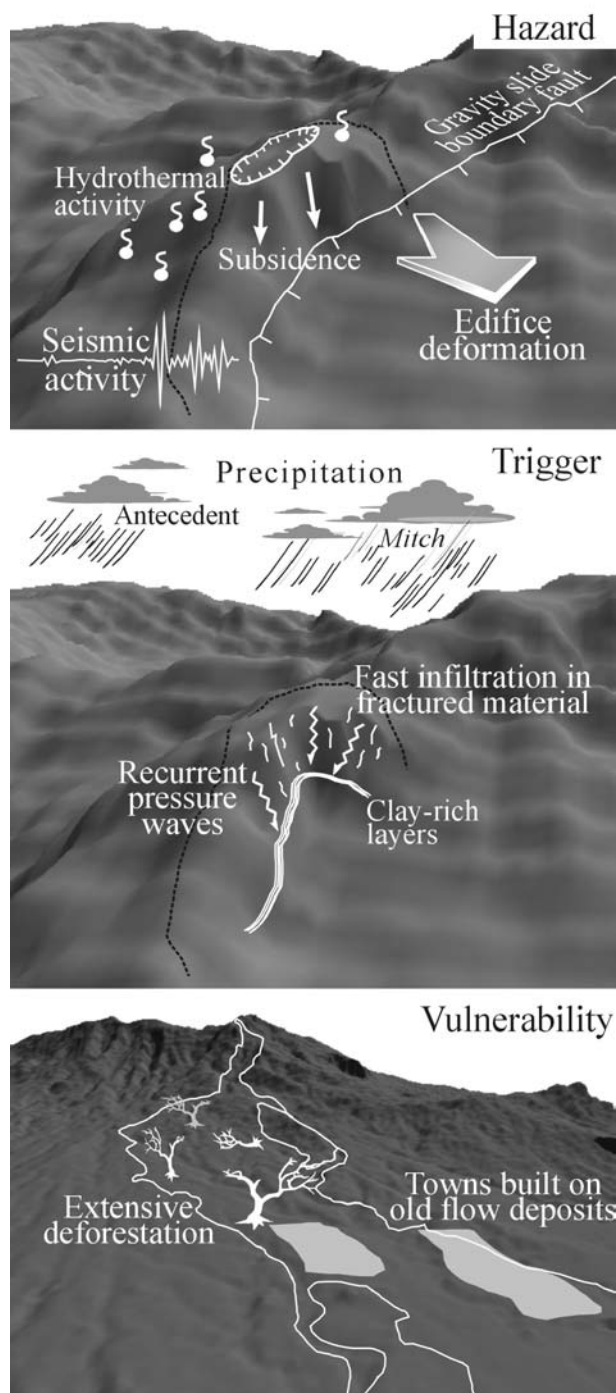
Risk is normally expressed as the product of hazard and vulnerability (Blakie et al. 1994). Although anthropogenic activity has in the past been shown to influence slope stability (Alexander 1992; Wasowski 1998), there is no evidence for any such effects on the failure flank's structural integrity, i.e. the hazard. Conversely, vulnerability was generated when settlements were established on Casita's southern slope, on top of old lahar deposits, and greatly amplified by progressive northward deforestation. The reduced hydraulic roughness not only permitted a largely unimpeded flow, but also facilitated the bulking of the material that constituted most of the lahar when it destroyed the towns. Figure 13 summarises all factors influencing the hazard, trigger, and vulnerability.

**Fig. 13** Cartoon summarising factors that influenced the flank collapse hazard and trigger, and the vulnerability of towns on Casita's southern flank. *Dashed line* denotes collapse scar
