Filo Verde, Panama Water Distribution System

International Senior Design

Filo Verde Water Distribution System: Rehabilitation and Addition

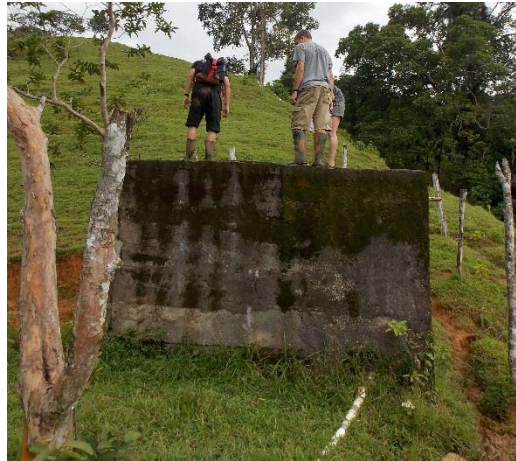
Figure 2: Current System Tank

The current water distribution system in Filo Verde has been in place for twenty years and is near the end of its lifespan. There is one source of water from a nearby spring feeding into a 2" PVC pipe that runs over 2,000-feet to the current tank. There is a spring box at the water source that consists of an angled wall structure with a small tank for storage. The current water holding tank is a reinforced concrete tank that is 10-feet in width, 10-feet in length, and 5-feet in height. It is located at an elevation of 253.3-feet. A photo of this tank is shown in Figure 2.

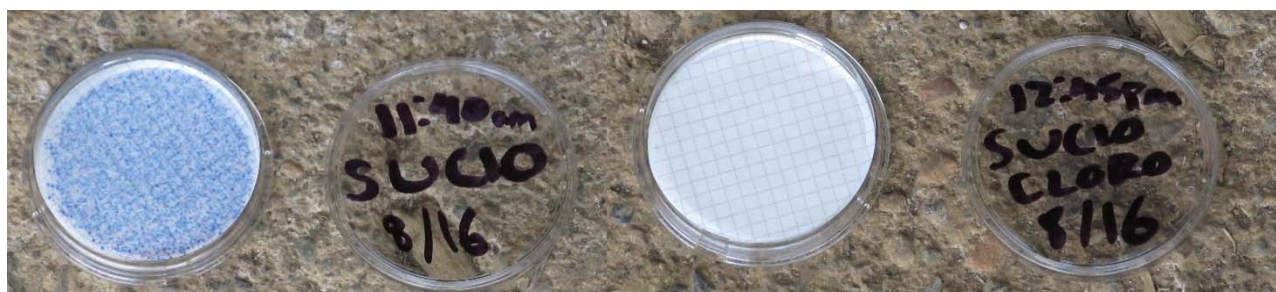
Figure 3: Water Quality Samples-Untreated vs Treated

community, with no E. coli growth but many fecal coliforms. The new spring source is uncovered, and the tests taken revealed E. coli and fecal coliform growth, most likely because it is open to the environment and runoff. When the water was either treated with chlorine or boiled, all growth ceased. Chlorine and boiling the water before use are both suitable treatments for the water in Filo Verde. Even water sources with large amount of harmful E. Coli can be treated and made safe to drink, as displayed in Figure 3.
